Drinking Water Audit Report

County:	Co. Galway	Date of Audit:	31 st July 2015
Plant(s) visited:	Mid Galway Water Treatment Plant, Scheme Code 1200PUB1038	Date of issue of Audit Report:	18 th August 2015
		File Reference:	DW2009/400
		Auditors:	Mr Darragh Page Ms Ruth Barrington
Audit Criteria:	<ul style="list-style-type: none"> • The <i>European Union (Drinking Water) Regulations 2014 (S.I. 122 of 2014)</i>. • The <i>EPA Handbook on the Implementation of the Regulations for Water Services Authorities for Public Water Supplies (ISBN: 978-1-84095-349-7)</i> • The recommendations specified in the <i>EPA Drinking Water Report</i>. • The recommendations in the previous EPA audit report dated 23/05/2014.

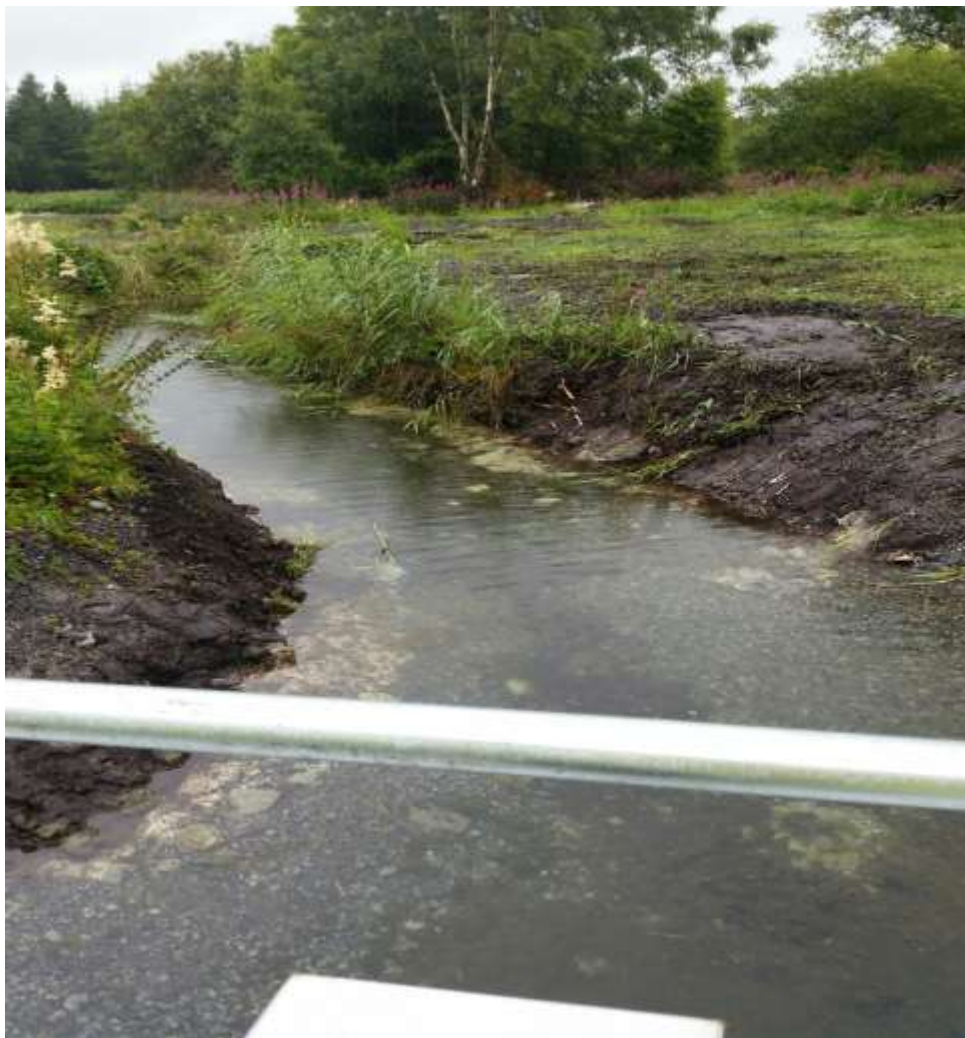
1.	<p>Source Protection</p> <ol style="list-style-type: none"> a. Water abstracted from the borehole now forms 10-15% of the raw water abstraction. b. The remaining abstraction is taken from the series of springs at the pond at the head of the Daingeanbeg River, and is piped to the treatment plant. The pond is currently open but there are plans to cover this source. c. Previously water from the spring flowed into the Daingeanbeg River for a distance of 500 m and was abstracted from the river at the Mid Galway plant. Since the previous audit Irish Water has cleared the vegetation around the spring (refer to photograph nos. 1 and 2) and now pumps the water directly via pipework from the spring to the treatment plant. This has eliminated surface water entering the raw water resulting in an improvement in raw water quality (improved UVT, reduced colour and turbidity). d. The immediate surroundings of the abstraction points are within the control of Galway County Council. Adjoining land is Coillte forestry. e. A Water Safety Plan is being developed for the supply by Irish Water, and will cover risk mitigation for catchment hazards such as contamination from pesticide use and siltation potentially arising from the forestry areas.

Photograph No. 1 Cleared vegetation around spring source and river

1. Irish Water shall complete the physical source protection work of covering the spring source as planned.

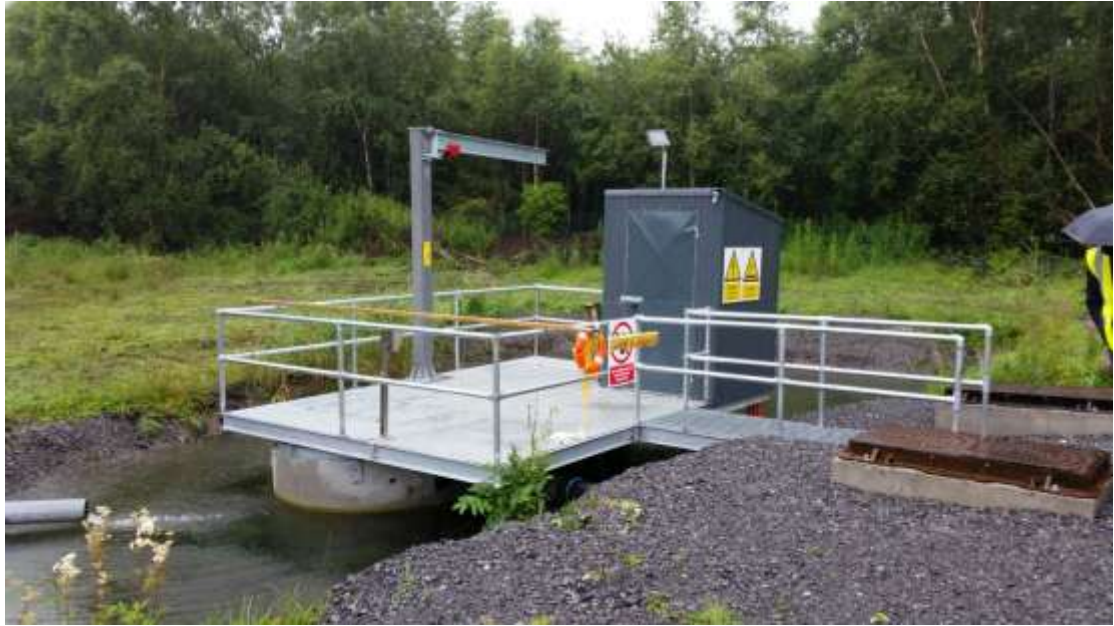
Photograph No. 2 Cleared vegetation around spring source
