Drinking Water Audit Report

County:	Galway	Date of Audit:	14 May 2014
Plant(s) visited:	Mid Galway Water Treatment Plant	Date of issue of Audit Report:	23 May 2014
		File Reference:	DW2009/400
		Auditors:	Mr Darragh Page
Audit Criteria:	<ul style="list-style-type: none"> • The <i>European Union (Drinking Water) Regulations 2014 (S.I. 122 of 2014)</i>. • The <i>EPA Handbook on the Implementation of the Regulations for Water Services Authorities for Public Water Supplies (ISBN: 978-1-84095-349-7)</i> • The recommendations specified in the EPA Report on <i>The Provision and Quality of Drinking Water in Ireland</i>. • The recommendations in any previous audit reports.

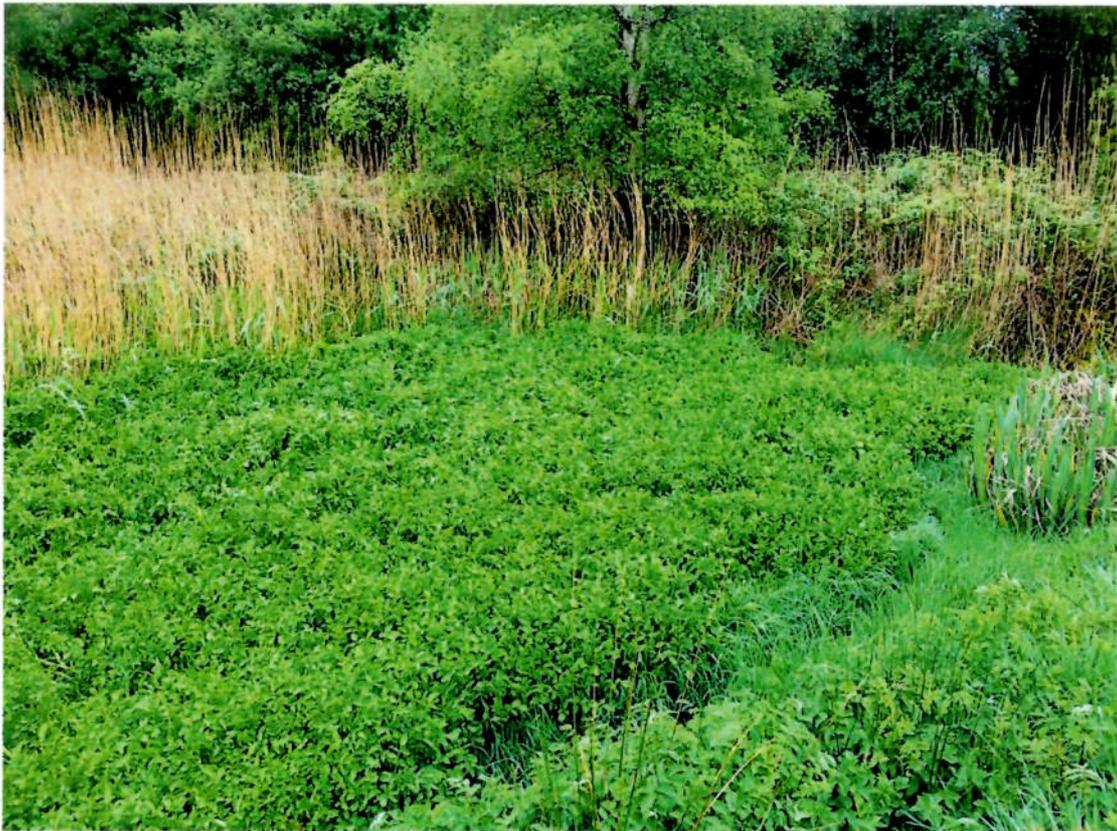
1.	<p>Source Protection</p> <ul style="list-style-type: none"> a. The source of the Mid Galway PWS is a stream that is fed from a spring approx. 600 m from the abstraction point. The supply is also fed from a borehole supply which supplies 25-30 m³/hr out of a total of 160 m³/hr. b. The two springs and the borehole were inspected as part of the audit. c. Irish Water stated that the springs are to be covered and water is to be piped directly from the spring to the plant to remove surface water run-off currently entering the stream which appears to be increasing the TOC levels in the raw water. There is considerable undergrowth to be cleared before the pipes can be laid and it was reported that this will take place when ground conditions are more favourable. d. Testing was carried out at the time of the audit which indicated that the UVT of the raw water at the spring (83.4%) was better than that in the stream (80%). Irish Water stated that this is expected to improve when the vegetation is removed from the spring (see photo 1). e. Galway County Council stated that the TOC levels in the borehole appear to be lower than that of the spring e.g. a sample on 3rd April 2014 found 3.1 mg/l in stream and 2.56 mg/l in borehole. The UVT was reported to be >90%.

Photo 1. Spring Source of the Mid Galway PWS.

1. Irish Water should submit an outline of the timeframe for the completion of the necessary works to cover the spring sources of the Mid Galway PWS and the installation of pipes to pipe water directly to the water treatment plant from the spring.
