# Drinking Water Audit Report

<b>County:</b>	Galway	<b>Date of Audit:</b>	16 October 2015
<b>Plant(s) visited:</b>	Moyola Park, Galway	<b>Date of issue of Audit Report:</b>	23 October 2015
		<b>File Reference:</b>	DW2015/33
		<b>Auditors:</b>	Ms Derval Devaney
<b>Audit Criteria:</b>	<ul style="list-style-type: none"> <li>• The <i>European Union (Drinking Water) Regulations 2014 (S.I. 122 of 2014)</i>.</li> <li>• <i>The EPA Handbook on the Implementation of the Regulations for Water Services Authorities for Public Water Supplies (ISBN: 978-1-84095-349-7)</i></li> <li>• The recommendations specified in the <i>EPA Drinking Water Report</i>.</li> <li>• The recommendations in the previous audit report issued 20 April 2015.</li> </ul>

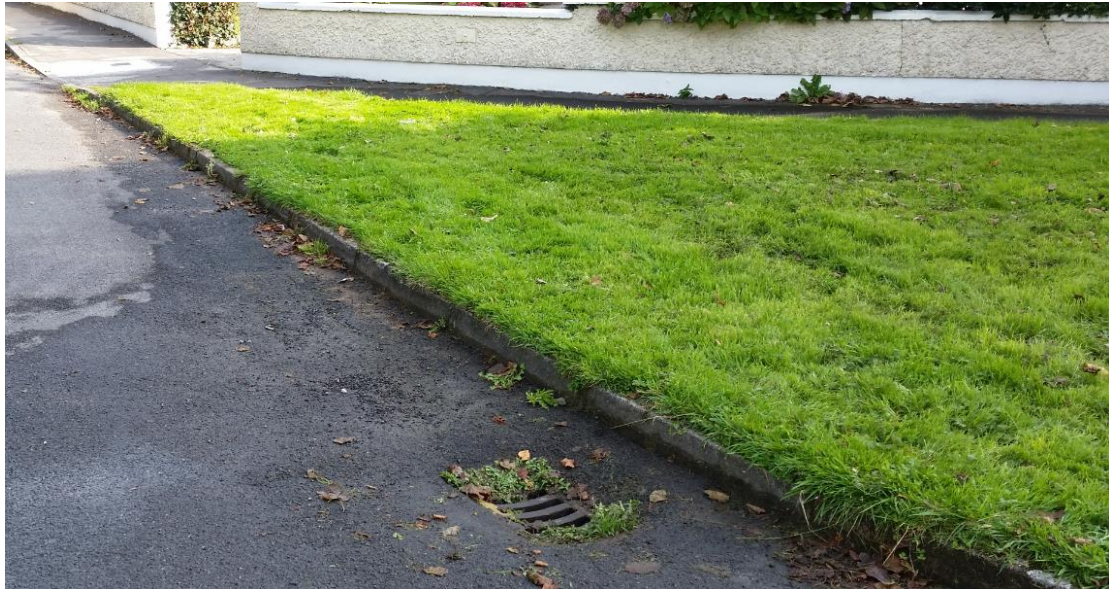
The location of one of the hydrants used for flushing was inspected during the audit and it was evident that water was being flushed to the same grassy location that was used in response to the incident last March. The flushed water that travelled over ground was entering a drain nearby but Irish Water was unclear if this drained to surface water or waste water (see Photographs 1 & 2). It was explained during the audit in March 2015 that flushing potentially contaminated water to grass and soil poses a risk of contaminating the surrounding water and soils which may lead to contaminated water leaching in through plastic mains pipe that is in present in Moyola Park. This matter was raised preciously in Recommendation 6 of March Audit Report. Concern was expressed that this practice continued to occur rather than containing contaminated flushed water or directing it to waste water for treatment.

**Photo 1** Grassy area in Myola Park where hydrant drains flushed water to. It was unclear if flushed water eventually drains to a surface water or waste water outlet.

- b) the March incident: as per Recommendation 6 of the last audit report which remains outstanding regarding progress on remediation of contaminated soils/water at [REDACTED] Moyola Park and that which possibly exists in the wider park area due to flushing of hydrants to grassy ground and drains and how it is to address any residual contamination that may remain in the domestic water systems to prevent risk of re-contamination of the water supply (including addressing the 6 houses that do not have meters/non-return valves).

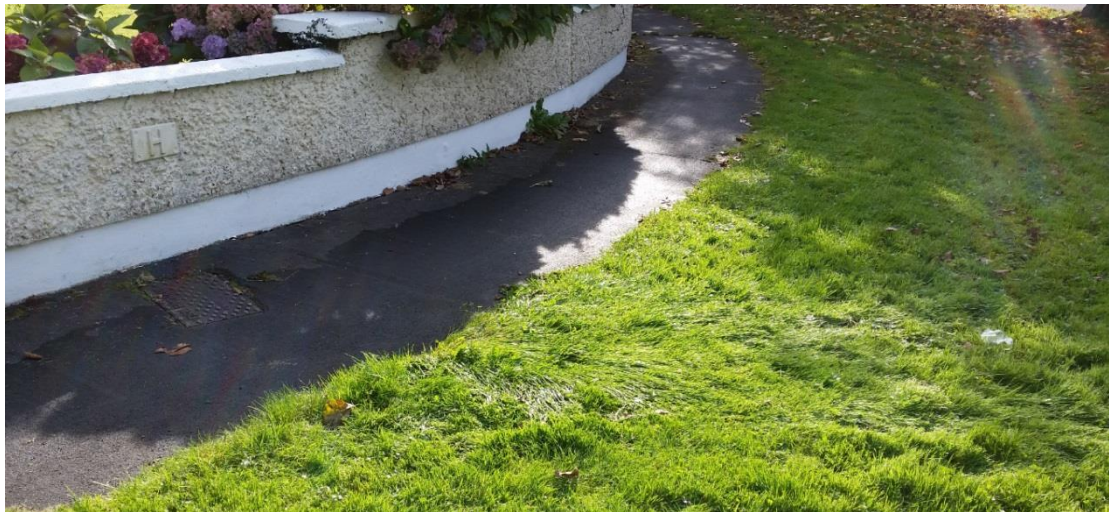
**Photo 2** Grassy area in Moyola park where hydrant drains flushed water to.

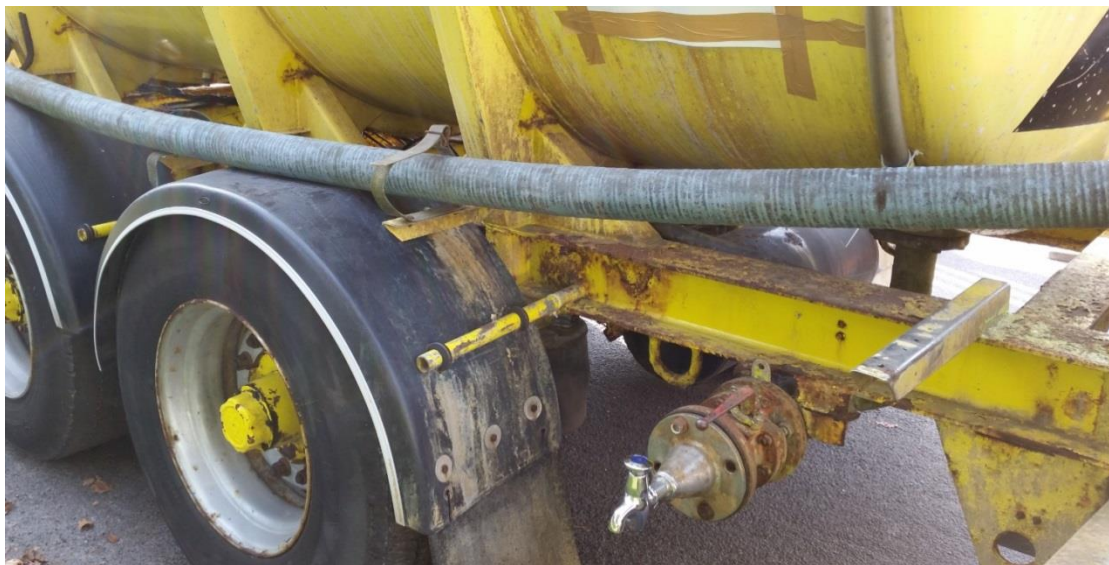
A water tanker and water bowsers were put in place in the park on 13/10/15 to supply the residents with an alternative water supply. The supply log was reviewed during the audit and it did not contain all information that the EPA specifies to be recorded. The name of the water supply that was used to fill the tanker and the quality of that water was not logged. Irish Water had to contact Galway City Council during the audit to verify where the water was being sourced from (the Galway City Water Supply at the docks area). The tanker appeared unfit for purpose (external surfaces were rusty and dirty) for storage of a food source (see Photographs 3 & 4). Irish Water had received complaints regarding the appearance of the tanker used as an alternative supply during this incident. These matters were raised during the last audit.

**Photo 3** Rustytanker used to supply alternative water in Moyola Park

- f) Informing consumers promptly when the HSE advises that a Water Restriction is to put in place to protect the public's health. Such information should be relayed to consumers promptly once advice is issued by the HSE to Irish Water and in accordance with Irish Waters Communication CoP.
- g) The provision of appropriate water storage facilities (e.g. water tankers) which are fit for purpose and meet the needs of the customer.

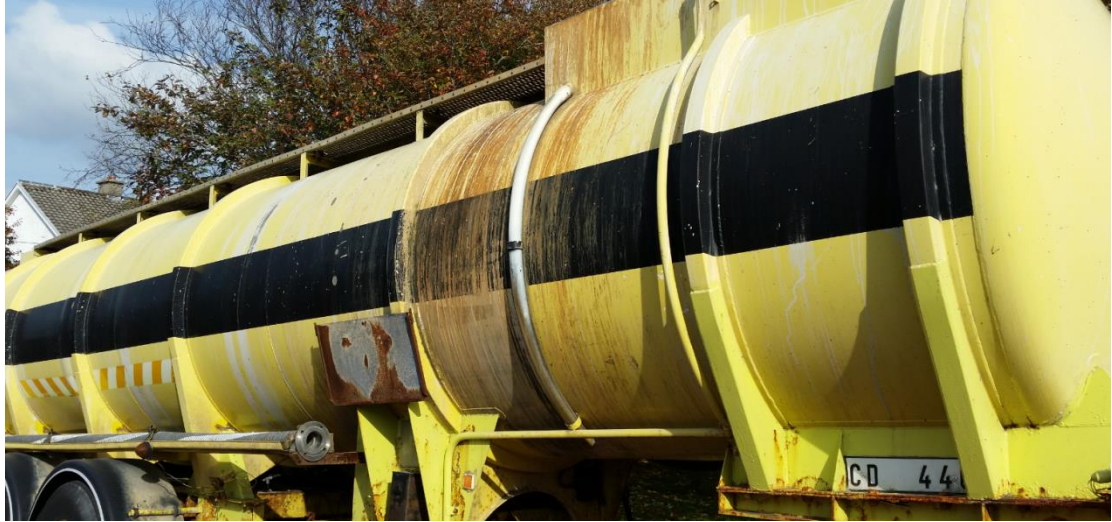
**Photo 3 Tanker supplying alternative water in Moyola Park**
