Drinking Water Audit Report

County:	Galway	Date of Audit:	18 August 2015
Plant(s) visited:	Mountbellew Water Treatment Plant	Date of issue of Audit Report:	27 th August 2015
		File Reference:	DW2015/128
		Auditors:	Ms Derval Devaney
Audit Criteria:	<ul style="list-style-type: none"> • The <i>European Union (Drinking Water) Regulations 2014 (S.I. 122 of 2014)</i>. • The <i>EPA Handbook on the Implementation of the Regulations for Water Services Authorities for Public Water Supplies (ISBN: 978-1-84095-349-7)</i> • The recommendations specified in the <i>EPA Drinking Water Report</i>. • The recommendations in any previous audit reports.

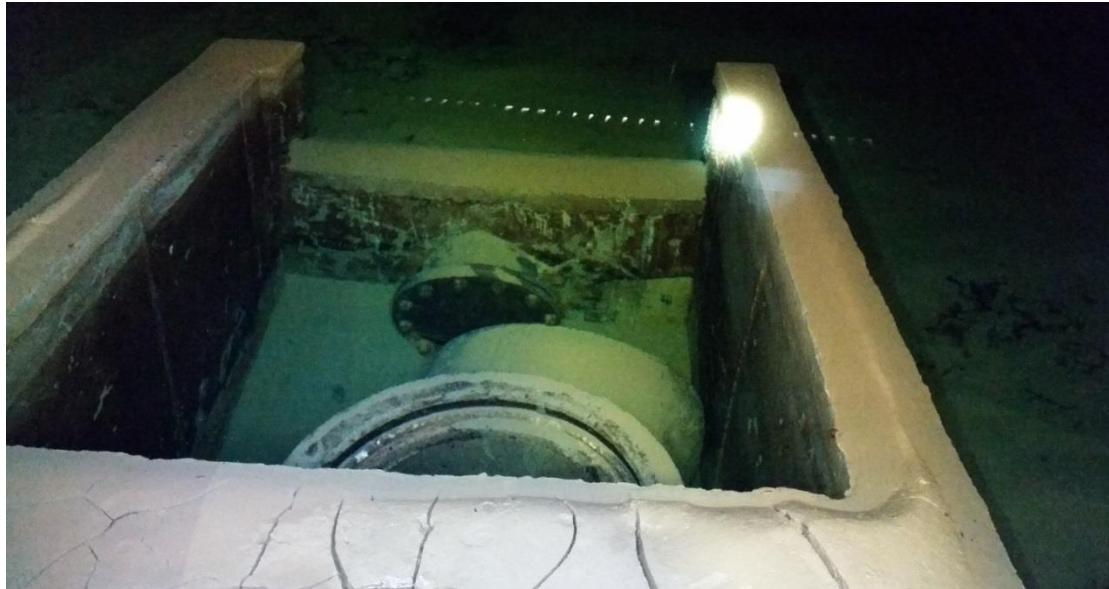
1.	<p>Source Protection</p> <ul style="list-style-type: none"> a. The spring source (Meelick Spring) for the Mountbellew PWS is covered (see Photo 1) to prevent unauthorised human or animal access and is gravity fed to the plant next to the spring. b. The EPA made reference during the audit to the report: “Establishing a Groundwater Source Protection Zone – Mountbellew PWS – Dec 2011” which is available on the EPA and GSI websites. The report states that the total Zone of Contribution (ZOC) area is considered to be 18.1 km² for this spring source. It also states that given the vulnerability of the spring to contamination, good agricultural practice relating to landspreading and slurry storage should be followed within the delineated ZOC. IW has not provided maps illustrating the ZOC to catchment users and actions to be taken in order to protect the water supply source. c. Meelick Spring is monitored quarterly under the EPA’s National Groundwater Quality Network. The presence of Coliforms and <i>E. coli</i> during 2013 and 2014s’ monitoring events indicates a surface water influence. The aforementioned SPZ report states that the spring’s discharges are “strongly influenced by rainfall events” with “an approximate 36-hour time lag”. Iron and manganese can also be elevated and exceed parametric values on occasion. d. There is an overflow from the spring chamber which is directed to a weir (water levels here have been monitored by the EPA since 2010). The quantity of water abstracted for drinking water treatment is relatively small compared to the total estimated discharge (7,530 m³/d average) of the spring. e. There is a raw water turbidity monitor on the raw water intake however this is not set to alarm when the turbidity goes above an unacceptable level. Colour is also monitored on the intake and the plant shuts down automatically if the colour is > 20 Hazen for 30 minutes.

Photo 1 Spring source covered - note thin layer of fine silt on inlet

3. Irish Water should liaise with Galway County Council in relation to the requirements of:
 - (a) *The European Union (Good Agricultural Practice for the Protection of Waters) Regulations 2014 (SI No.31 of 2014)* to ensure, unless an alternative setback distance has been set as per Article 17, that catchment users and landowners within the ZOC of the water supply are advised of their obligations as follows:

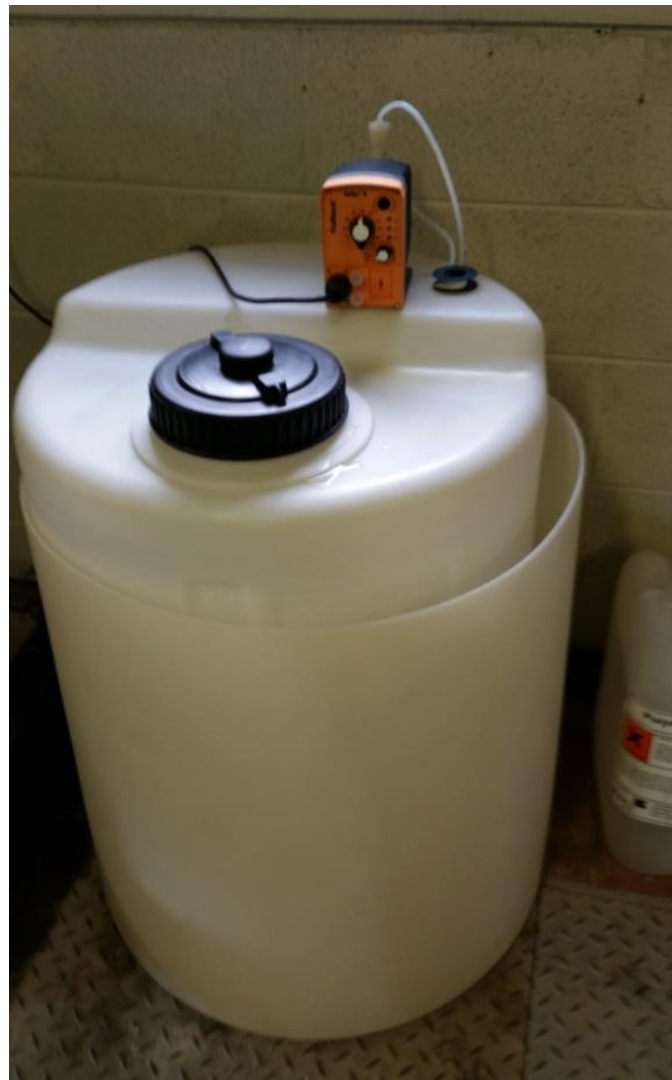
2.	<p>Coagulation, Flocculation and Clarification</p> <ul style="list-style-type: none"> a. Treatment using Poly Aluminium Chloride (PAC) initiated in 2013 and is manually introduced prior to filtration at times when the raw water turbidity approaches 1 NTU. The pre-mixed liquid PAC is set at a fixed concentration on the inlet to the filter and is flow-proportional. There are no jar tests carried out on site to determine the dose according to the raw water quality (see Photo 2). b. From January 2015 to date PAC was manually introduced at the plant on 7 occasions (4 of those were within the last month). The introduction of this treatment process is reliant on the caretaker observing that the raw water source has deteriorated. This is observed by checking

Photo 2 Liquid Poly Aluminium Chloride (PAC) dosed intermittently pre-filtration

2. Irish Water should ensure that the levels of turbidity in the filtered water are as low as possible and no greater than 0.25 NTU post filtration. Irish Water should undertake a review of the coagulation process at the water treatment works to include automation of the PAC treatment when the raw water quality deteriorates. Aluminium levels in the final water should also be monitored and recorded with the PAC treatment is in operation. Irish Water should take account of the recently published EPA Advice Note 15: Optimisation of Chemical Coagulation Dosing at Water Treatment Works available online at <http://www.epa.ie/pubs/advice/drinkingwater/dwadvicenote15.html>.

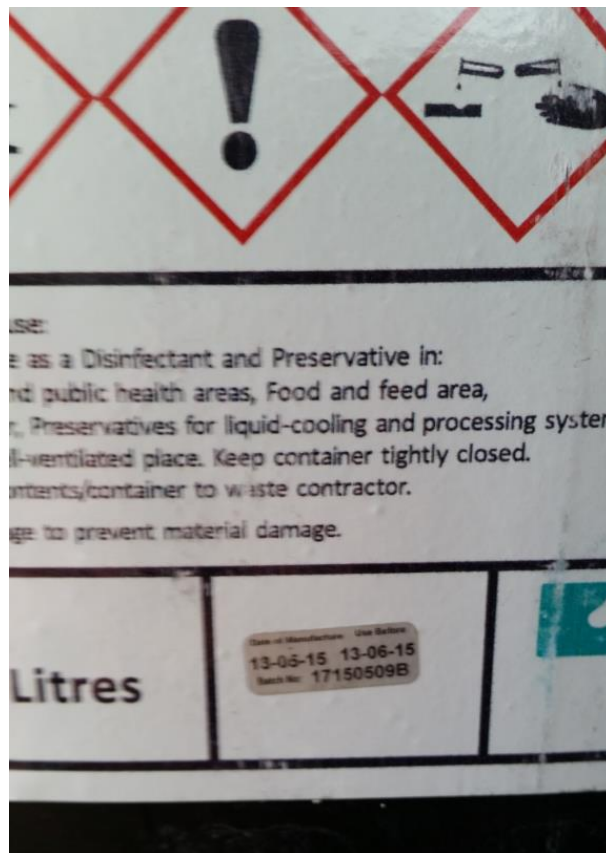
8.	<p>Chemical storage and bunds</p> <p>a. A drum of Sodium Hypochlorite 14% was out of date (expiry date of 13/06/15 was on the drum's label - see Photo 4). It was stated post the audit that this was not used in the treatment process but for general cleaning on-site.</p>

Photo 4 A Drum of Sodium Hypochlorite 14% gone past its “Use Before” date
