Drinking Water Audit Report

County:	Galway	Date of Audit:	2 nd October 2017
Plant visited:	Portumna Public Water Supply (1200PUB1042)	Date of issue of Audit Report:	19 th October 2017
		File Reference:	DW2008/146
		Auditor:	Aoife Loughnane
Audit Criteria:	<ul style="list-style-type: none"> • The <i>European Union (Drinking Water) Regulations 2014 (S.I. 122 of 2014)</i>. • The <i>EPA Handbook on the Implementation of the Regulations for Water Services Authorities for Public Water Supplies (ISBN: 978-1-84095-349-7)</i> • The recommendations specified in the <i>EPA Drinking Water Report</i>. • EPA Drinking Water Advice Notes No.s 1 to 16. • The recommendations in any previous audit reports.

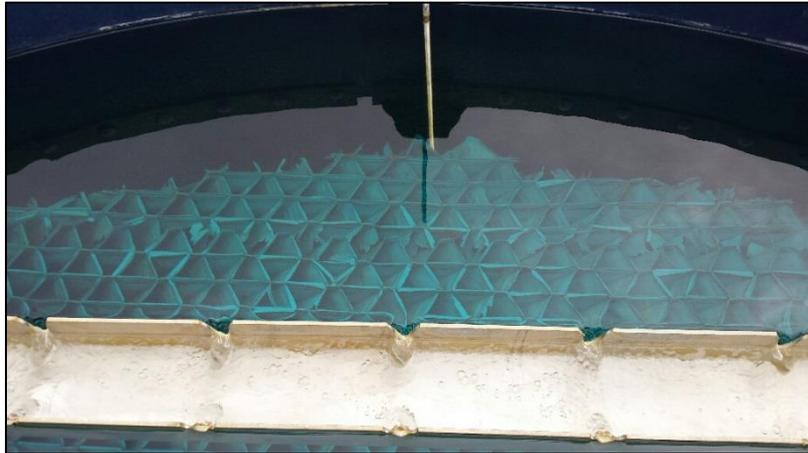
2.	<p>Clarification</p> <p>a. Since the previous audit, Irish Water has investigated the cause of floc carry over from the clarifiers to the filters and has put in place more comprehensive cleaning of the clarifiers and tube settlers, monthly jar testing, and increased the sludge bleed duration.</p> <p>b. A visual inspection of both clarifiers showed floc rising to the surface at the edges of the tanks where the tube settlers are not flush against the clarifier walls. Some of the tube settlers appeared to be damaged with bits of plastic broken off, especially at the edges (see photo 1).</p> <p>c. Irish Water confirmed that the sludge cone is located in the centre of the tanks, with sludge drawn off from the central tube settlers only, and not from the outer tubes.</p>

Photo 1: Damaged tube settlers in the clarifier

1. Irish Water should continue to regularly inspect the coagulation / flocculation processes at the water treatment works, and continue the programme of jar testing of the raw and coagulated waters to determine the optimum chemical coagulant dose and pH for the treatment of the water. The frequency of checks should be appropriate to the nature of supply and changing conditions. Results should be recorded at the treatment works and used for control of the treatment plant.
2. Irish Water should review the performance of the tube settlers in the clarifiers, and replace the damaged tubes as necessary, to prevent floc rising to the surface at the edge of the tanks. The extent of the sludge cone should also be examined to establish the optimum regime of sludge draw-off.

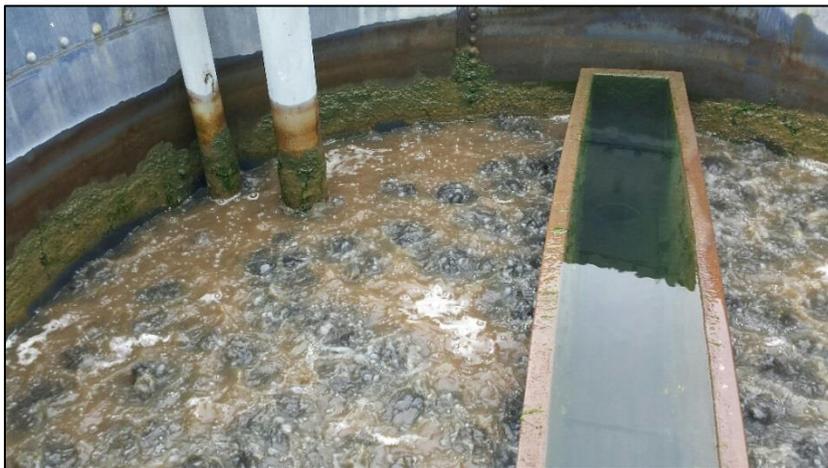
3.	<p>Filtration</p> <p>a. During a backwash of Filter No. 1, the following issues were observed:</p> <ul style="list-style-type: none"> i. a build-up of algae present on filter walls & decanting channel (see photo 2); ii. less vigorous air scour in the area close to the inlet pipework (see photo 2); and iii. uneven flow of backwash water over the weir (see photo 3).

Photo 2: Algae on filter walls and uneven air scour during backwash of Filter No. 1

3. Irish Water should address the following aspects of filter management at the plant:
 - i. ensure the filters are cleaned on a regular basis to prevent build-up of algae on the walls and the decanting channels;
 - ii. ensure the air/water backwash is even across the filter and that air nozzles are fully functional and not blocked or damaged; and
 - iii. ensure that filter weirs are level to allow an even flow of backwash water into the decanting channels.

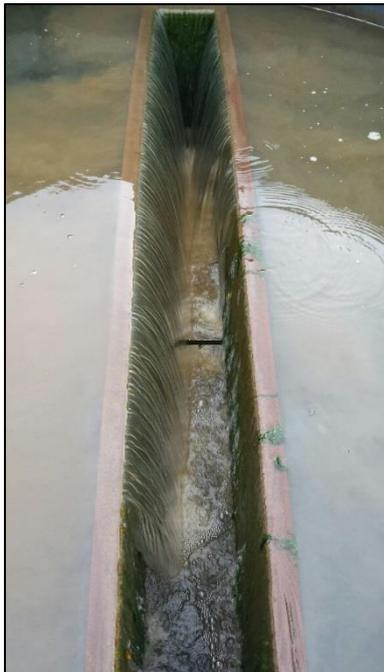
Photo 3: Uneven flow of backwash water over the weir in Filter No. 1

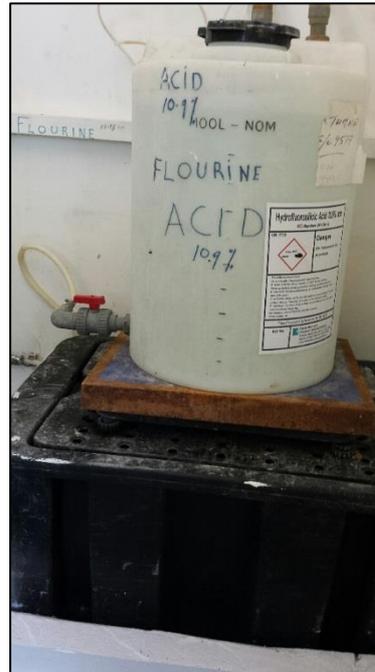
Photo 4: Hydrofluorosilicic Acid day tank

6.	<p>Chemical storage and bunds</p> <p>a. As identified in the previous audit, the current arrangement of the hydrofluorosilicic acid day tank bund presents a risk that any potential acid spill or leakage may not be contained within the bund (see photo 4). Some works have been carried out to lower the tank into the bund. Further works remain to be completed, including the installation of a screen to prevent acid splash out.</p>

5. Irish Water should ensure that any potential spillage or leakage from the hydrofluorosilicic acid day tank will be contained in the bund.
