Drinking Water Audit Report

County:	Kerry	Date of Audit:	09/04/2019
Plant(s) visited:	Caherdaniel Public Water Supply (1300PUB1051)	Date of issue of Audit Report:	08/05/2019
		File Reference:	DW2009/204
		Auditors:	Cliona Ní Eidhin
Audit Criteria:	<ul style="list-style-type: none">The European Union (Drinking Water) Regulations 2014 (S.I. 122 of 2014), as amended.The EPA Handbook on the Implementation of the Regulations for Water Services Authorities for Public Water Supplies (ISBN: 978-1-84095-349-7)The recommendations specified in the EPA Drinking Water Report.EPA Drinking Water Advice Notes No.s 1 to 15.The recommendations in any previous audit reports.

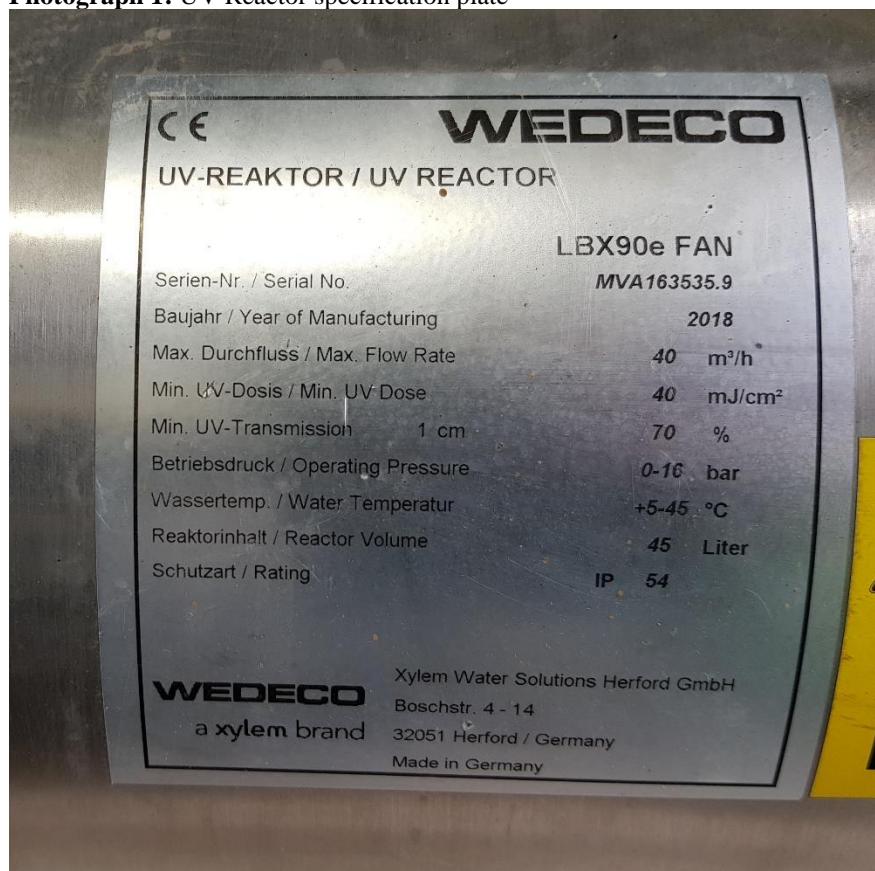
5.	Ultra Violet Treatment a. Duty and standby Wedeco LBX90e UV reactors have been operational at Caherdaniel since November 2018. The units are validated to the USEPA approach to treat water with a minimum UVT of 70% and to deliver a dose of 40 mJ/cm ² . The

<p>maximum flow rate treatable by an individual unit is 40 m³/hr. (See Photograph 1) Irish Water advised that the actual maximum flow is 22 m³/hr. Irish Water advised that the design UV dose of 40mJ/cm² is to provide secondary treatment for protozoa and bacteria inactivation.</p> <p>b. The UV units have UVT and UVI monitors in place which are alarmed. Automatic run to waste and automatic shut-down are triggered at set-points as set out in correspondence submitted to the EPA on 08/04/2019. Alarm set-points were not visible on the control panel and could not be verified as active by the auditor. These set-points were verified as active to the auditor by Irish Water following the audit. The auditor highlighted that visibility of alarm set-points by the plant operator is critical to the management of the UV disinfection units. These should be available on site for verification by the operator at all times.</p>

Photograph 1: UV Reactor specification plate

- Irish Water should ensure that the UV disinfection units' operating parameters and alarm set points are available on the relevant HMI control panel at all times and in real time for regular verification and oversight by the plant operator.
