Drinking Water Audit Report

County:	Kerry County Council	Date of Audit:	06/10/2014
Plant(s) visited:	Barraduff 1300PUB1015	Date of issue of Audit Report:	10/10/2014
		File Reference:	DW2009/103
		Auditors:	Mr Niall Dunne
Audit Criteria:	<ul style="list-style-type: none"> • The <i>European Union (Drinking Water) Regulations 2014 (S.I. 122 of 2014)</i>. • The <i>EPA Handbook on the Implementation of the Regulations for Water Services Authorities for Public Water Supplies (ISBN: 978-1-84095-349-7)</i> • The recommendations specified in the EPA Report on <i>The Provision and Quality of Drinking Water in Ireland</i>. • The recommendations in any previous audit reports.

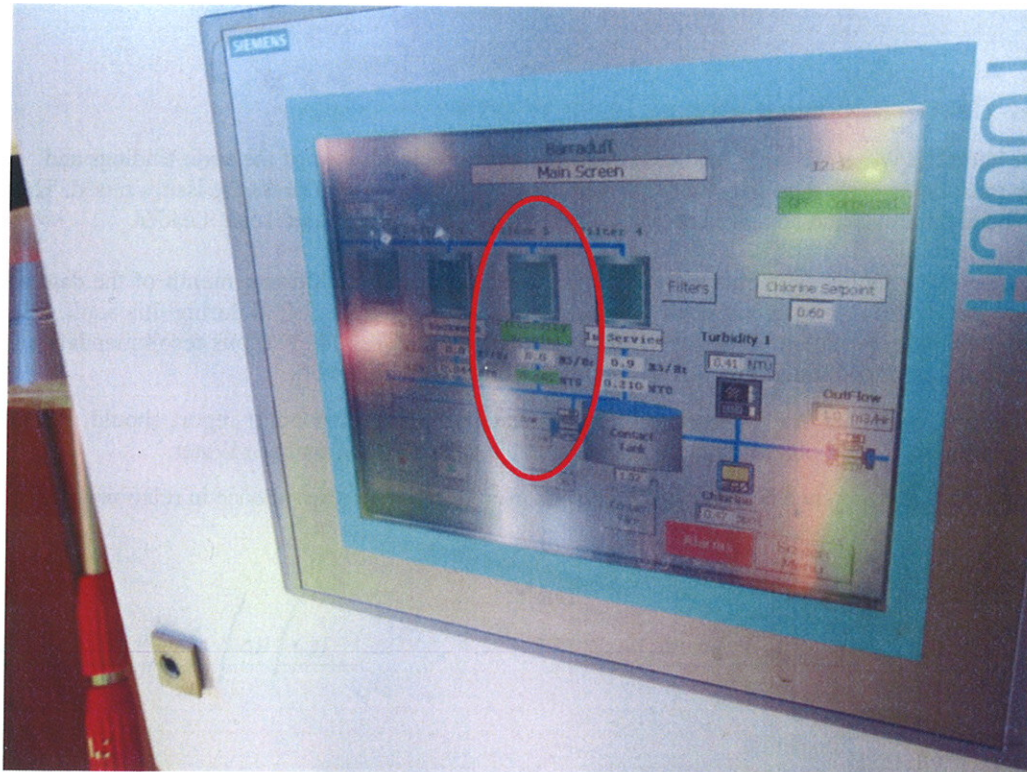
During the audit there appeared to be an issue with the displayed SCADA results for flow and turbidity for filter No 3. The Water Services Authority should ensure that the results displayed on SCADA are correct and that they mirror the results on the monitors.

Photograph 1: Flow in filter 3 was reading 0.00 m3/hr, Turbidity for filter 3 was reading 0.661NTU.

4. The Water Services Authority should ensure that the readings for both flow and turbidity on the SCADA are properly displayed and correct.
5. Water Services Authority should investigate the difference in flow across filters, and should investigate turbidity increases as flow increase through the filters.

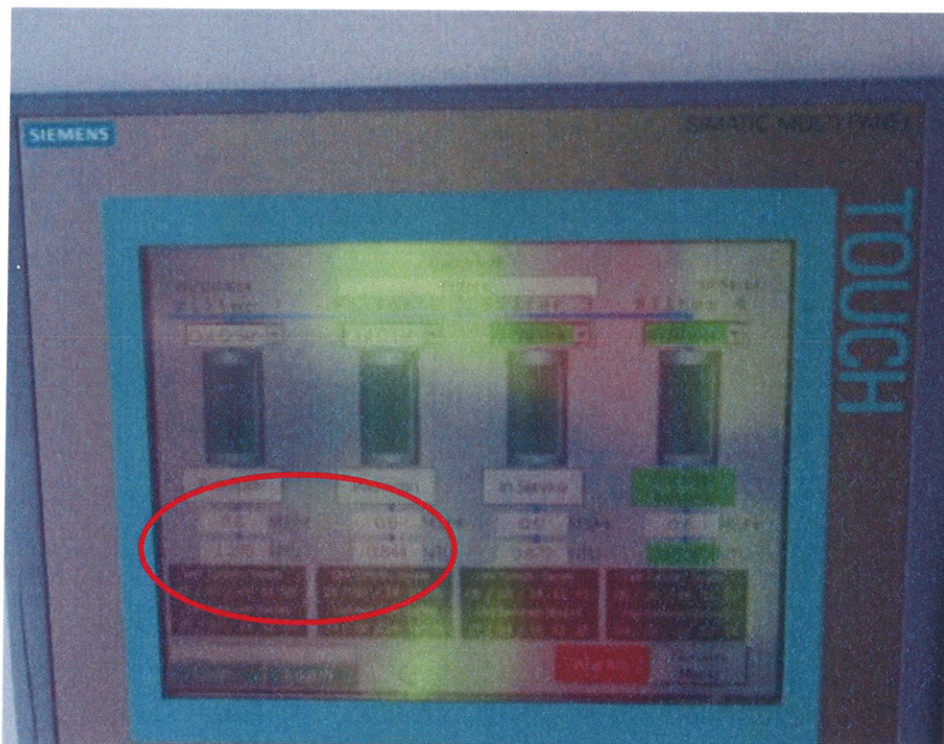
Photograph 2: Turbidity readings for filter 1 and 2, which were not in use at the time of the audit, were reading historical turbidity results of 1.27 NTU and 0.844 NTU. (please note that this picture was cropped to display the results.)

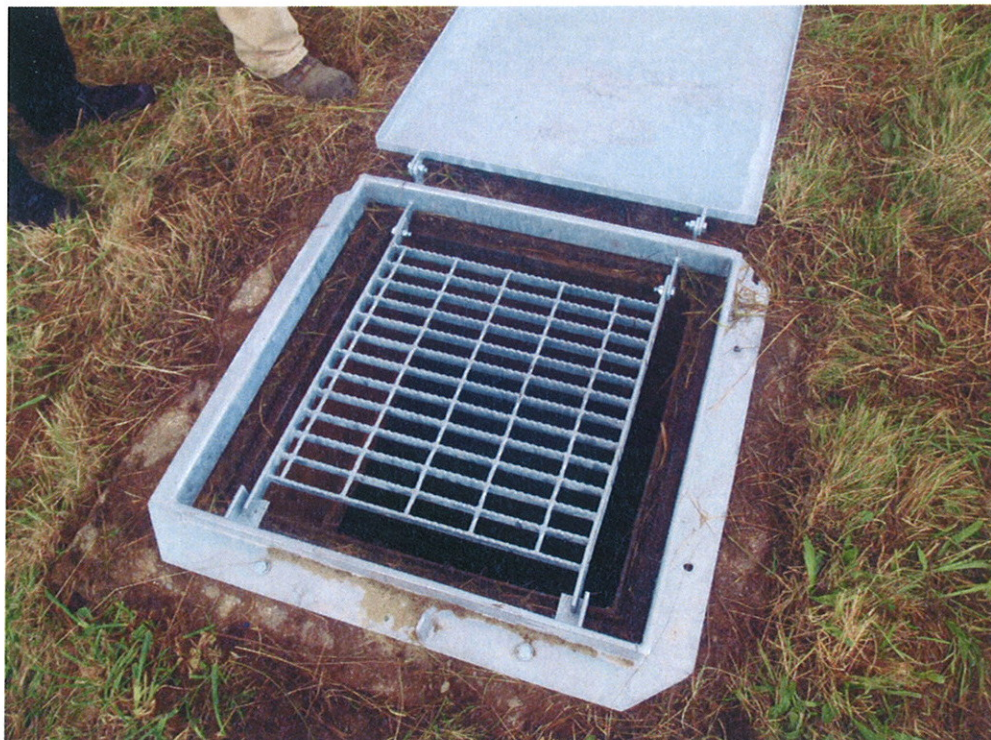
Photograph 4: All hatches were sealed and lockable.
