Drinking Water Audit Report

| County: | County Kerry | Date of Audit: | 18/07/2014 |
| Plant(s) visited: | Breanlee (1300PUB1094) | Date of issue of Audit Report: | 12/08/2014 |

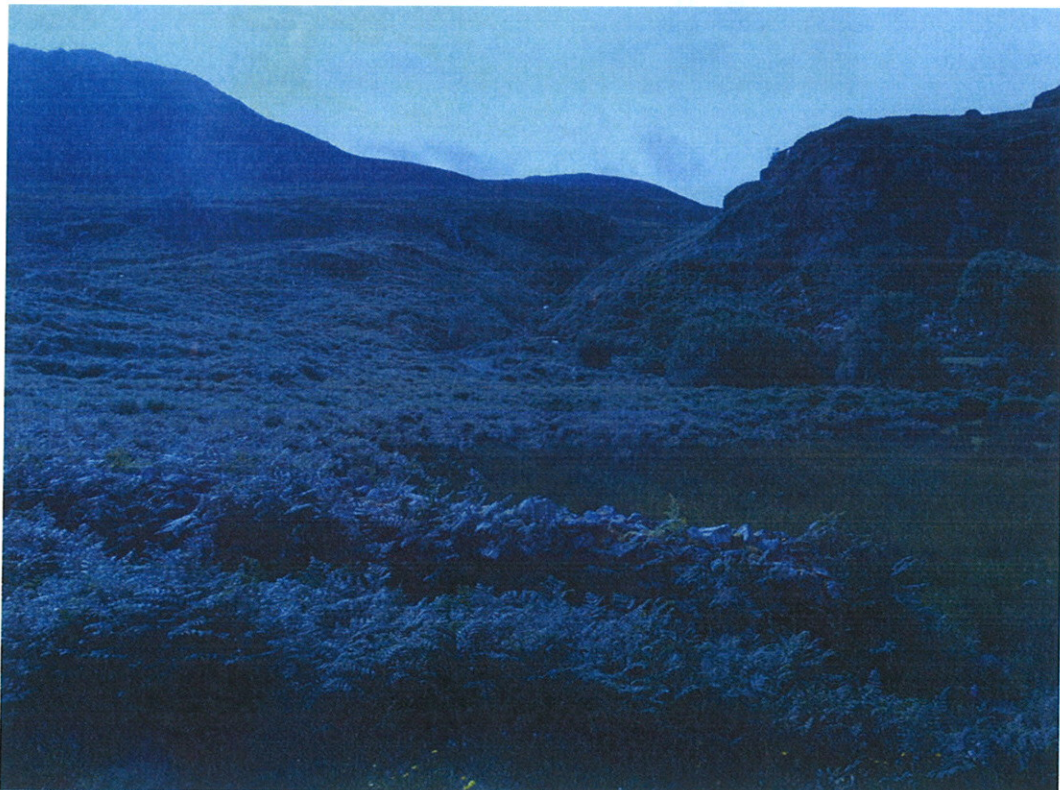
Photograph 1: Catchment

| 1. | Source Protection <ul style="list-style-type: none">a. The raw water source is a tributary of the Cottoners River, an upland mountain stream (see photograph 1).b. Sheep mainly graze the mountainous commonage catchment (see photograph 1).c. The abstraction point was surrounded with both an inner and an outer protection fence.d. There is a turbidity meter on the raw water, the reading on the day was 1.29 NTU. This monitor is not alarmed and there was no calibration sticker observed on the monitor.e. The <i>Cryptosporidium</i> risk score for this supply was calculated in October 2013 as moderate risk.f. KCC stated that the raw water quality is variable, especially after heavy rain fall, and that this can lead to issues regarding chemical dosing. |

1. The Water Services Authority should continue to characterise the variability in raw water quality. Trends in raw water quality should be analysed and used to determine the optimum treatment conditions, and compared against the calibration dosing curve.

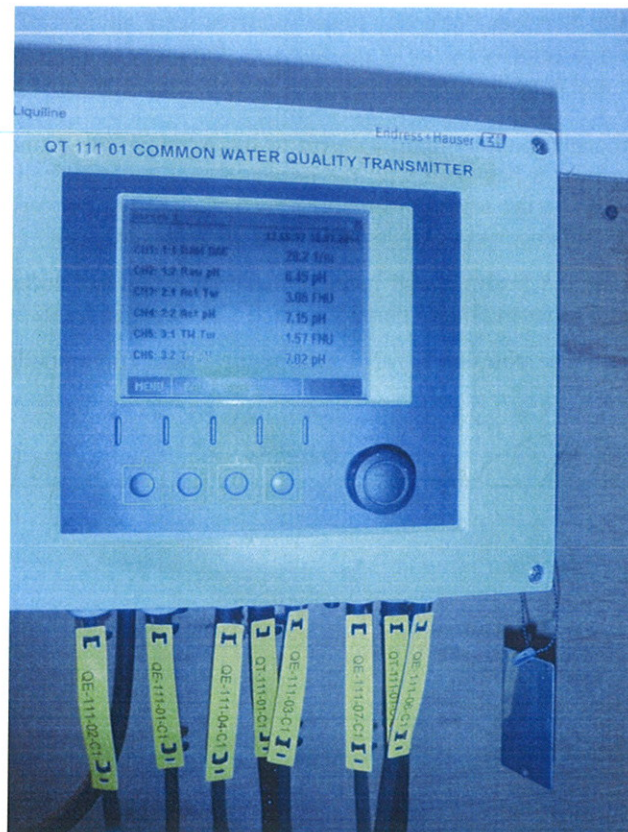
Photograph 2: SAC monitor

| 2. | Actiflow <ul style="list-style-type: none">a. Treatment consists of a new Actiflow plant, commissioned in March 2012, according to KCC.b. KCC stated that the coagulant dosing is controlled by a spectral absorbance coefficient (SAC) monitor and probe, (see photograph 2 & 3), which assesses chemical dosing based on a water quality calibration curve developed by Veolia, the design and build contractor. KCC stated that they queried the original dosing curve, especially for increased high SAC readings. On the 17/06/2014 KCC received a revised dosing curve but have also expressed concerns over the accuracy of the curve.c. There were no validation certificates for the SAC monitor on site. |

| | <p>d. KCC stated that there is no alarm on the SAC monitor, on the day of the audit the reading on the SAC monitor was 29.2 l/m. However KCC were unable to confirm whether this reading was correct. KCC propose to use a hand held UV meter in the future to check the accuracy of the SAC monitor. The SAC monitor was calibrated in November 2013 and is due for calibration in November 2014.</p> <p>e. KCC stated that they check the sand levels in the Actiflow on a daily basis and that sand is topped up once a month.</p> |

There appears to be issues with the accuracy of monitoring equipment in general at the plant, especially the SAC monitor, which is used to control chemical dosing. Irish Water should put measures and checks in place to ensure that the SAC monitor and probe and all other monitoring and dosing equipment is working correctly at all times, especially during and after periods of heavy rainfall.

2. The Water Services Authority should put measures in place to ensure that the SAC monitor is operating correctly at all times and that the calibration curve is fit for purpose, ensuring that the correct chemical dose is continually being achieved, especially during and after periods of heavy rain fall. The SAC monitor should be fitted with dial out alarms to alert the caretaker to any abnormal readings. The SAC monitor should also be connected to SCADA so that readings can be recorded and reviewed.
