# Drinking Water Audit Report

<b>County:</b>	County Kerry	<b>Date of Audit:</b>	23/06/2016
<b>Plant(s) visited:</b>	Caherdaniel PWSS 019H (1300PUB1051)	<b>Date of issue of Audit Report:</b>	07/07/2013
		<b>File Reference:</b>	DW2009/204
		<b>Auditors:</b>	Mr Niall Dunne
<b>Audit Criteria:</b>	<ul style="list-style-type: none"> <li>• The <i>European Union (Drinking Water) Regulations 2014 (S.I. 122 of 2014)</i>.</li> <li>• The <i>EPA Handbook on the Implementation of the Regulations for Water Services Authorities for Public Water Supplies (ISBN: 978-1-84095-349-7)</i></li> <li>• The recommendations specified in the <i>EPA Drinking Water Report</i>.</li> <li>• EPA Drinking Water Advice Notes No.s 1 to 15.</li> <li>• The recommendations in any previous audit reports.</li> </ul>

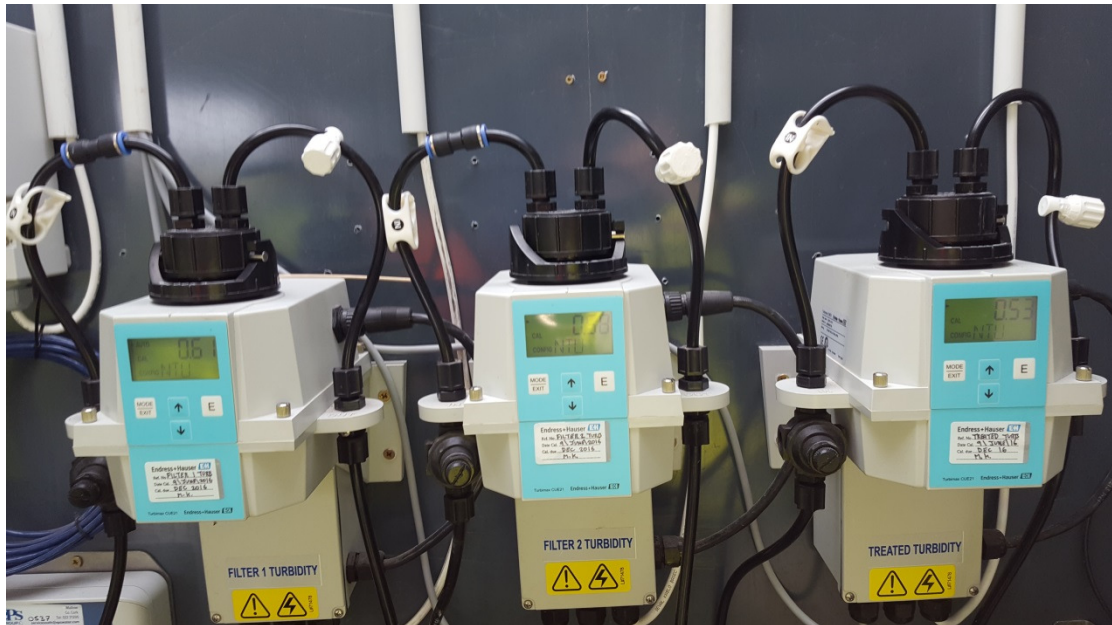
**Photograph 1: Turbidity monitors, with results  $> 0.2$  NTU. Readings from filters 0.61 NTU, 0.58 NTU and reading in contact tank, 0.53 NTU.**

4. Irish Water should progress the installation of the run to waste facility following backwash of the filters.
5. Irish Water should review the alarm levels of the filters to ensure that filtered turbidity does not exceed 0.2 NTU. Alarm levels should also allow adequate time for the caretaker to respond appropriately.
6. Irish Water should review the current location of the turbidity sampling points to ensure that accurate turbidity results are recorded and that the risk of contamination from open tanks is eliminated.

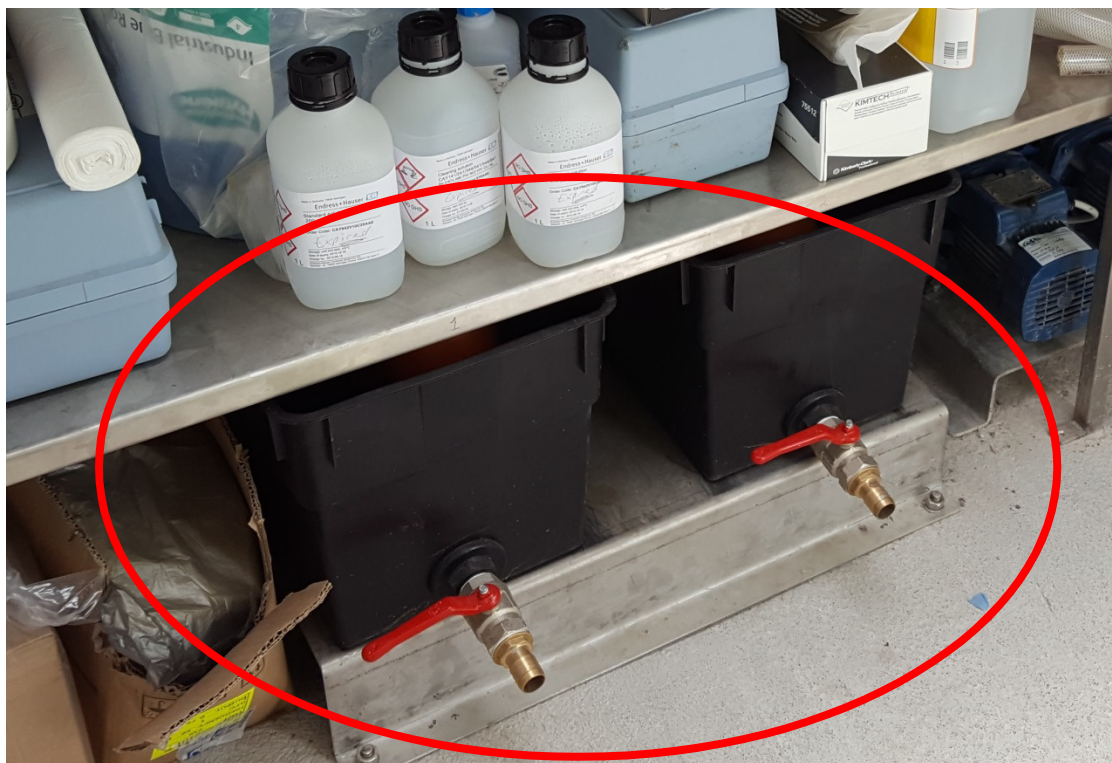
**Photograph 2: Open tanks where turbidity readings are taken from. ( Picture cropped for clarity).**
