# Drinking Water Audit Report

<b>County:</b>	County Kerry	<b>Date of Audit:</b>	23/06/2016
<b>Plant(s) visited:</b>	Castlecove PWSS 023H (1300PUB1052)	<b>Date of issue of Audit Report:</b>	07/07/2013
		<b>File Reference:</b>	DW2009/206
		<b>Auditors:</b>	Mr Niall Dunne
<b>Audit Criteria:</b>	<ul style="list-style-type: none"> <li>• The <i>European Union (Drinking Water) Regulations 2014 (S.I. 122 of 2014)</i>.</li> <li>• The <i>EPA Handbook on the Implementation of the Regulations for Water Services Authorities for Public Water 2009 Supplies (ISBN: 978-1-84095-349-7)</i></li> <li>• The recommendations specified in the <i>EPA Drinking Water Report</i>.</li> <li>• EPA Drinking Water Advice Notes No.s 1 to 15.</li> <li>• The recommendations in any previous audit reports.</li> </ul>

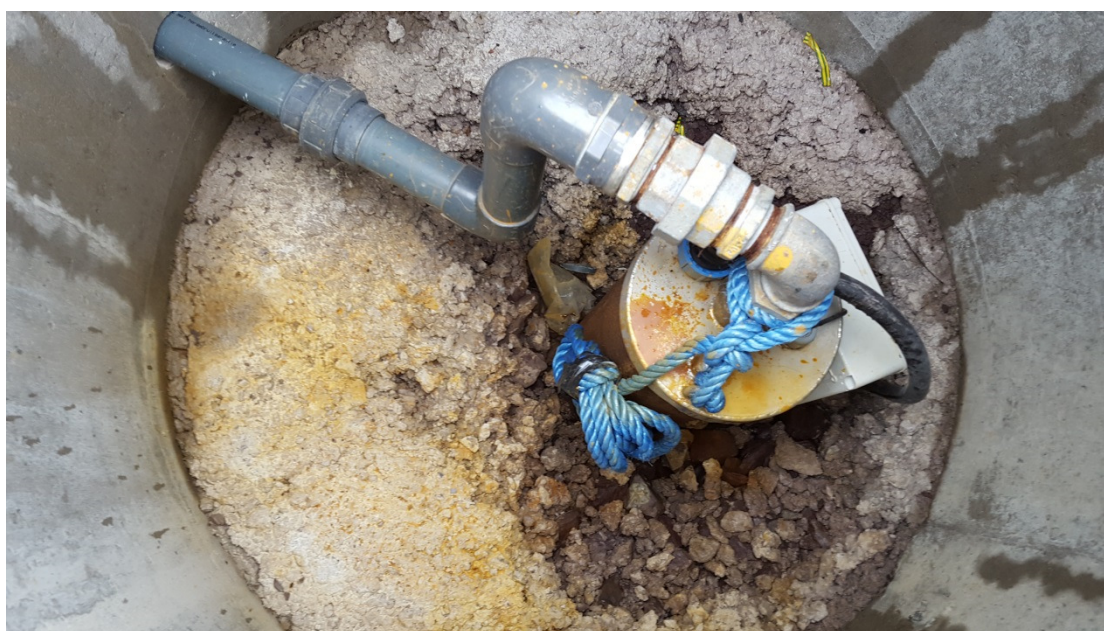
<p><b>1.</b></p>	<p><b>Source Protection</b></p> <ol style="list-style-type: none"> <li>The main source for the supply is a mountain stream called the Gowla River. A borehole located adjacent to the WTP supplements supply during high demand. The borehole was observed to be properly capped and well protected, (see photograph 1).</li> <li>The land surrounding the stream is used for grazing sheep. The stream source was observed to be well fenced off.</li> <li>KCC stated that they have colour and pH monitors on the raw water and that these are alarmed. The colour alarm is set at 30 Hazens.</li> <li>It was observed from documented raw water data that the turbidity is generally in the region of 0.2 NTU and the colour varies from 96.2 to 170 Hazen.</li> <li>KCC stated that the water from the borehole is run to waste for 2-3 days prior to being brought into service and that microbiological, iron, manganese, pH and turbidity samples are taken prior to use. There is no turbidity monitor on the borehole.</li> <li>Water from the stream and the borehole are blended prior to treatment.</li> </ol>

**Photograph 1: Borehole head adequately sealed and protected.**

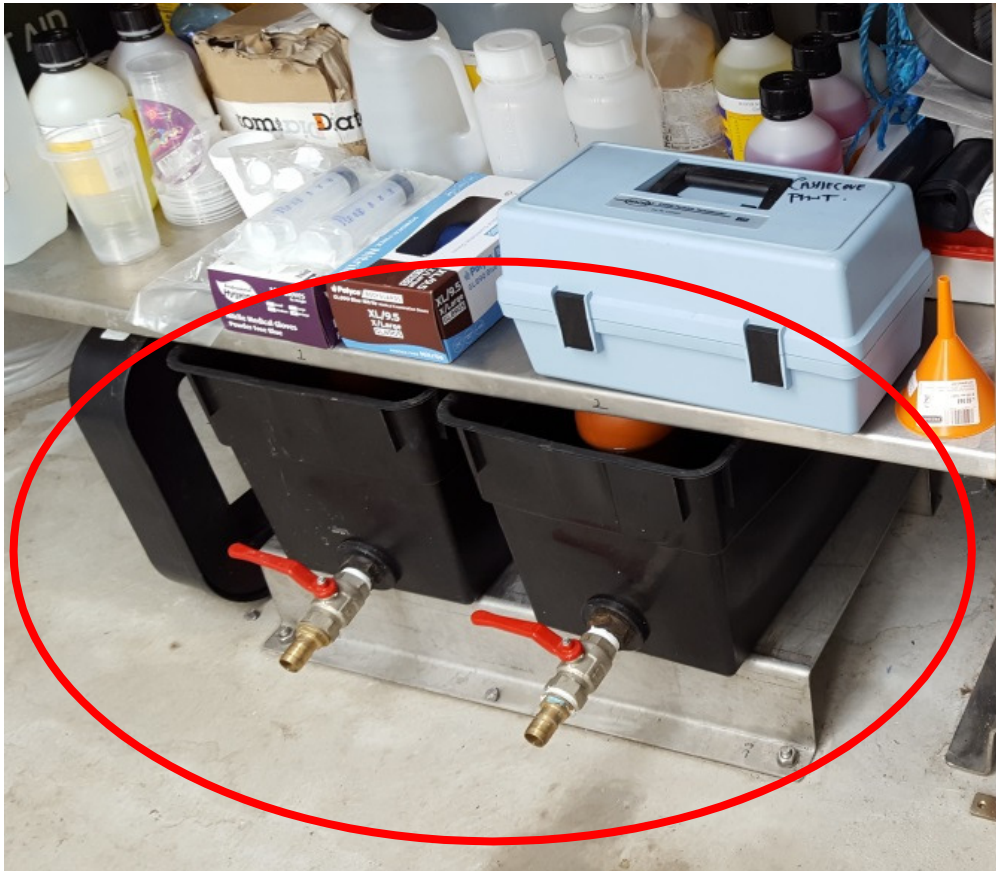
<b>3.</b>	<p><b>Filtration</b></p> <ul style="list-style-type: none"> <li>a. There are two rapid gravity filters; the filter rate through each filter is estimated as 12.5 m<sup>3</sup>/hr.</li> <li>b. KCC stated that the filters are backwashed automatically every 24 hours. The filters are brought back into service with a slow start. KCC confirmed that as part of the upgrade works a run to waste facility is being considered.</li> <li>c. A back wash cycle was observed during the audit, there did not appear to be any issues.</li> <li>d. There are turbidity monitors after the filters, alarm levels are set to 0.3 NTU.</li> <li>e. The observed turbidity readings on SCADA from each filter were 0.06 and 0.15 NTU, (see photograph 2).</li> <li>f. KCC stated that the filtered turbidity is not measured directly from the filter outlet but from open holding tanks, (see photograph 3). KCC stated that this could result in a time lag of up to 20 min in displayed turbidity readings. KCC also expressed concerns regarding the open tanks and their potential for contamination.</li> </ul>

**Photograph 3: Open tanks where turbidity readings are taken from. ( Picture cropped for clarity).**

6. Irish Water should progress the installation of the run to waste facility following backwash of the filters.
7. Irish Water should review the practice of discharging the supernatant to the local stream to ensure that there is no environmental degradation of the stream.
8. Irish Water should review the alarm levels of the filters to ensure that filtered turbidity does not exceed 0.2 NTU. Alarm levels should also allow adequate time for the caretaker to respond appropriately.
9. Irish Water should review the current location of the turbidity sampling points to ensure that accurate real time turbidity results are recorded and that the potential risk of contamination from open tanks is eliminated.

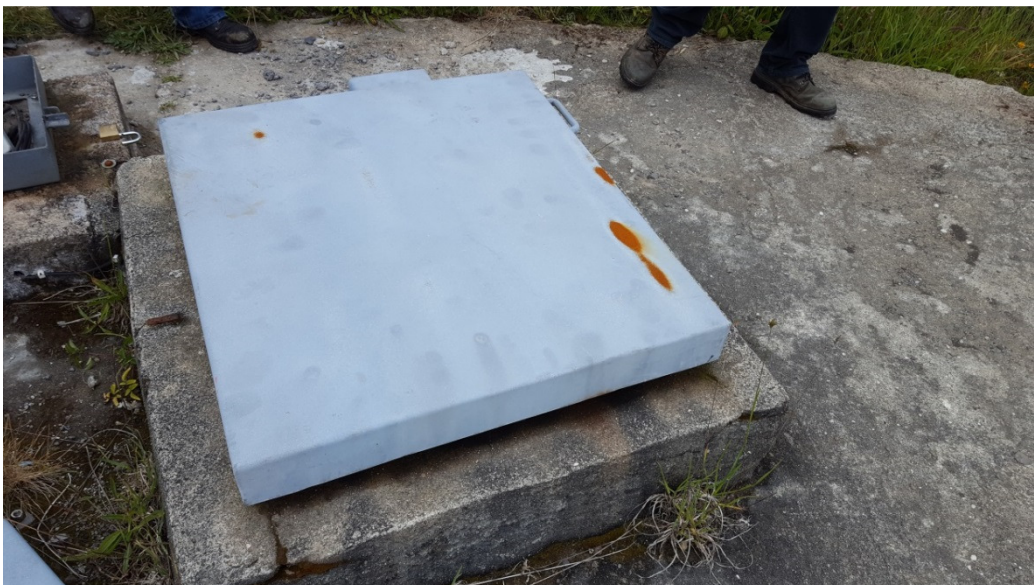
**Photograph 4: Appropriate covers on reservoir to stop contamination and insect ingress.**
