# Drinking Water Audit Report

<b>County:</b>	Kerry	<b>Date of Audit:</b>	16/02/2015
<b>Plant(s) visited:</b>	Maulin PWSS 066H (1300PUB1115)	<b>Date of issue of Audit Report:</b>	09/03/2015
		<b>File Reference:</b>	DW2009/330
		<b>Auditors:</b>	Mr Niall Dunne
<b>Audit Criteria:</b>	<ul style="list-style-type: none"> <li>• The <i>European Union (Drinking Water) Regulations 2014 (S.I. 122 of 2014)</i>.</li> <li>• The <i>EPA Handbook on the Implementation of the Regulations for Water Services Authorities for Public Water Supplies (ISBN: 978-1-84095-349-7)</i></li> <li>• The recommendations specified in the <i>EPA Drinking Water Report</i>.</li> <li>• The recommendations in any previous audit reports.</li> </ul>

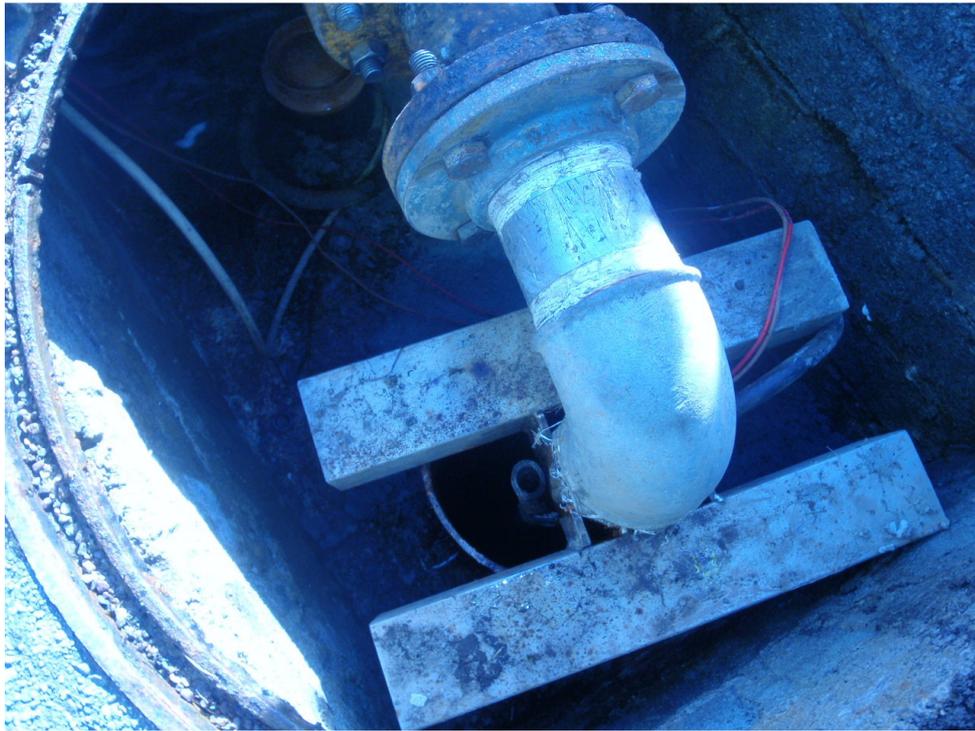
**Photograph 1: There appeared to be no grouting between the inner and outer casing.**

4. The Water Services Authority should ensure that the borehole and wellhead is constructed in accordance with *EPA Drinking Water Advice Note - No. 14 Borehole Construction and Wellhead Protection* and that grouting is installed between the inner casing and the outer borehole casing.

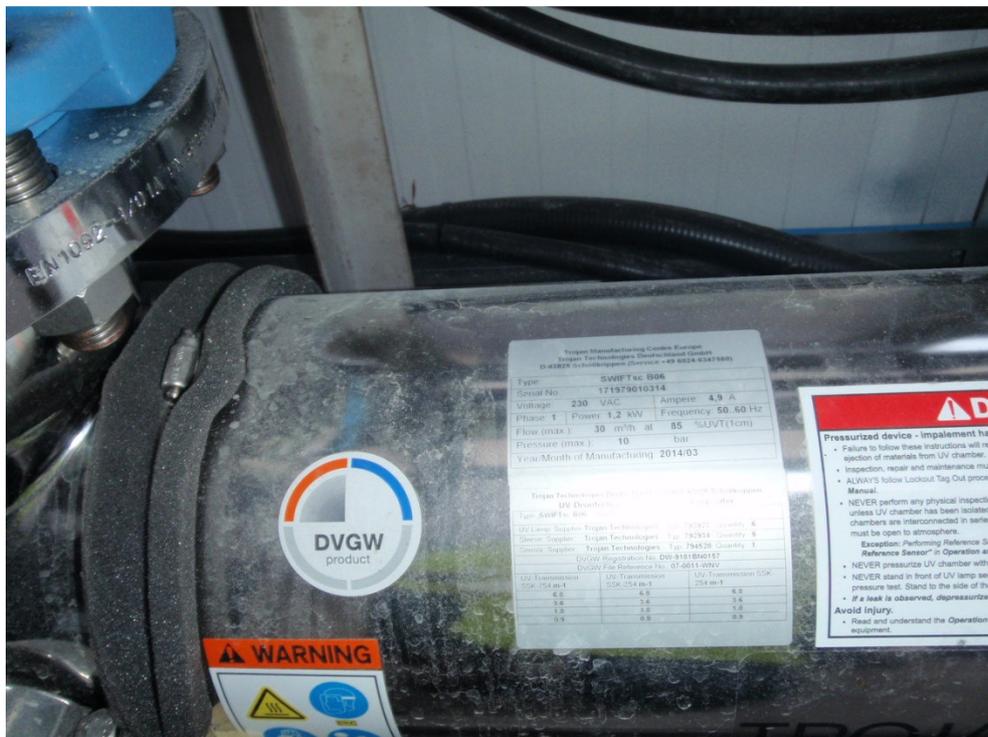
This supply is on the RAL for not having a *Cryptosporidium* barrier. A *Cryptosporidium* barrier has now been installed; and at the time of the audit was undergoing the commissioning phase. Super-chlorination is being used to treat for THMs. Disinfection is by UV and chlorination; however, according to Kerry County Council (KCC) the UV units are not adequate as the UVT of the raw water is on occasion below the validated range of the UV units. KCC also stated that there are issues with the SCADA and that results are not trended. Irish Water must ensure that the UV units operate within their validation range at all times and that results are recorded and properly trended.

**Photograph 2: UV unit validated to 30 m<sup>3</sup>/hr and 85% UVT. KCC stated that the UVT of the water can be below 85% UVT.**

1. The Water Services Authority should submit the following information to assist in the supply being removed from the RAL;
  - a. A copy of the validation certificate for the UV lamps including details of the validated range of the lamp, showing validated flow and % UVT/UVI.

- b. Confirmation that there is a UVI or UVT monitor on the UV lamp; that this is connected to a recording device and results are being trended to verify the UV units are operating within their validated range.

- d. Verification that the new UV unit, when installed, has operated within its validated range at all times (i.e. a print out for the past two months in graph form of the UVI or UVT readings; include flow through the plant on the graph).

2. The Water Services Authority must ensure, until such time as the existing UV units have been replaced, that measures are in place to ensure that consumers receive adequately disinfected water at all times.

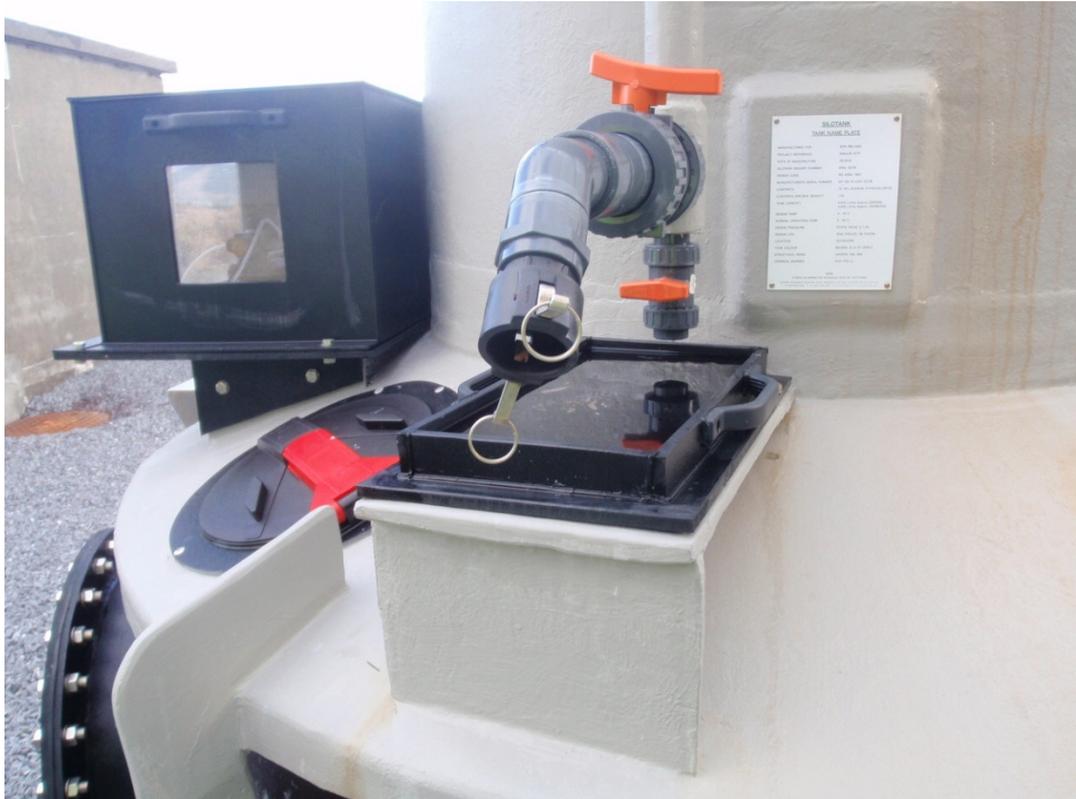
**Photograph 3: Drip tray was full of liquid and not directly below the inlet delivery point.**
