# Drinking Water Audit Report

<b>County:</b>	County Kerry	<b>Date of Audit:</b>	03/06/2015
<b>Plant(s) visited:</b>	Lissardboola 1300PUB 1105 (Network); Lisloose 1300PUB1106 (Network)	<b>Date of issue of Audit Report:</b>	09/06/2015
		<b>File Reference:</b>	DW2008/330
		<b>Auditors:</b>	Ms Cliona Ni Eidhin Mr Niall Dunne
<b>Audit Criteria:</b>	<ul style="list-style-type: none"> <li>• The <i>European Union (Drinking Water) Regulations 2014 (S.I. 122 of 2014)</i>.</li> <li>• The <i>EPA Handbook on the Implementation of the Regulations for Water Services Authorities for Public Water Supplies (ISBN: 978-1-84095-349-7)</i></li> <li>• The recommendations specified in the <i>EPA Drinking Water Report</i>.</li> <li>• The recommendations in any previous audit reports.</li> </ul>

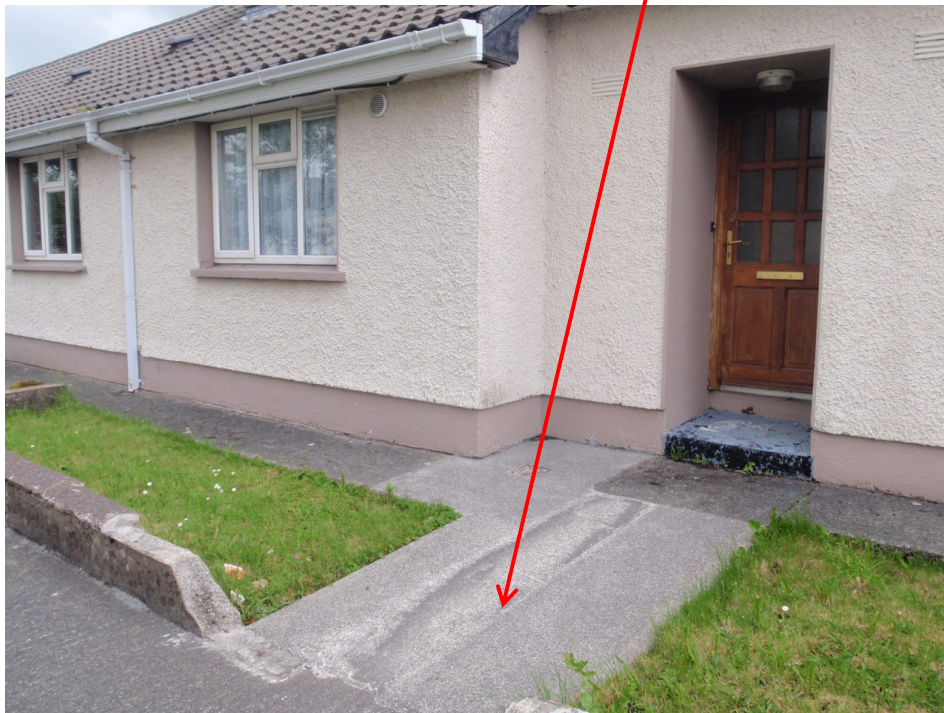
<p>c. KCC said that the new main was laid in the gardens to the front of the houses. On observation there were visible scars in the footpaths and at the front entrances of the houses, indicating some previous works had been undertaken on the communication pipe. (See photograph 1).</p> <p>d. Subsequent monitoring results for these properties were not available at the time of the audit.</p>
<b>3.</b>	<p><b>Cloonmore Road</b></p> <p>a. KCC identified that there were 123 m of lead main in Cloonmore Road.</p> <p>b. According to IW this work was completed in October 2012.</p> <p>c. According to KCC there was approximately 19 houses connected to the lead main. KCC stated that there were no local authority houses in this area.</p> <p>d. The main was located in two separate alleyways. Each alleyway was located at the side and rear of the houses.</p> <p>e. In one alley way there were visible trench scars in the road surface. In the other, the road had been resurfaced and no trench scars were visible, but new stopcock / water meter chambers were observed (see photograph 2 and 3).</p> <p>f. No monitoring results were available at the time of the audit. KCC were unaware if property owners had been given appropriate advice regarding the removal of internal lead plumbing.</p>

**Photograph 1 Balloonagh Close; trench scar to stopcock.**

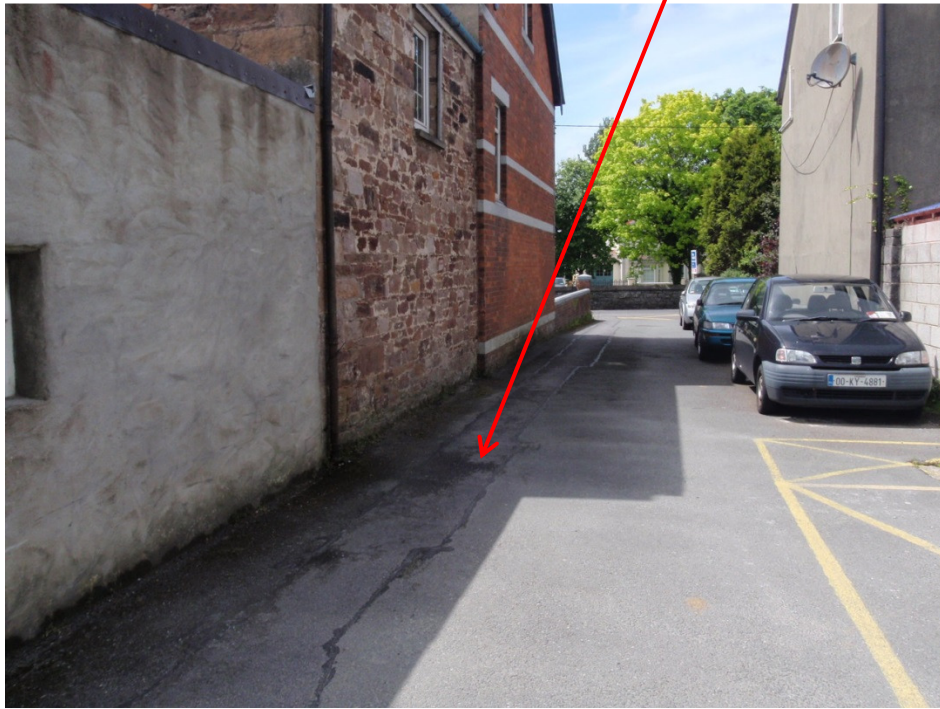
**Photograph 2. Cloonmore Road, trench scar in alley way.**

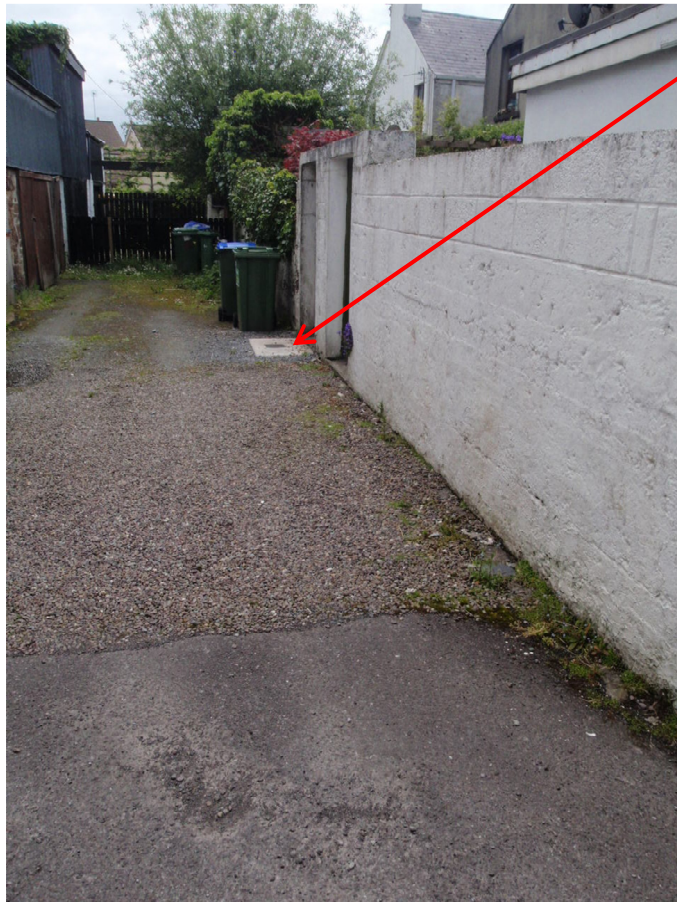
**Photograph 3: Cloonmore Road, no visible trench scar, but new meter chambers observed.**

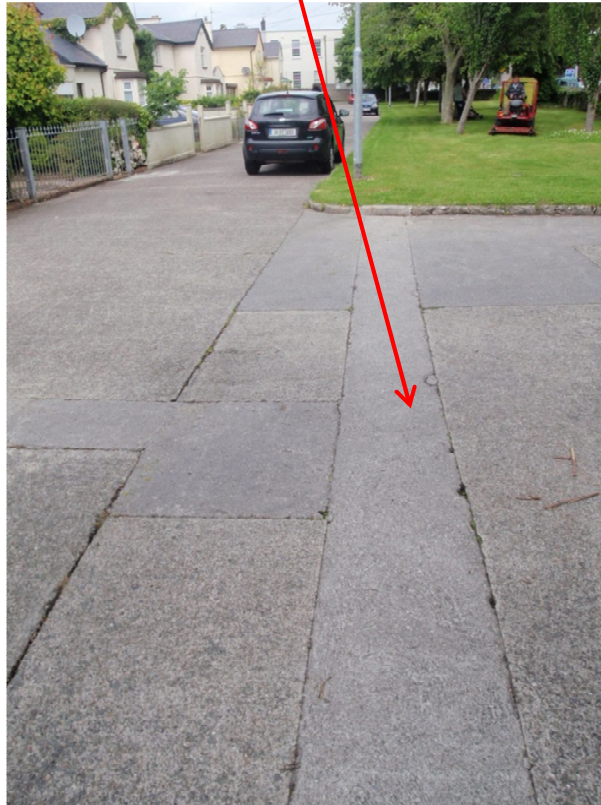
**Photograph 4 Cloonbeg Terrace; trench scar**

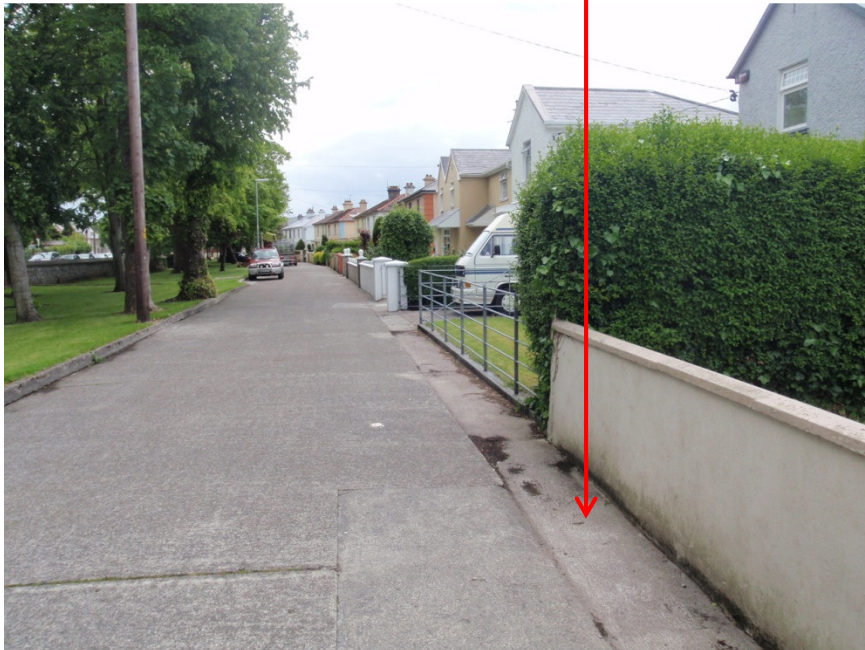
**Photograph 5: Cloonbeg Terrace, trench scar observed at stopcocks.**

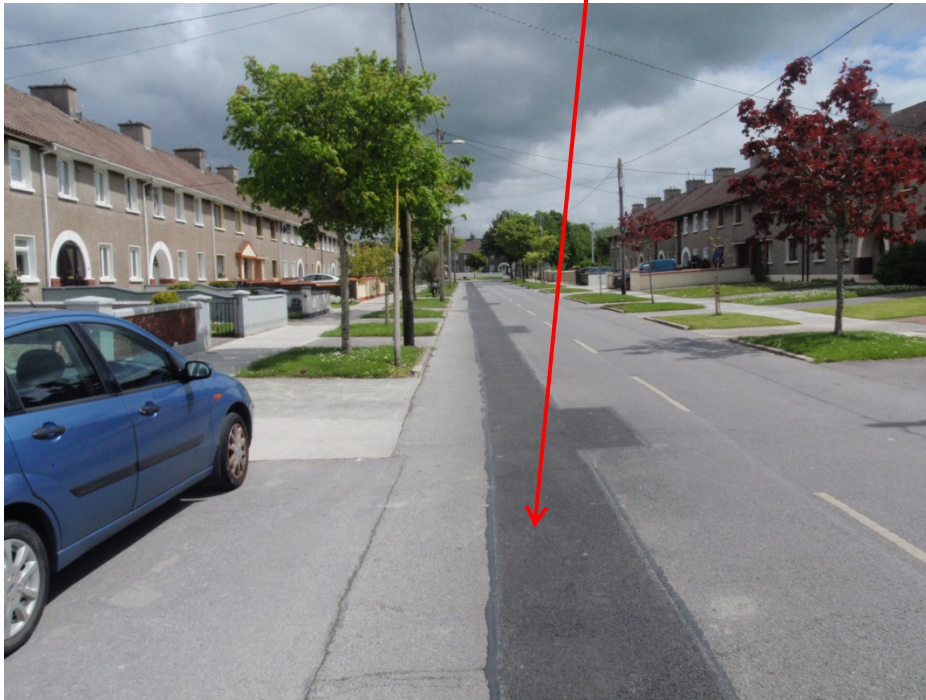
<ul style="list-style-type: none"> <li>i. KCC also gave the EPA a copy of the as built drawings; these drawings showed new HDPE mains were laid to front of the houses where lead mains were previously identified.</li> <li>j. St Brendan's Park was visited as part of this audit. At the locations where KCC had originally identified lead mains, trench scars were observed in the roadways and on the footpaths leading to the water stopcocks. External plumbing was also observed on the outside of some properties (see photograph 6 and 7).</li> </ul>
--	--

**Photograph 6: St Brendan's Park. Trench scar observed.**

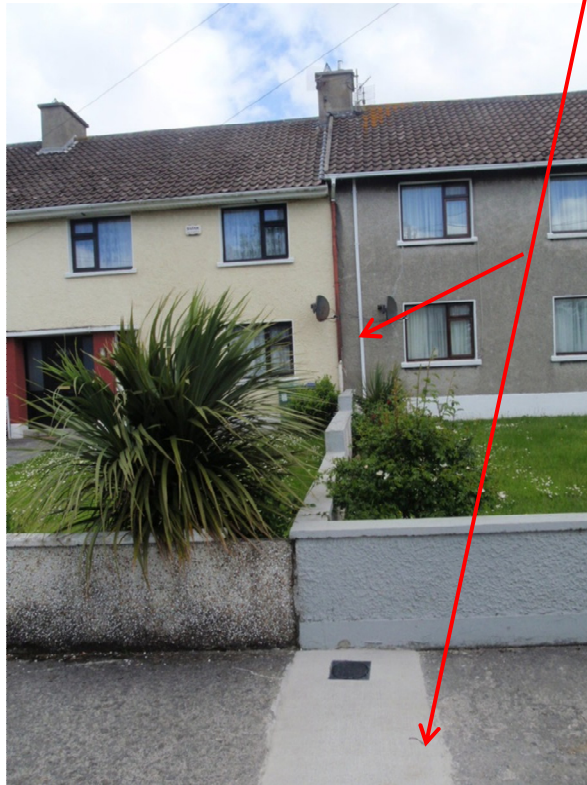
**Photograph 7: St Brendan's Park. Trench Scar and external plumbing.**
