Drinking Water Audit Report

| County: | Kerry | Date of Audit: | 20/09/16 | |
| Plant(s) visited: | (Scheme Code 1300PUB1062) | Date of issue of Audit Report: | 28/09/16 | |

Under the European Union (Drinking Water) Regulations 2014 the Environmental Protection Agency is the supervisory authority in relation to Irish Water and its role in the provision of public water supplies. This audit was carried out to assess the performance of Irish Water in providing clean and wholesome drinking water in the Templenoe Public Water Supply (PWS).

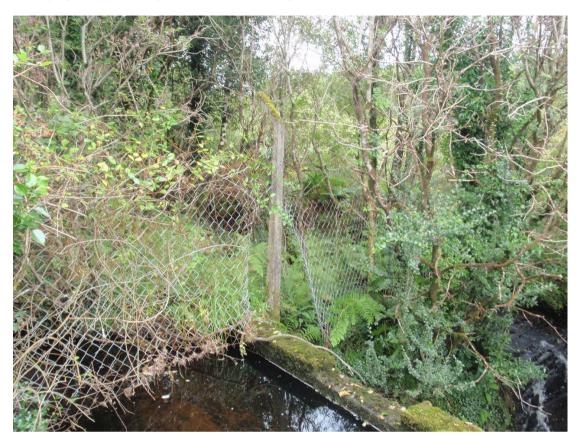
- a. The surrounding land use includes low intensity agriculture and forestry. Livestock on the catchment include cattle (dry stock) sheep and deer in low numbers. Stock proof fencing was present at the intake but a gap in the fence was observed adjacent to the intake (Photograph No. 1). All livestock potentially have direct access to the feeder streams upstream of the intake. Slurry spreading does not take place on the catchment up gradient of the source. The *Cryptosporidium* Risk Score was reported as 79 (high risk). The risk assessment did not include the septic tanks within catchment. It was outlined that the risk score would be revised by KCC.

Photograph No. 1: Damaged Fence at abstraction point

- 3. Irish Water should ensure that the source protection and catchment risk assessment score for the *Cryptosporidium* risk assessment is reviewed in detail and appropriate measures implemented to reduce the risk. The risk assessment needs to be updated to include the assessment of septic tanks in the catchment.
- 4. Irish Water should take action to ensure that the source is made secure and fenced off to prevent livestock access.
- 5. Irish Water should include the Templenoe PWS under the raw water monitoring programme for 2016.

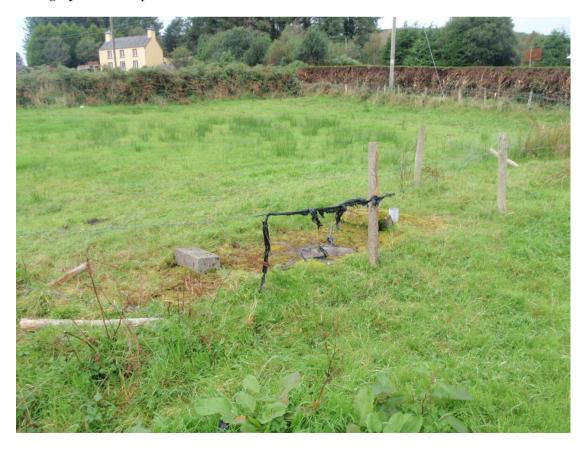
- c. There are 2 to 3 no. private houses likely to be served by domestic waste water treatment systems (DWWTS). One septic tank was observed up gradient of the intake approximately 200m to west in a field with rushes present (Photograph No. 2). None of the septic tanks within the catchment have been assessed under the DWWTS National Inspection Plan.

Photograph No. 2: Septic Tank Located Within 200m of Water Abstraction Location

2. Irish Water should liaise with Kerry County Council to ensure that (i) farm inspections

including pesticide survey and (ii) septic tank inspections on the domestic wastewater treatment system at houses near the source are carried out.
