Drinking Water Audit Report

| County: | Kerry | Date of Audit: | 16/02/2015 |
| Plant(s) visited: | Waterville PWSS 075H 1300PUB1057 | Date of issue of Audit Report: | 09/03/2015 |

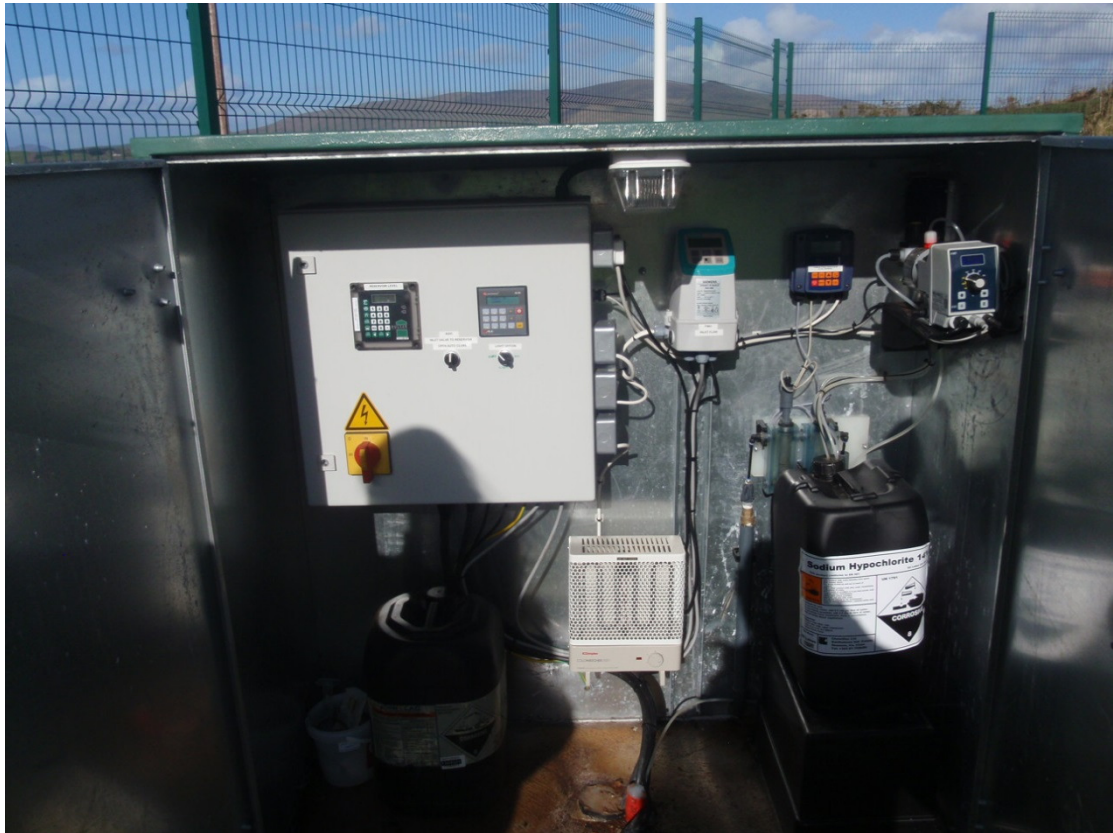
| 3. | <p>Chlorination and Disinfection</p> <ul style="list-style-type: none"> a. Disinfection at this plant consists of duty and standby UV units. There is no automatic switch over between the UV units. The UV units are validated to 76% UVT at a max flow rate 100 m³/hr. The units are not connected to a recording device i.e. SCADA and UVT and UVI are not trended. The caretaker takes daily readings at the plant. b. EPS confirmed that there are proposals to connect the UV units to SCADA and to install auto shut off by the week ending 20/02/2015. The low level alarm is set at 86% UVT. c. Chlorine is dosed via duty and standby dosing pumps; there is auto switch over between the duty and standby pumps. d. Chlorine is dosed flow proportionally and is not connected to residual levels. e. During the audit the chlorine residual reading from the outlet of the reservoir was observed as 0.57 mg/l. f. A residual chlorine reading of 0.21 mg/l in the extremities of the network was noted from the caretaker's diary. g. Within the network there is booster chlorination, where there is only a single duty dosing pump, which doses flow proportionally (see photograph 1). There is a chlorine monitor on site and it is connect to SCADA. It was observed that the expiration date on the drum of sodium hypochlorite at the booster station had passed. EPS at the time of the audit could not confirm the low level alarm at this location. |

Photograph 1: Duty chlorine dosing pump only at the booster station, no standby dosing pump. The expiration date on the chlorine drum was observed to have passed.

- 5. The Water Services Authority should install duty and standby chlorine dosing pumps with automatic switch over at the chlorine booster station.
 - 6. The Water Services Authority should put a system in place so that stocks of reagents and chemicals kept on-site are regularly checked to see if they are in date.
