Drinking Water Audit Report

County:	Kildare	Date of Audit:	06/07/2017
Plant visited:	Ardcarraig Clogherinkoe Water Treatment Plant (WTP) Scheme Code: 1400PUB1051	Date of issue of Audit Report:	14/07/2017
		File Reference:	DW2017/65
		Auditors:	Ms Pauline Gillard Ms Aoife Loughnane
Audit Criteria:	<ul style="list-style-type: none"> • The <i>European Union (Drinking Water) Regulations 2014 (S.I. 122 of 2014)</i>. • <i>The EPA Handbook on the Implementation of the Regulations for Water Services Authorities for Public Water Supplies (ISBN: 978-1-84095-349-7)</i> • The recommendations specified in the <i>EPA Drinking Water Report</i>. • EPA Drinking Water Advice Notes No.s 1 to 15.

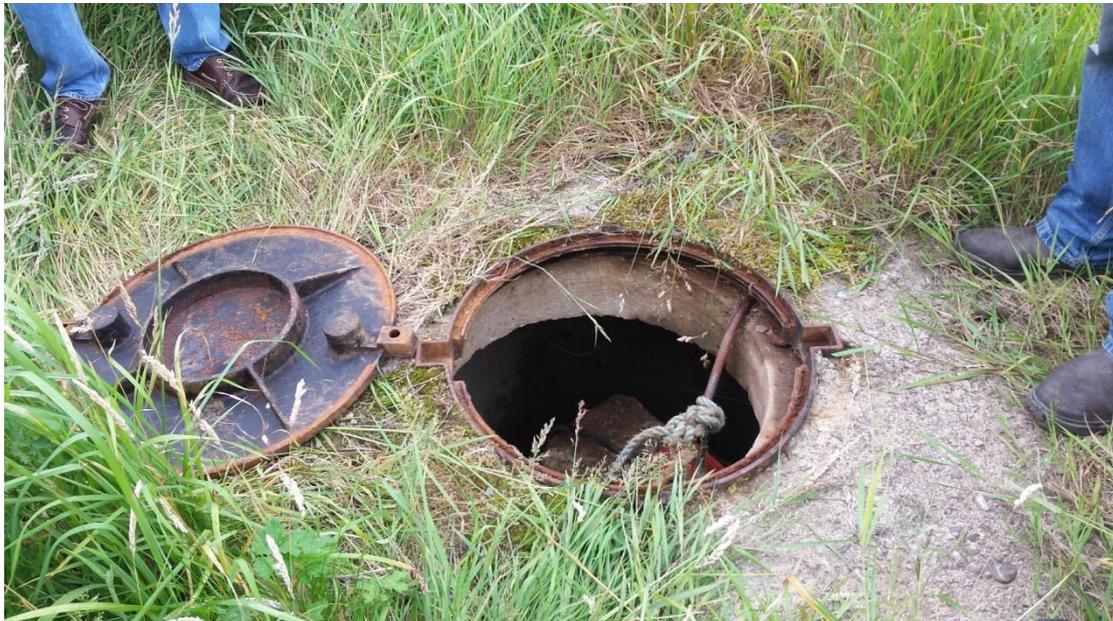
Photograph No. 1: Borehole chamber located below ground level

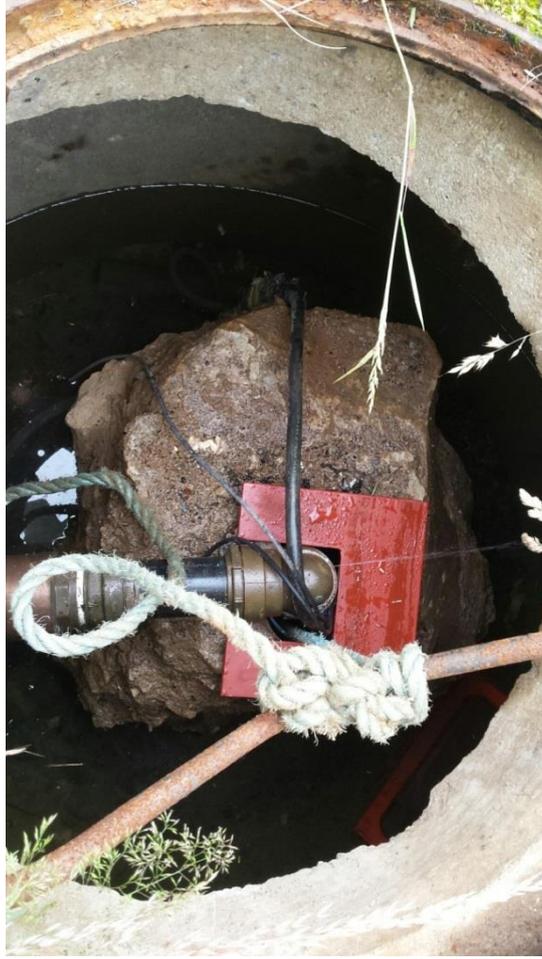
Photograph No. 2: Poor wellhead protection and standing water in the borehole chamber

4. Irish Water should ensure that the wellhead is properly designed and completed and all borehole linings and seals are maintained in accordance with *EPA Advice Note No. 14: Borehole Construction and Wellhead Protection*.

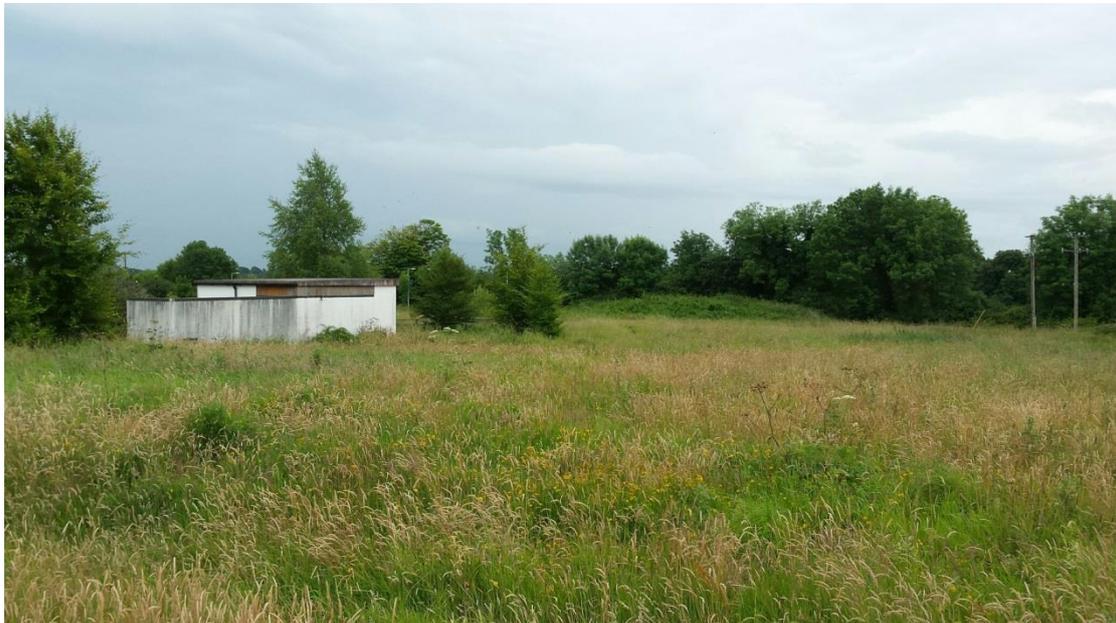
Photograph No. 3: No fencing around borehole or Water Treatment Plant.

1. Irish Water should take action to ensure that the borehole source is made secure and fenced off to prevent livestock access.
2. Irish Water should ensure that the source protection and catchment risk assessment score for the *Cryptosporidium* risk assessment is reviewed in detail and appropriate measures implemented to reduce the risk.
