Drinking Water Audit Report

County:	Kilkenny	Date of Audit:	07/05/19
Plant(s) visited:	Glenmore Water Treatment Plant (Scheme Code 1500PUB1006)	Date of issue of Audit Report:	23/05/19
		File Reference:	DW2017/126
		Auditor:	Regina Campbell
Audit Criteria:	<ul style="list-style-type: none"> • The <i>European Union (Drinking Water) Regulations 2014 (S.I. 122 of 2014), as amended.</i> • <i>The EPA Handbook on the Implementation of the Regulations for Water Services Authorities for Public Water Supplies (ISBN: 978-1-84095-349-7)</i> • The recommendations specified in the <i>EPA Drinking Water Report.</i> • EPA Drinking Water Advice Notes No.s 1 to 15. • The recommendations in any previous audit reports.

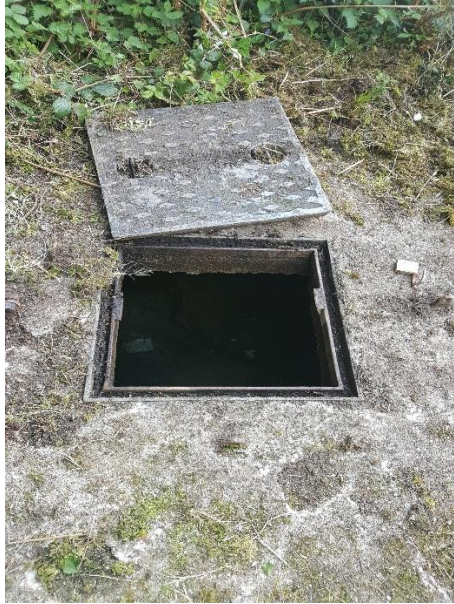
Photo 1 Cover on First Spring

- ii. **Irish Water should take immediate actions to improve the source protection measures at both the first spring and middle spring chambers. The covers over both spring chambers should be sealed to prevent surface water ingress. The middle spring should be made secure from unauthorised access.**

2.	<p>Source Protection</p> <ol style="list-style-type: none"> a. Raw water is sourced from two springs, the first spring (or Holy Well), which is reported to be the main source, and the second (middle) spring. The supply is reported to be in use since the late 1940s. Both springs are located on rough ground near to the public road. b. The lids covering both spring chambers are not adequately sealed to prevent contamination from surface water ingress (see Photos 1 and 2). Dirt and vegetation were visible around the edges of both chambers. The first spring was padlocked and had a gate preventing access from the nearby road. The middle spring had no padlock on the cover on the day of the audit and the gate separating the spring from the nearby public road was missing. c. Buffer zones (100m and 250m) have been delineated around the springs. The land in the nearby vicinity is agricultural in nature (silage and grazing). Kilkenny County Council said that landowners had been written to under the <i>European Union (Good Agricultural Practice for the Protection of Waters) Regulations 2014 (SI No.31 of 2014)</i>. The zone of contribution to the supply is generally ‘extremely’ vulnerable to contamination (according to the Co. Kilkenny Groundwater Protection Scheme Report, 2002). d. There is a continuous inflow monitor which was reading 8.2 m³/h at the time of the audit. e. There is no other continuous monitoring of the raw water. f. At present, monthly monitoring is undertaken on the raw water for E. coli, coliforms, Cryptosporidium, turbidity and UVT.

2. Irish Water should take immediate actions to improve the source protection measures at both the first spring (Holy Well) and middle spring. The covers on both springs should be sealed to prevent surface water ingress. The middle spring should be made secure from unauthorised access.
3. Irish Water should continue to carry out monthly monitoring for *Cryptosporidium* and continue to characterise the raw water including sampling for *E. coli*, coliforms, turbidity and UVT.
4. Irish Water should install an alarmed continuous turbidity monitor to alert plant operators of any changes in raw water quality.
5. Irish Water should construct, seal and protect the proposed new groundwater well in accordance with EPA Advice Note No. 14: Borehole Construction and Wellhead Protection.
