Drinking Water Audit Report

County:	Kilkenny	Date of Audit:	25/06/19
Plant visited:	Kilkenny (Troyswood) Scheme Code1500PUB1011	Date of issue of Audit Report:	26/07/19
		File References:	DW2019/87 and DW2014/322
		Auditor:	Regina Campbell
Audit Criteria:	<ul style="list-style-type: none"> • The <i>European Union (Drinking Water) Regulations 2014 (S.I. 122 of 2014)</i>, as amended. • <i>The EPA Handbook on the Implementation of the Regulations for Water Services Authorities for Public Water Supplies (ISBN: 978-1-84095-349-7)</i>. • The recommendations specified in the <i>EPA Drinking Water Report</i>. • EPA Drinking Water Advice Notes No.s 1 to 15.

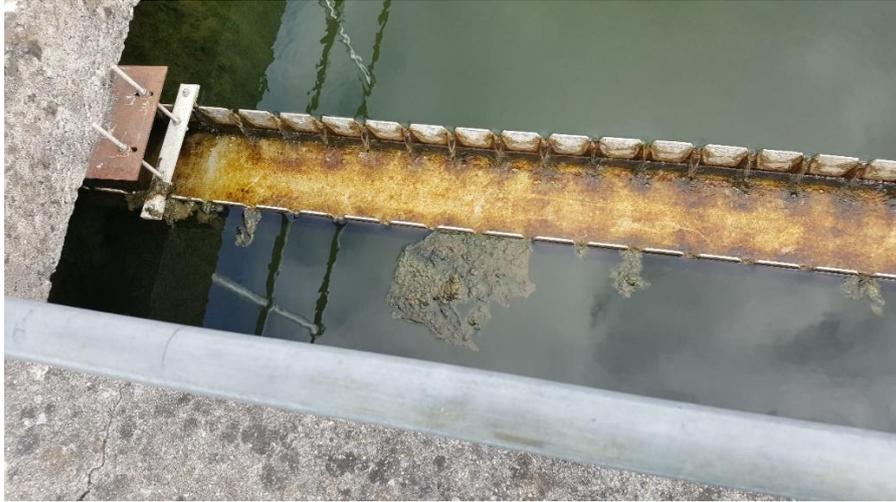
<p>minutes for 5 minutes).</p> <ul style="list-style-type: none"> h. The clarifiers were observed to have a build-up of algal growth on the walls and clumps of flocs/algae were collecting in the decanting channels (see Photo 1). The caretaker said that the decanting channels on the clarifiers are washed once per week and the clarifiers are cleaned once per year. i. There is no online turbidity monitoring of the settled water. j. Daily aluminium testing of the final water is undertaken at the plant and results are recorded in the daily logbook. Results viewed for April, May and June were satisfactory.

Photo 1: Flocs/algae collecting in decanting channel of clarifier

8. Irish Water should install automatic changeover of the pH, coagulant and fluoride dosing pumps in the event of the failure of the duty pump.
9. Irish Water should investigate adding additional staff to the cascade system for responding to alarms and ensuring a timely response.
10. Irish Water should ensure that the CFC tanks (including settled water outlet channels) and filtration tanks are cleaned on a regular basis to prevent the build-up of algae and any subsequent impacts on treatment processes.

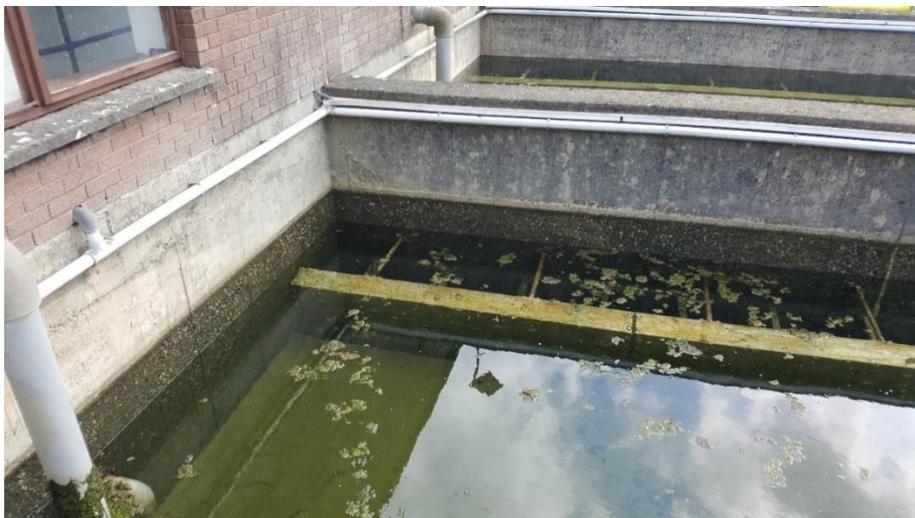
3.	<p>Filtration</p> <ul style="list-style-type: none"> a. Three rapid gravity filters are in operation at the plant. b. Large clumps of flocs/algae were observed floating on all three filters (see Photo 2). The caretaker said that the filters are power-washed every 2-3 weeks to clean them. c. There is no media depth gauge on any of the filters. Kilkenny County Council staff said that the media depth was 800 mm but this could not be verified during the audit. d. Each filter is backwashed every 72 hours on rotation. There is no backwashing based on turbidity or headloss. The backwash is run to waste. A backwash of Filter no. 2 was observed and no issues were noted. e. On the day of the audit, it was found that the online turbidity monitors on the individual filters and on the final water were not alarmed. Irish Water subsequently advised the EPA on 17/07/19 that turbidity alarms on each filter and on the final filter are now in place. f. Online turbidity readings noted at the audit were as follows: Filter 1, 0.09 NTU; Filter 2, 0.08 NTU; Filter 3, 0.09 NTU and final water 0.1 NTU. g. While it was possible to observe turbidity trends on the HMI panel, there was an IT issue on the day of the audit which meant that trends over a longer time period could not be viewed on the SCADA. Daily final turbidity readings are recorded in the daily log-book.

Photo 2: Algae floating on a filter
