Drinking Water Audit Report

County:	Kilkenny	Date of Audit:	11/3/20115
Plant(s) visited:	Pilltown/Fiddown (1500PUB1013)	Date of issue of Audit Report:	26/03/2015
		File Reference:	DW2015/31
		Auditors:	Ms. Yvonne Doris Ms. Cliona Ní Eidhin Ms. Michelle Roche
Audit Criteria:	<ul style="list-style-type: none"> • The <i>European Union (Drinking Water) Regulations 2014 (S.I. 122 of 2014)</i>. • The <i>EPA Handbook on the Implementation of the Regulations for Water Services Authorities for Public Water Supplies (ISBN: 978-1-84095-349-7)</i> • The recommendations specified in the <i>EPA Drinking Water Report</i>. • The recommendations in any previous audit reports.

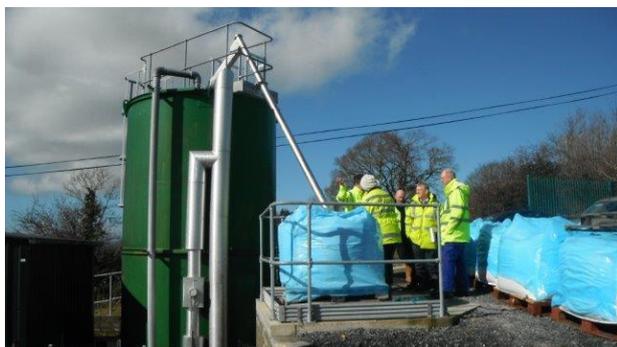
Photograph 1: CaCO₃ plant adjacent to borehole on site.

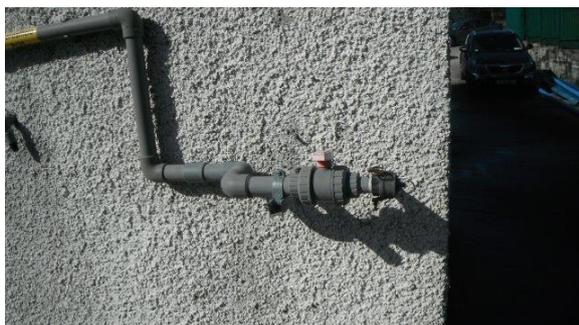
8.	<p>Chemical storage and bunds</p> <ul style="list-style-type: none"> a. The caretaker supervises all chemical deliveries. b. The fill point for Fluorosilicic acid was unbunded and had no drip tray (see photograph 2)

Photograph 2: Fluorosilicic acid fill point (unbundled and no drip tray)

6. Irish Water should review chemical storage arrangements at the treatment plant. Chemicals must be stored in bunded areas capable of containing at least 110% of the volume of chemicals stored therein. Fill points for storage tanks inside the bunds should be within the bunded area. Refer to EPA guidance document –“*IPC Guidance Note on Storage and Transfer of Materials for Scheduled Activities*”.
