Drinking Water Audit Report

County:	Kilkenny	Date of Audit:	15/11/2018
Plant(s) visited:	Piltown-Fiddown PWS (Scheme Code 1500PUB1013)	Date of issue of Audit Report:	14/12/2018
		File Reference:	DW2018/182
		Auditors:	Ms. Regina Campbell
Audit Criteria:	<ul style="list-style-type: none"> • The <i>European Union (Drinking Water) Regulations 2014 (S.I. 122 of 2014), as amended.</i> • <i>The EPA Handbook on the Implementation of the Regulations for Water Services Authorities for Public Water Supplies (ISBN: 978-1-84095-349-7)</i> • The recommendations specified in the <i>EPA Drinking Water Report.</i> • EPA Drinking Water Advice Notes No.s 1 to 15. • The recommendations in any previous audit reports.

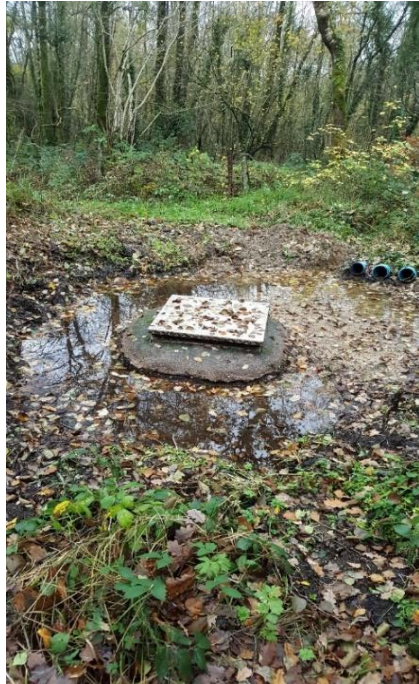
Photo 1 Spring No. 1

There was a lot of standing water in the vicinity of Spring no. 1 (see Photo 1).

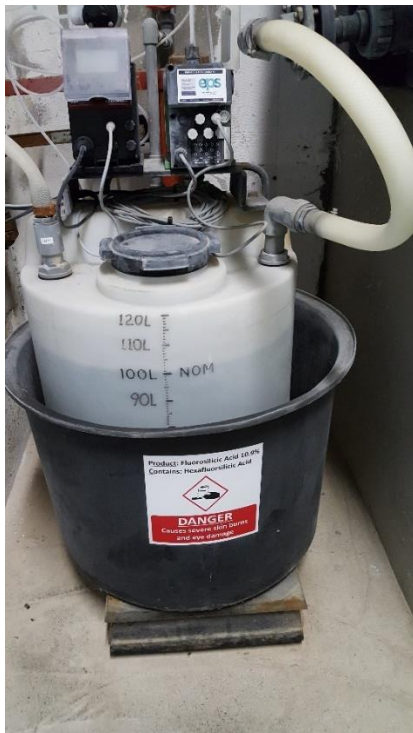
<p>3.</p>	<p>Treated Water Storage and Distribution Network</p> <ol style="list-style-type: none"> a. The caretaker said that the reservoir was built in the 1930 and it has capacity of 450m³. b. The caretaker takes free chlorine readings in the network several times a week and he said generally they are above the minimum required of 0.1mg/l.
<p>4.</p>	<p>Exceedances of the Parametric Values</p> <ol style="list-style-type: none"> a. Cryptosporidium was detected in the supply on 09/10/2018 and previously in July 2016. Resampling results to date have been clear.
<p>5.</p>	<p>Chemical storage and bunds</p> <ol style="list-style-type: none"> a. On the day of the audit, several pallets of calcium carbonate had just been delivered and were stored very near to the hatch covering the groundwater borehole. b. The current arrangement of the fill point for the fluorosilicic acid day tank presents a risk that any potential acid spillage or leakage may not be contained within the bund (see Photo 2).

Photo 2 Fill point of fluorosilicic acid day tank

9. Irish Water should review chemical storage arrangements at the treatment plant. Chemicals must be stored in banded areas capable of containing at least 110% of the volume of chemicals stored therein. Fill points for storage tanks inside the bunds should be within the banded area. Refer to EPA guidance document "*IPC Guidance Note on Storage and Transfer of Materials for Scheduled Activities*". The review should also have regard to the *Code of Practice on Fluoridation of Drinking Water*.
