# Drinking Water Audit Report

<b>County:</b>	Laois	<b>Date of Audit:</b>	21 <sup>st</sup> October 2015
<b>Plant visited:</b>	Ballyroan PWS	<b>Date of issue of Audit Report:</b>	10 <sup>th</sup> November 2015
	Scheme code	<b>File Reference:</b>	DW2012/50
	1600PUB1074	<b>Auditor:</b>	Aoife Loughnane
<b>Audit Criteria:</b>	<ul style="list-style-type: none"> <li>• The <i>European Union (Drinking Water) Regulations 2014 (S.I. 122 of 2014)</i>.</li> <li>• <i>The EPA Handbook on the Implementation of the Regulations for Water Services Authorities for Public Water Supplies (ISBN: 978-1-84095-349-7)</i></li> <li>• The recommendations specified in the <i>EPA Drinking Water Report</i>.</li> <li>• The recommendations in any previous audit reports.</li> </ul>

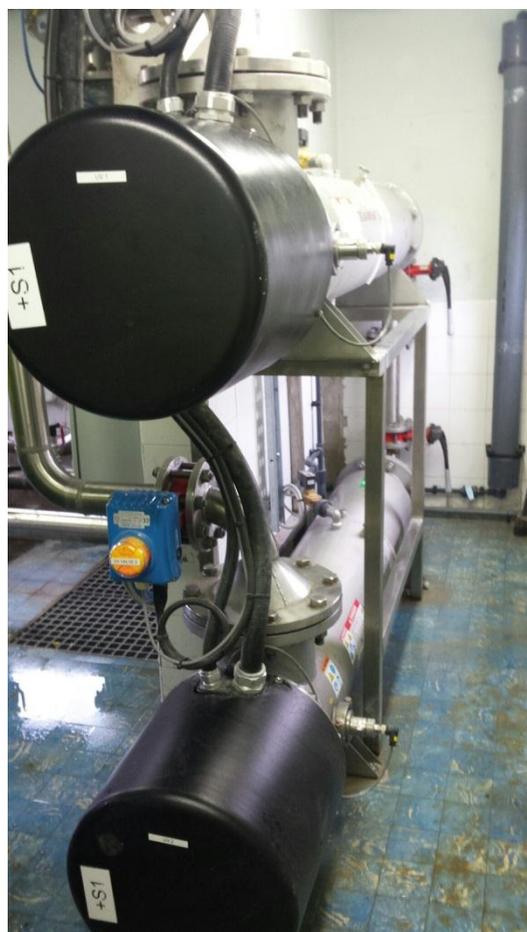
**Photo 2: New duty and standby UV disinfection units**
