Drinking Water Audit Report

Local Authority:	Laois County Council	Date of Audit:	30 November 2012
Plant(s) visited:	Portlaoise PWS	Date of issue of Audit Report:	12 December 2012
		File Reference:	DW2009/315
		Auditors:	Ms Yvonne Doris Ms Ruth Barrington Ms Doireann Nicholls (observer)
Audit Criteria:	<ul style="list-style-type: none"> • The <i>European Communities (Drinking Water) (No. 2) Regulations, 2007</i>. • The <i>EPA Handbook on the Implementation of the Regulations for Water Services Authorities for Public Water Supplies (ISBN: 978-1-84095-349-7)</i> • The recommendations specified in the EPA Report on <i>The Provision and Quality of Drinking Water in Ireland</i>. • The recommendations in any previous audit reports.

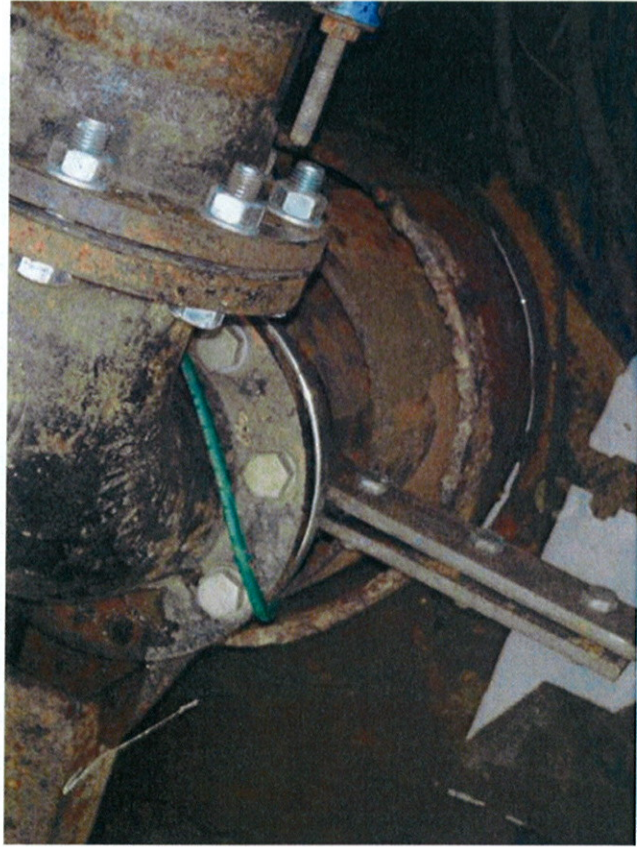
1.	Source Protection <ul style="list-style-type: none">a. The Derrygarran boreholes were selected to visit. The wellheads were covered and locked.b. The wellheads were unsealed (photo 2) and below ground level. Standing water was observed in both wellhead chambers (photo 1) and the top of borehole 1 was only 2-3 inches above the base of the wellhead chamber. It was not known whether overflow pipes in the wellhead chambers were sealed to prevent ingress of surface water or to prevent animal access (photo 3).c. There is some work ongoing in relation to implementation of the GAP regulations, setback distances, communicating with landowners and farmers and monitoring of activities in the 200m buffer zone but details could not be confirmed at the time of the audit.d. Raw water Manganese results are approximately 0.07mg/l and treated Manganese results are approximately 0.04mg/l.

Photograph 2: Unsealed wellhead, Borehole 2, Derrygarran

4. The Water Services Authority should ensure that all borehole linings and seals are maintained.
5. The Water Services Authority should ensure that all wellheads are covered to prevent ingress of surface water.
6. The Water Services Authority should ensure that any pipework leading into wellhead chambers are sealed to prevent entry of surface water or animal access.

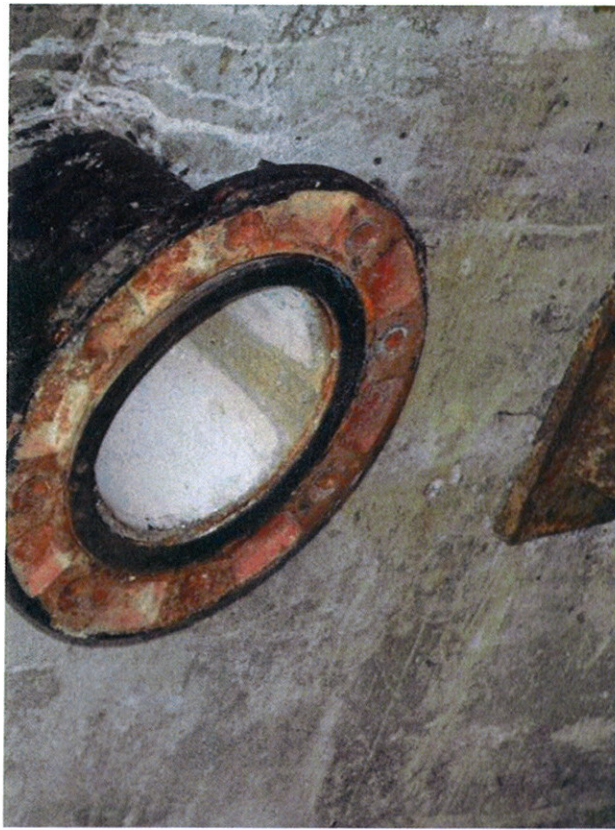
Photograph 3: Overflow pipe in wellhead chamber, Borehole 1, Derrygarran

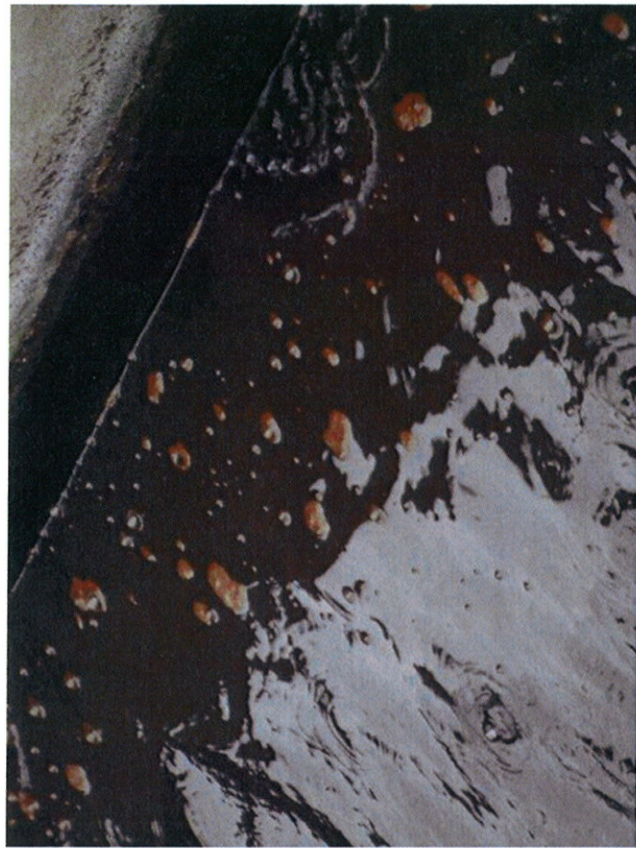
Photograph 4: Brown scum on filter No. 1 at end of backwash sequence

7. The Water Services Authority should ensure that the water backwash is even across the filter.

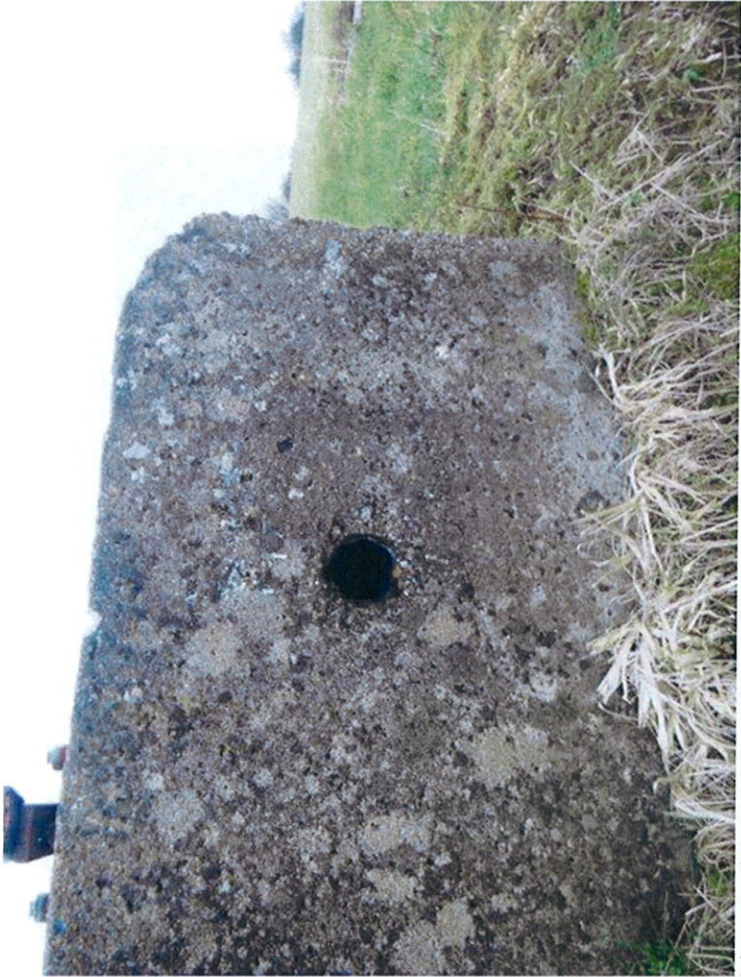
4.	<p>Treated Water Storage</p> <p>a. There were two reservoirs at the plant and a further reservoir at Pallas.</p> <p>b. The plant reservoirs had 8 locked hatches and 4 covered vents. The reservoirs had not been inspected or cleaned. A pipe from an access hatch on reservoir 1 was observed (photo 5).</p>

Photograph 5: Pipe from access hatch on reservoir 1 at Kilminchy plant

9. The Water Services Authority should carry out an integrity assessment of the reservoirs at the Kilminchy plant to ensure that there is no ingress into the reservoir. The reservoirs should be inspected and cleaned if required. The WSA should have regard to EPA Advice Note No. 10 when carrying out any inspections or cleaning.
10. The Water Services Authority should ensure that any pipework leading into access hatches are sealed to prevent entry of surface water or animals to the reservoir.
