Drinking Water Audit Report

Local Authority:	Laois County Council	Date of Audit:	29/11/2013
Plant(s) visited:	Roundwood Supply 1600PUB 0028	Date of issue of Audit Report:	19/12/2013
		File Reference:	DW2013/28
		Auditors:	Mr Niall Dunne
Audit Criteria:	 The European Communities (Drinking Water) (No. 2) Regulations, 2007. The EPA Handbook on the Implementation of the Regulations for Water Services Authorities for Public Water Supplies (ISBN: 978-1-84095-349-7) The recommendations specified in the EPA Report on The Provision and Quality of Drinking Water in Ireland. 		
	The recommendations in any previous audit reports.

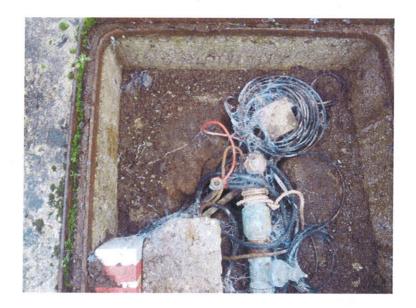
- a. The source for this supply is a bored well.
- b. The well head is located below ground level (see photograph 1). The cover for the well is not secure against surface water ingress.
- c. Laois County Counicl (LCC) stated that they do not have borehole records for this well.
- d. LCC stated that farmers within the vicinity of the source have not been written to with regard to the GAP regulations.
- e. There is a turbidity monitor in place, the reading on the day of the audit was 0.065 NTU. The high turbidity alarm was set at 1 NTU.

Photograph 1: Well head below ground level.

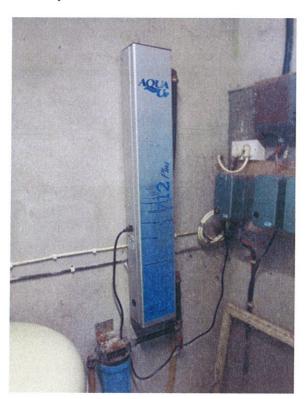
- a. The Direction issued on the 8th April 2013, required LCC to upgrade the UV system. The works were required to be completed by the 28th June 2013. LCC propose to abandon this supply and connect consumers to the Mountrath supply. These works were scheduled to be completed by 9th December 2013.
- b. The disinfection system in place at the time of the audit consisted of a single UV unit, which was not validated. The UV unit was not connected to a UV monitor, recording device or alarm. (see photograph 2).
- c. There is no secondary disinfection system in place on this supply.

The disinfection system that was in place, at the time of the audit, does not conform to Regulation 13(2) of the DW Regulations, which requires that the efficiency of the disinfection treatment is verified.

Furthermore, the disinfection system is inadequate and does not meet the guidelines set out in EPA Advice Note No.3. There was no standby UV unit in place. There was only a duty unit which was not validated and which was not connected to a UV monitor, recording device or alarms. There was also no secondary chlorination system in place. This leaves the supply vulnerable to contamination and puts the health of the consumers at risk.

Photograph 2: Duty UVunit only.

1. The Water Services Authority must as a matter of priority must ensure that the consumers on this supply receive properly disinfected water, as per EPA Advice Note Number 3.
