<h1>Drinking Water Audit Report</h1>
---	--------------------------------------

County:	Waterford	Date of Audit:	18/09/18
Plant(s) visited:	Strancally Water Treatment Plant (Scheme Code 3100PUB1094)	Date of issue of Audit Report:	04/10/18
		File Reference:	DW2018/155
		Auditors:	Regina Campbell
WAudit Criteria:	<ul style="list-style-type: none"> • The <i>European Union (Drinking Water) Regulations 2014 (S.I. 122 of 2014) as amended.</i> • <i>The EPA Handbook on the Implementation of the Regulations for Water Services Authorities for Public Water Supplies (ISBN: 978-1-84095-349-7)</i> • The recommendations specified in the <i>EPA Drinking Water Report.</i> • EPA Drinking Water Advice Notes No.s 1 to 15. • The recommendations in any previous audit reports.

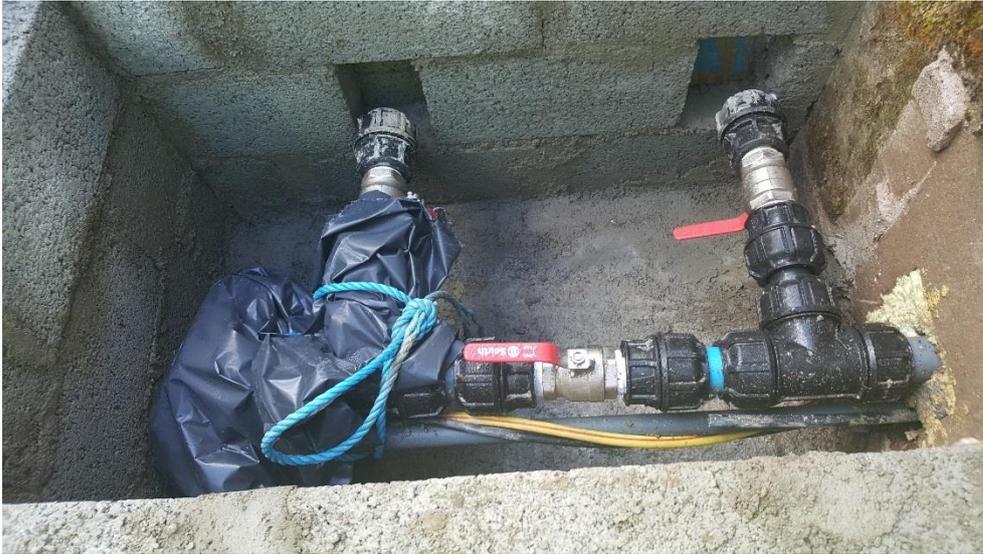
1.	<p>Source Protection</p> <ol style="list-style-type: none"> a. A Boil Water Notice (BWN) was placed on the Strancally Public Water Supply (PWS) on the 03/09/2018. The Boil Water Notice was placed on the supply due to elevated turbidity in the raw water that coincided with excavation works carried out close to the groundwater borehole earlier that day. The excavation works were associated with upgrade works being undertaken on behalf of Irish Water within the Water Treatment Plant compound. b. The groundwater borehole is adjacent to the Water Treatment Plant and secure fencing surrounds the borehole and water treatment plant. A high turbidity alarm (>10 NTU) was triggered after the network supply was reinstated following completion of the construction works. c. Waterford City and County Council (WCCC) personnel responded to the alarm. Despite flushing the line at the WTP, no improvement in turbidity levels was noted and a decision was made to issue a BWN at approximately 8pm on 03/09/18. Twenty households (pop. 36) were affected. The HSE were also consulted in relation to the BWN. d. On the 04/09/18 Irish Water and WCCC began an investigation and concluded that the likely cause of elevated turbidity was damage to the borehole as a result of the excavation works. e. The excavation works were undertaken by a sub-contracted civils crew. At the audit it was outlined that the excavation works were not supervised by Irish Water or WCCC and that the borehole was put back into production without any pumping of water to waste. f. Remedial works began on 04/09/18 to restore the quality of water in the borehole. Turbidity levels at this point had begun to fall to <1.5 NTU. Remedial works continued on 05/09/18 and 06/09/18 as turbidity levels fell to < 0.2 NTU. g. The BWN was lifted on 14/09/18 following satisfactory follow up sampling results on the network. h. At the audit, it was observed that a new concrete base and concrete chamber were under construction around the well-head. A temporary cover was in place over the chamber and plastic was placed over the borehole head to prevent contamination (see Photo 1). I was

Photo 1: Borehole wellhead chamber under construction at audit

1. Irish Water should undertake a review of procedures to ensure that proposed construction works are risk assessed and that suitable mitigation measures are in place to prevent damage or contamination of groundwater sources during construction works. The construction works and reinstatement of the network supply should be adequately supervised at all times. The quality of the raw water should be checked after construction works are completed and prior to reinstatement of the network supply. This recommendation should be considered and addressed at all other treatment plants operated and managed by Irish Water when undertaking construction works.

3. Irish Water should ensure that the borehole well-head is constructed, sealed and protected in accordance with EPA Drinking Water Advice Note No. 14: Borehole Construction and Wellhead Protection.

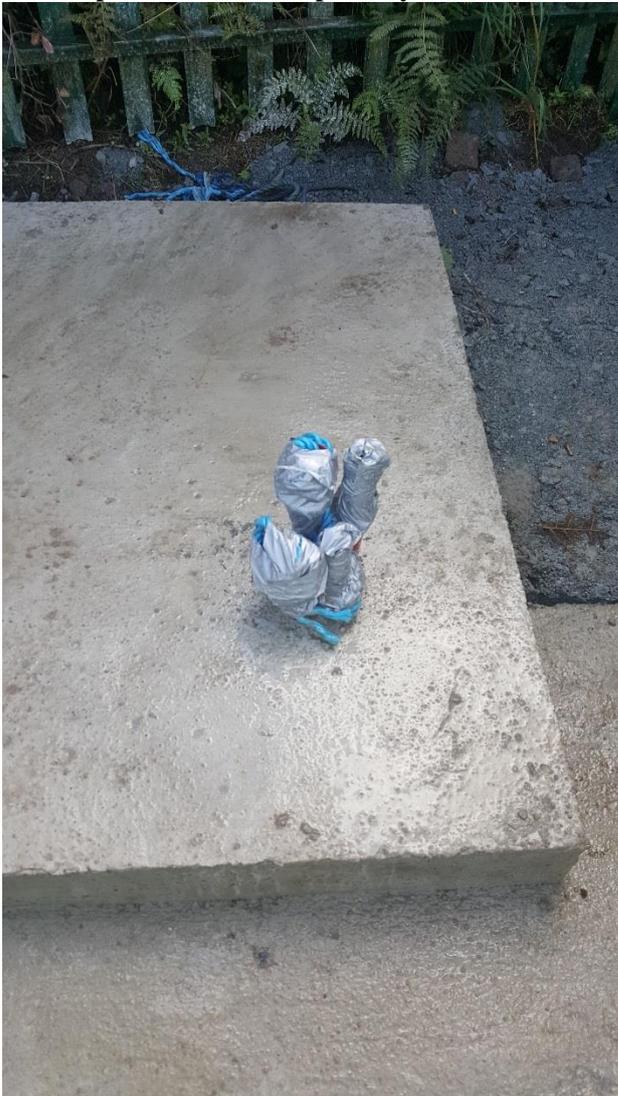
<p>advised that the construction works would be completed in the next three weeks.</p> <ul style="list-style-type: none"> i. A pH correction unit was also under construction (see Photo 2) j. The borehole is classified by Irish Water as a G3 (High Risk) Groundwater source. The borehole has a depth of 30m according to the Scheme Record Management Document. However WCCC said that no well drill logs are available. k. The land in the vicinity of the borehole is agricultural. Irish Water or WCCC did not know when farmers had last been contacted in relation to their obligations regarding the buffer zones required under the European Union (Good Agricultural Practice for Protection of Waters) Regulations 2014 (S.I. No. 31 of 2014). l. There is a continuous pH monitor in place. The pH of the raw water was observed to be 5.48 which is not in compliance with the pH parametric value in the Drinking Water Regulations. Irish Water said pH correction was being installed as part of the disinfection upgrade works.

Photo 2 pH correction unit partially constructed at audit

4. Irish Water should confirm when the pH correction unit is commissioned in order to ensure compliance with the pH parametric value.
