Drinking Water Audit Report

Local Authority:	Laois County Council	Date of Audit:	29/11/2013
Plant(s) visited:	The Strand Supply 1600PUB 0027	Date of issue of Audit Report:	19/12/2013
		File Reference:	DW2012/100
		Auditors:	Mr Niall Dunne
Audit Criteria:	<ul style="list-style-type: none"> • The <i>European Communities (Drinking Water) (No. 2) Regulations, 2007</i>. • The <i>EPA Handbook on the Implementation of the Regulations for Water Services Authorities for Public Water Supplies (ISBN: 978-1-84095-349-7)</i> • The recommendations specified in the EPA Report on <i>The Provision and Quality of Drinking Water in Ireland</i>. • The recommendations in any previous audit reports.

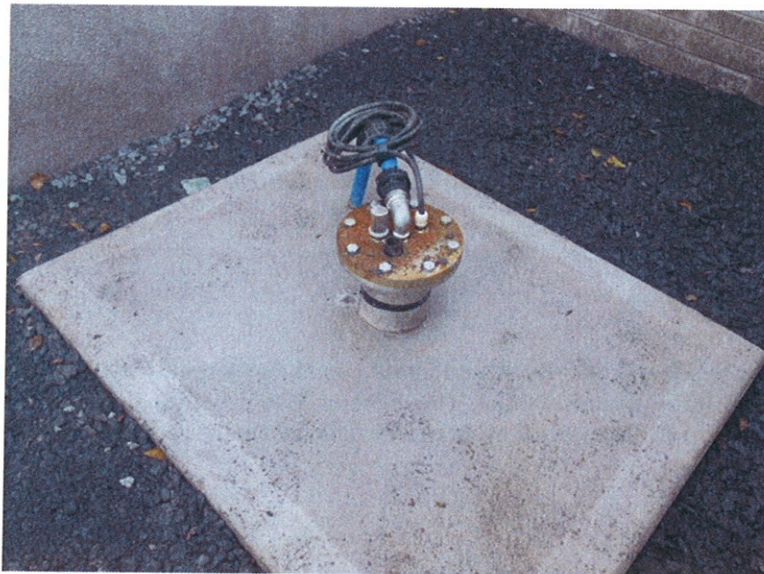
1.	Source Protection <ul style="list-style-type: none">a. The source for this supply is a bored well.b. Since the previous audit of the Strand supply, Laois County Council (LCC) have purchased the land surrounding the well.c. The well head is capped, (see photograph 1). At the time of the audit and according to LCC a kiosk has to be placed over the well head. LCC stated that since the last audit the well had been cleaned and flushed out.d. LCC stated that the Crypto risk assessment has not yet been revised. The original Crypto score was 29 (low risk). LCC stated that the farmers within the vicinity of the source have not yet been written to regarding their responsibilities under the GAP regulations.e. There is a turbidity monitor on the raw water; the reading on the day of the audit was 0.41 NTU. The high turbidity alarm is to be set at 0.8 NTU.f. LCC have also carried out some source protection works on the adjacent stream.

Photograph 1: Well head. Kiosk to be placed over well head.

1. The Water Services Authority should submit the revised *Cryptosporidium* risk assessment for this supply.
2. The Water Services Authority should write to farmers with in the vicinity of the well to inform them of their responsibilities under the requirements of the *European Communities (Good Agricultural Practice for the Protection of Waters) Regulations 2010 (SI No.610 of 2010)*.
3. The Water Services Authority should ensure that the outstanding well head protection works are complete by the end of 2013.

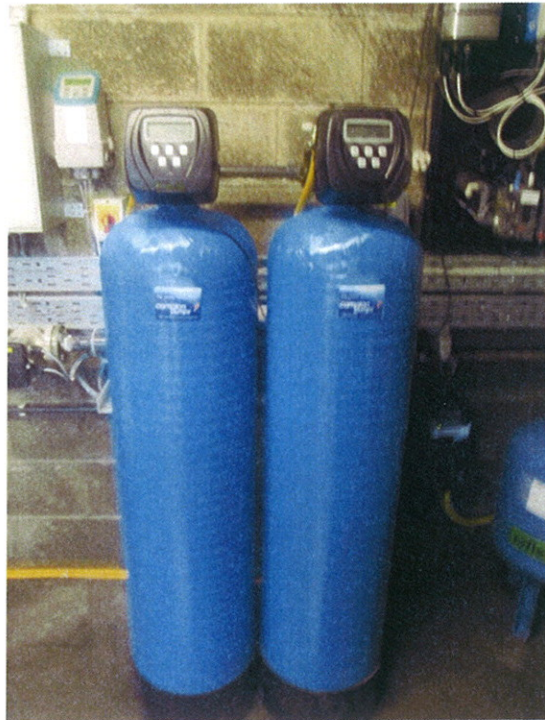
2.	Filtration <ul style="list-style-type: none">a. LCC have installed a manganese and iron filter (see photograph 2). According to LCC these filters are backwashed every day. The backwash is sent to a sludge holding tank (see photograph 3). As the plant is new LCC have not yet established how often the holding tank is to be de-sludged.b. LCC have also installed a Cintropur filter after the chlorine contact tank. LCC stated that the filter membrane is changed based on filter pressure but have not yet determined the schedule for when the filter needs to be replaced.

Photograph 2: Manganese and iron filters.

5. The Water Services Authority should develop a documented management system to assist in the management of drinking water for this supply. The written documented procedure should also detail the maintenance and performance of the iron and manganese filters, the Cintropur filter and the sludge holding tank. The Water Services Authority should also take action to ensure that the procedures are being complied with

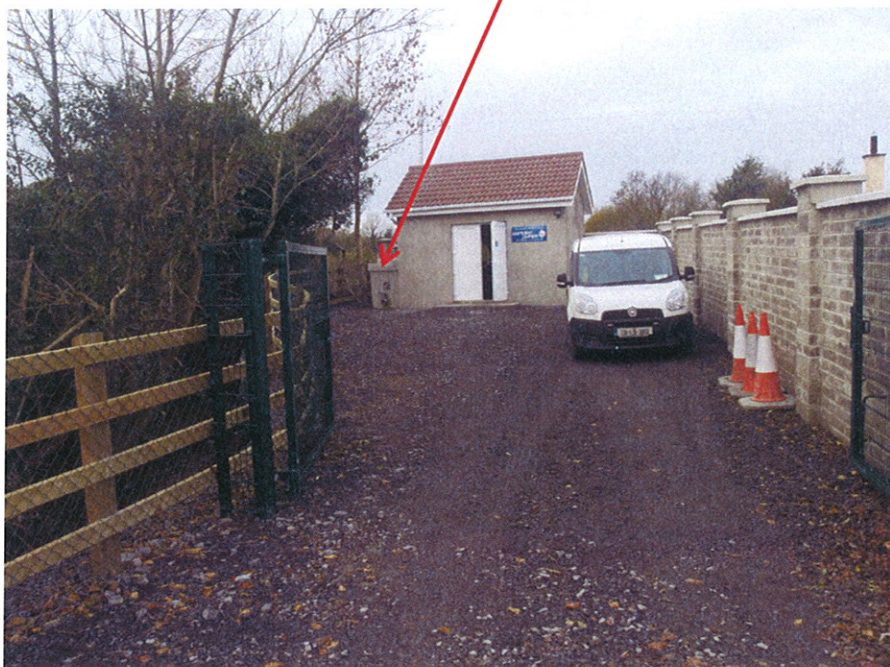
3.	Chlorination and Disinfection <ul style="list-style-type: none">a. The Direction issued on the 19th October 2012, required LCC to upgrade the chlorination system.b. LCC have constructed a new chlorination building (see photograph 3).c. There are duty standby chlorine dosing pumps in place, with 24 hour automatic change over. Dosing is flow proportional.d. There is a chlorine monitor in place, but it is not yet connected to recording device. The SCADA system is to be set up before the end of 2013. The reading on the chlorine monitor was 0.5 mg/l.e. LCC stated that the contact time is between 20 and 30 minutes. LCC did not have the contact time calculations on site.f. According to LCC that there is also auto shut off in place if the chlorine levels drop below 0.1mg/l.g. The dial out alarms are not yet operational but are set at 0.1 and 0.8 mg/l for low and high respectively.h. There is still a boil water notice (BWN) in place on this supply. LCC stated that it will remain in place until they have sampled for three samples clear of <i>E.coli</i>. LCC stated that the BWN should be lifted before the end of 2013.

Photograph 3: New chlorination building with sludge holding tank.
