Drinking Water Audit Report

County:	Limerick	Date of Audit:	06/02/2018
Plant(s) visited:	Croom Public Water Supply (1900PUB1023)	Date of issue of Audit Report:	15/02/2018
		File Reference:	DW2016/49
		Auditors:	Cliona Ní Eidhin Regina Campbell
Audit Criteria:	<ul style="list-style-type: none"> • The <i>European Union (Drinking Water) Regulations 2014 (S.I. 122 of 2014) (as amended)</i> • The <i>EPA Handbook on the Implementation of the Regulations for Water Services Authorities for Public Water Supplies (ISBN: 978-1-84095-349-7)</i> • The recommendations specified in the <i>EPA Drinking Water Report</i>. • EPA Drinking Water Advice Notes No.s 1 to 15. • The recommendations in any previous audit reports.

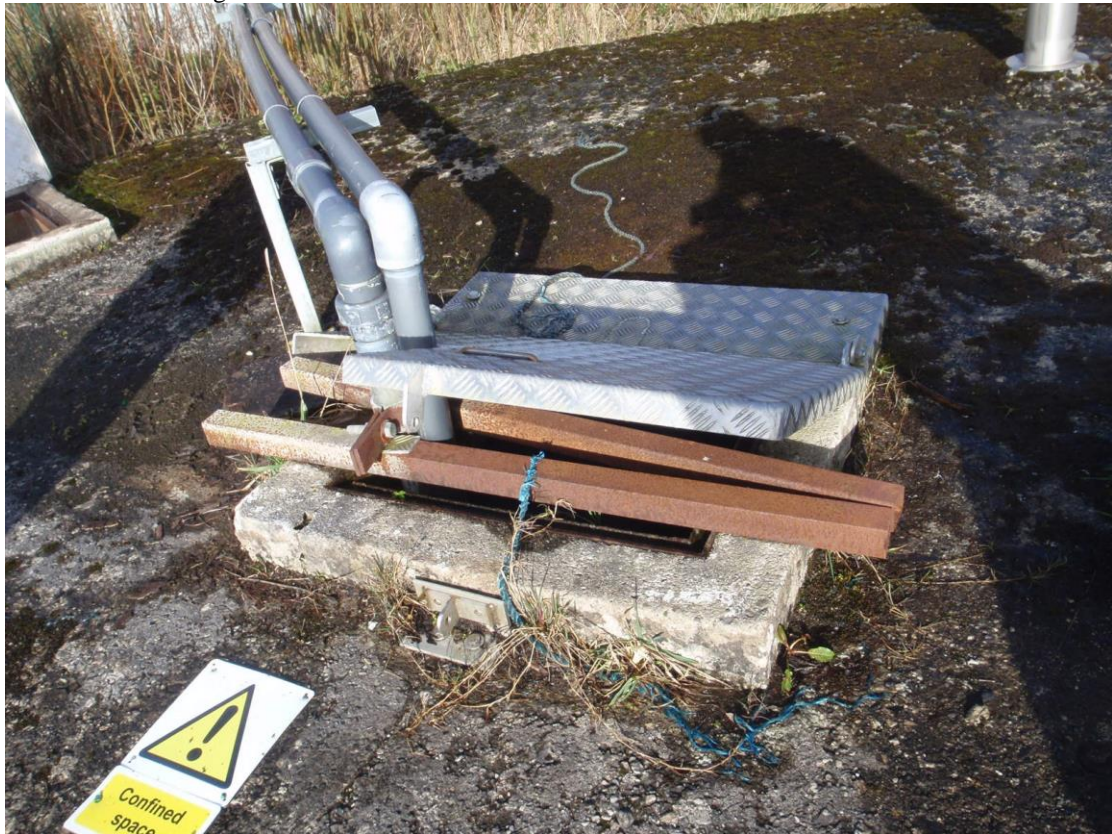
<p>the spring chamber was inadequate.</p> <ol style="list-style-type: none"> Two inspection hatches were present; one hatch cover could not be closed (See Photograph 1) and the second was not adequately sealed. Two vents were present but it was noted that the built-in screen was not fine enough to prevent ingress by insects. (See Photograph 2) <p>e. The farmer using lands near the spring compound has not been written to in relation to his/her obligations under the Good Agricultural Practice Regulations in recent years.</p> <p><u>Cois Srutháin Borehole</u></p> <p>f. This borehole source was not visited during the audit. Whilst it is not currently owned/operated by Irish Water, it is utilised for the public supply during times of high demand. Details on the borehole construction were not available for review at the audit.</p>

Photograph 1: Inspection hatch at Skagh Spring – cover unable to close to protect spring water from contamination or ingress.

4. Irish Water should undertake works at the Skagh spring chamber to establish integrity and prevent contamination of the spring source.
5. Irish Water should delineate the ZOC associated with the Skagh spring.

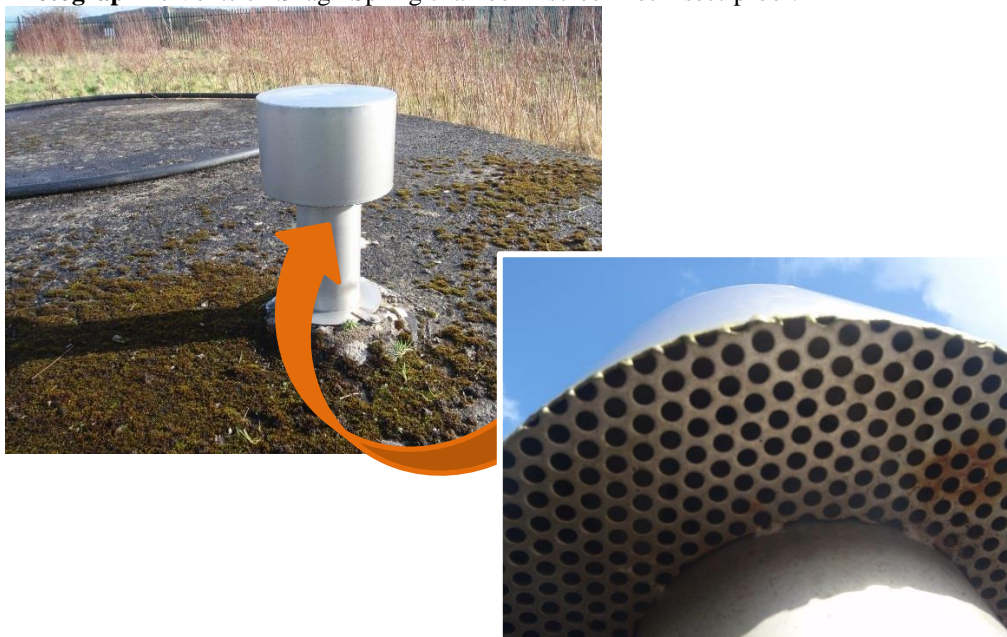
Photograph 2: Vents on Skagh Spring chamber – screen not insect-proof.
