Drinking Water Audit Report

County:	Limerick	Date of Audit:	02/08/2018
Plant(s) visited:	Galbally Public Water Supply (1900PUB1028)	Date of issue of Audit Report:	27/08/2018
		File Reference:	DW2014/12
		Auditors:	Cliona Ní Eidhin
Audit Criteria:	<ul style="list-style-type: none"> • The <i>European Union (Drinking Water) Regulations 2014 (S.I. 122 of 2014) as amended.</i> • The <i>EPA Handbook on the Implementation of the Regulations for Water Services Authorities for Public Water Supplies (ISBN: 978-1-84095-349-7)</i> • The recommendations specified in the <i>EPA Drinking Water Report.</i> • EPA Drinking Water Advice Notes No.s 1 to 15. • The recommendations in any previous audit reports.

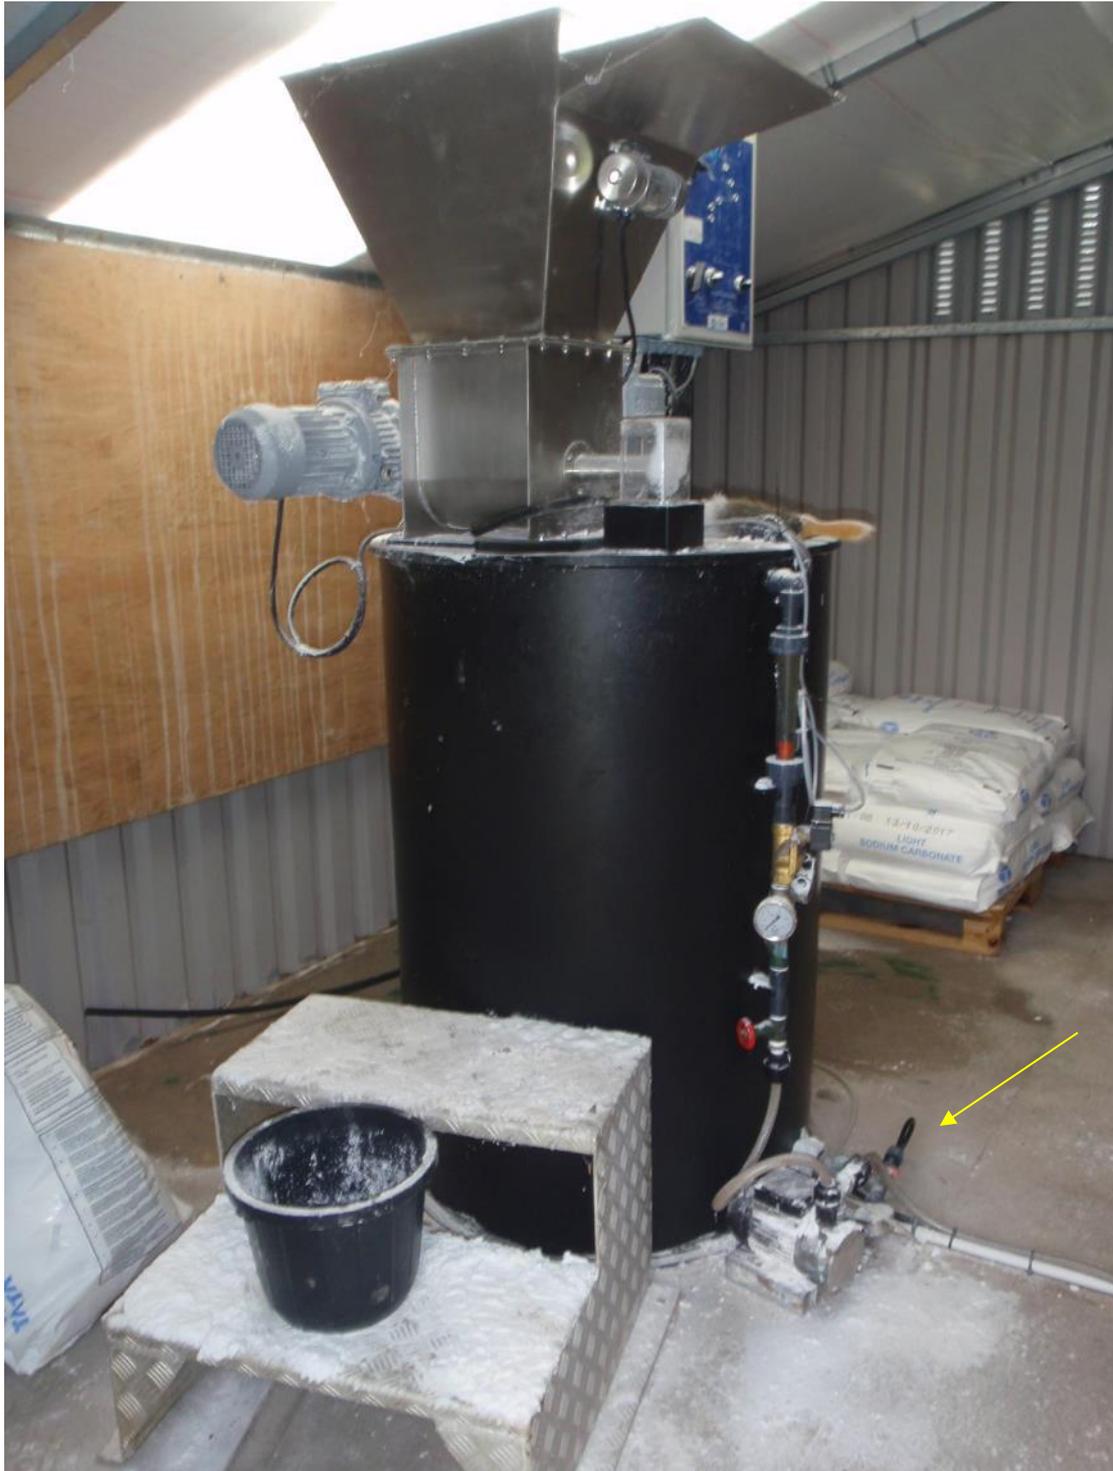
<p>3.</p>	<p>Disinfection</p> <ul style="list-style-type: none"> a. pH correction, using sodium carbonate, takes place prior to disinfection to address the raw water pH of 6.2 towards optimal disinfection. The auditor observed that some of the dosing pipework and instrumentation was at floor level and in the pathway to the bulk storage area for soda ash (see Photograph 1). b. Sodium hypochlorite is the disinfectant used at the plant. Duty and standby dosing pumps are in place with automatic switchover in the event that the duty pump fails. c. A chlorine monitor is in place and operational. It was reading 0.6mg/l on inspection and displayed little or no fluctuation when observed during the audit. The monitor is alarmed with a low set point of 0.2 mg/l and a high level of 1.2 mg/l. Automatic shutdown of the supply occurs if the low-level alarm is triggered. The monitor and alarms are linked to SCADA and can be queried at any time by the caretaker or area foreman. d. A chlorine contact tank is in place and the chlorine monitor measures chlorine at the outflow from this contact tank. e. One daily check is undertaken in the network by the caretaker using a hand held chlorimeter. It was noted that the same premises are used each day for this check and it was not known if this was representative of the extremity of the network. The auditor advised that the sampling point should be varied and that network sampling for chlorine residual should capture the network extremity.

Photograph 1: Soda ash dosing pipework – potentially vulnerable to damage.

4. Irish Water should ensure that pipework and dosing apparatus in the soda ash house are made safe from any potential damage.
5. Irish Water should ensure that the premises sampled for chlorine residual is varied to represent different localities of the network, including the network extremity.

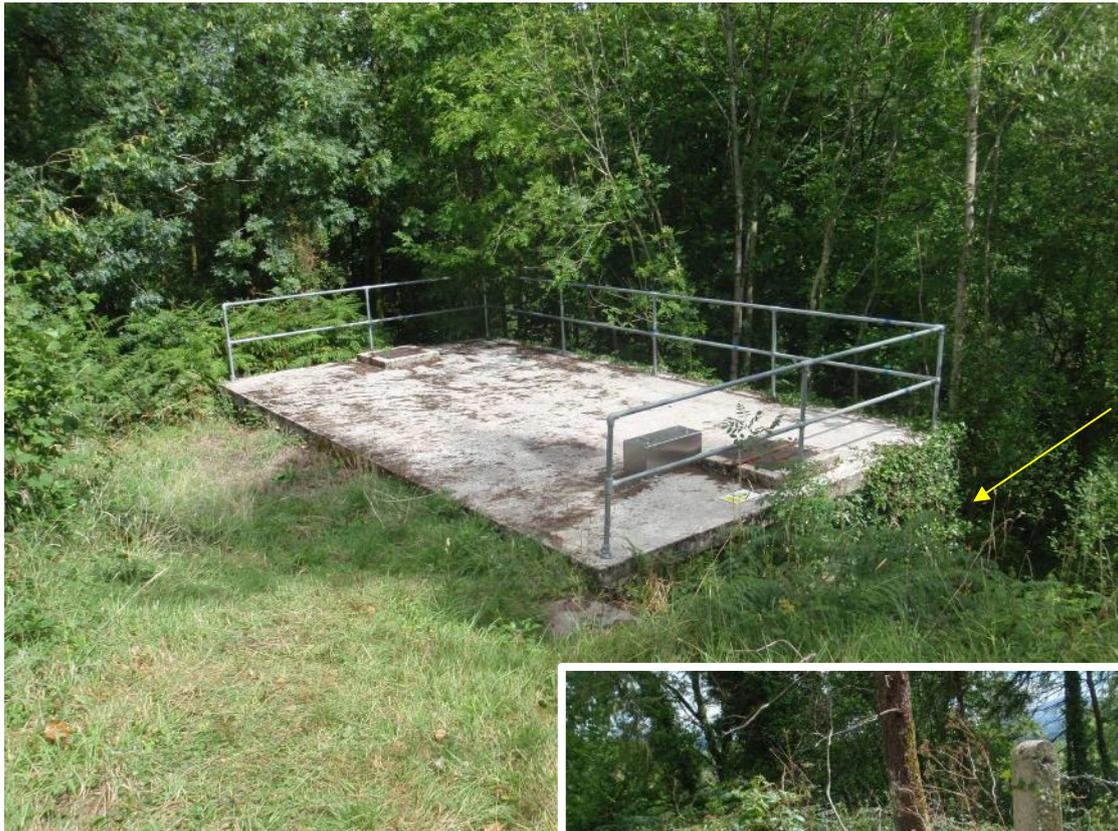
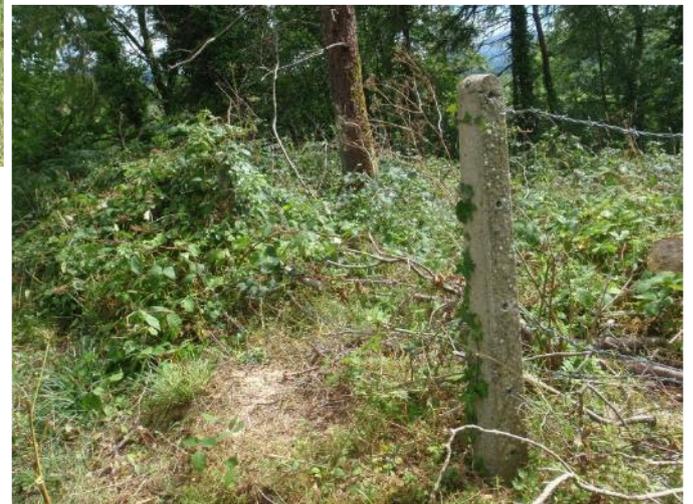
<p>4.</p>	<p>Chemical storage and bunds</p> <ul style="list-style-type: none"> a. 25 l drums of sodium hypochlorite are brought to site from an area depot in Kilmallock. None were present for inspection during the audit. The chlorine day tank was adequately bunded. b. Sodium carbonate is brought to site on a pallet and loaded by hand into the soda ash dosing house. Only the date of manufacture was provided on soda ash bags; no use by date was provided.
<p>5.</p>	<p>Treated Water Storage and Distribution Network</p> <ul style="list-style-type: none"> a. A single reservoir is located adjacent to the treatment plant and was inspected externally during the audit. There were no vents and the inspection hatches were securely locked. b. The auditor was informed that the reservoir had been cleaned out by a robotic cleaning machine in 2010. c. Some ivy growth was visible on the outer walls of the structure which should be kept in check. d. Steep ground downslope of the structure provides security on that approach to the reservoir, however some improvement to fences on other sides was noted to be necessary to ensure stock proofing (see Photograph 2).

Photograph 2: Reservoir: ivy on side of structure and perimeter fence not stock proof.

6. Irish Water should ensure that the site boundary surrounding the treated water reservoir is made secure and stock-proof.
