Drinking Water Audit Report

County:	Limerick	Date of Audit:	08/03/2016
Plant(s) visited:	Kilteely PWS 0300PUB1068	Date of issue of Audit Report:	31/03/2016
		File Reference:	DW2016/46
		Auditors:	Mr Niall Dunne
Audit Criteria:	<ul style="list-style-type: none"> • The <i>European Union (Drinking Water) Regulations 2014 (S.I. 122 of 2014)</i>. • The <i>EPA Handbook on the Implementation of the Regulations for Water Services Authorities for Public Water Supplies (ISBN: 978-1-84095-349-7)</i> • The recommendations specified in the <i>EPA Drinking Water Report</i>. • EPA Drinking Water Advice Notes No.s 1 to 15. • The recommendations in any previous audit reports.

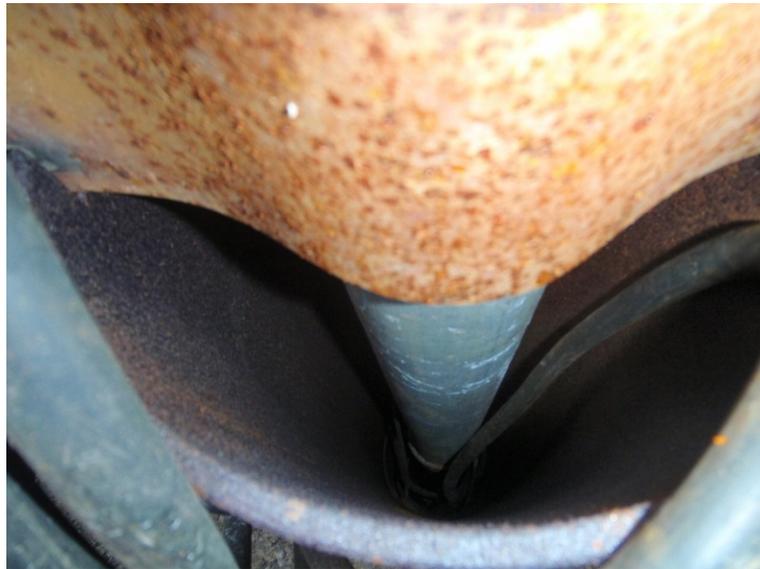
1.	Source Protection <ul style="list-style-type: none">a. Kiltelly supply is fed from a bored well. LCC (Limerick County Council) stated that the bore hole is approximately 50 m deep. It was observed that there was no grouting between the inner and outer casings of the borehole, (see photograph 1).b. The well head was observed to be above ground level and the well head was sealed (see photograph 2).c. Raw water sample taken on the 27/04/2016, showed 0 No. <i>E.coli</i> /100mls and 0 No. coliform bacteria / 100 mls. The UVT of the raw water was recorded as 97.6% and the turbidity 0.2 NTU.d. The crypto risk assessment score was calculated as 73.1, moderate risk.

Photograph 1: No grouting between the inner and outer casings of the bored well.

1. Irish Water should ensure that the issue with the countywide SCADA system is rectified, without delay.
2. Irish Water should install grout between the inner and outer casings of the borehole in accordance with *EPA's Guidance Note Number 14 Borehole and Well Head Construction*.
3. Irish Water must ensure that all chlorine monitoring equipment is regularly calibrated and that calibration stickers are placed on the equipment to reflect this.
4. Irish Water should ensure that chlorine readings are taken at the end of the network on a regular basis to ensure that chlorine residuals of 0.1 mg/l are being achieved at the extremities of the network.
5. Irish Water should put plans in place to remediate against the regular pipe breakages within the network.
6. Irish Water should put plans in place to ensure that adequate storage capacity is maintained within the network all times.

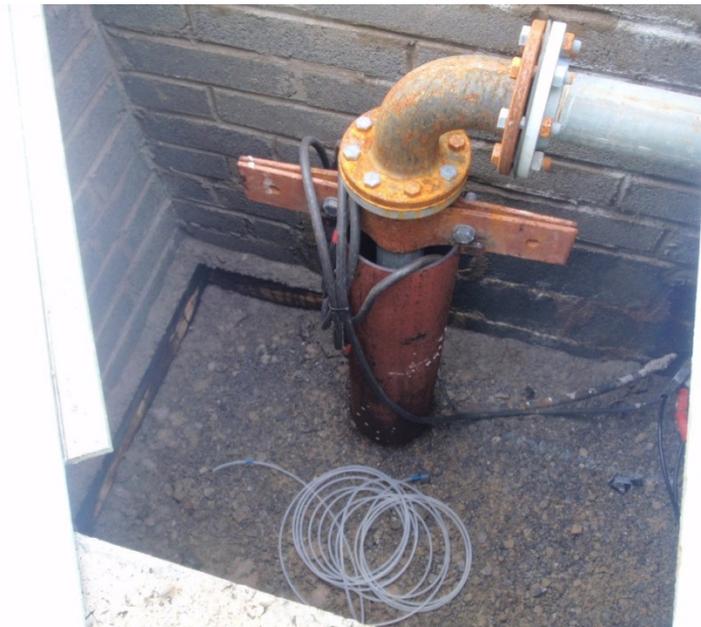
Photograph 2: Top well head above ground level.

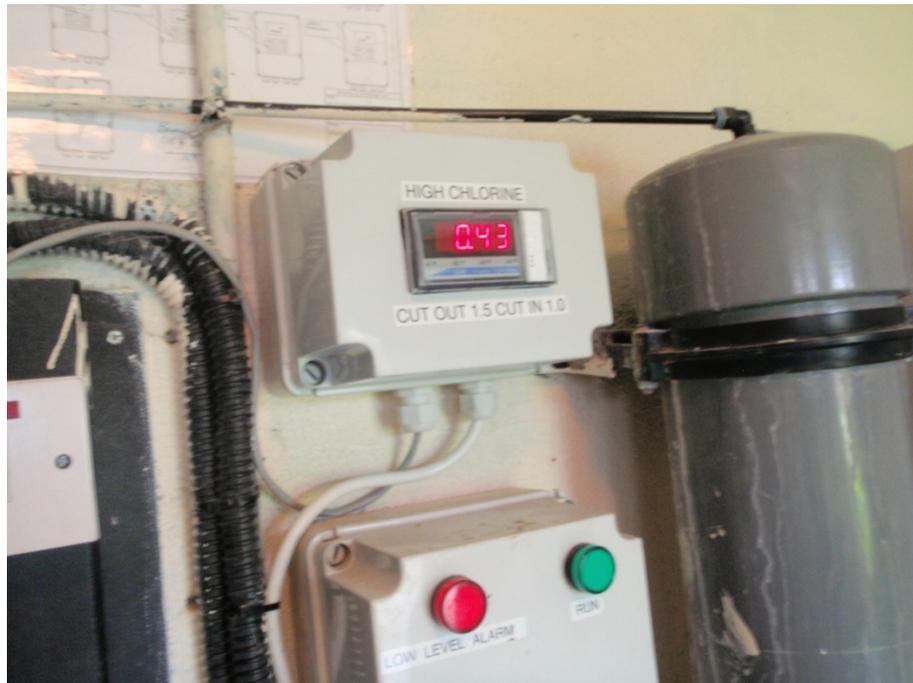
It was noted that there was a difference in the chlorine residual reading taken with the handheld monitor and that observed on the chlorine residual monitor. It was also observed that the calibration sticker on the hand held monitor was out of date. Irish Water should ensure that all chlorine residual monitoring equipment is regularly calibrated and that calibration stickers are placed on all chlorine monitoring equipment to reflect this.

Photograph 3: Reading on chlorine monitor 0.43mg/l, reading on hand held chlorine monitor was 0.62 mg/l.
