# Drinking Water Audit Report

<b>County:</b>	Limerick	<b>Date of Audit:</b>	20/02/2017
<b>Plant(s) visited:</b>	Newcastlewest PWS	<b>Date of issue of Audit Report:</b>	30/03/2017
		<b>File Reference:</b>	DW2014/283
		<b>Auditors:</b>	Ms. Cliona Ní Eidhin Ms. Criona Doyle
<b>Audit Criteria:</b>	<ul style="list-style-type: none"> <li>• The <i>European Union (Drinking Water) Regulations 2014 (S.I. 122 of 2014)</i>.</li> <li>• The <i>EPA Handbook on the Implementation of the Regulations for Water Services Authorities for Public Water Supplies (ISBN: 978-1-84095-349-7)</i></li> <li>• The recommendations specified in the <i>EPA Drinking Water Report</i>.</li> <li>• EPA Drinking Water Advice Notes No.s 1 to 15.</li> <li>• The recommendations in any previous audit reports.</li> </ul>

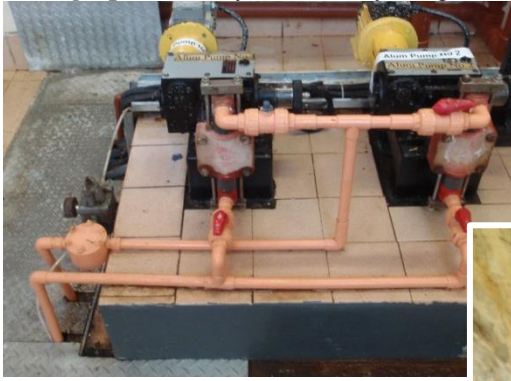
**Photograph 1a:** Duty and Standby Coagulant dosing pumps

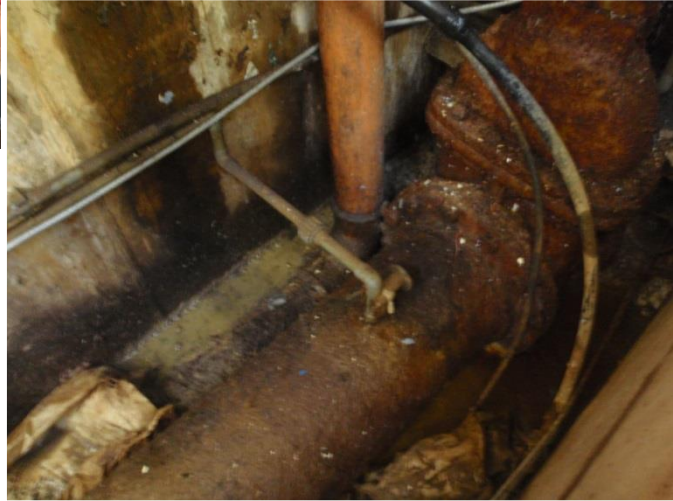
**Photograph 1b:** Single coagulant dosing line.

2. Irish Water should ensure that duty and standby dosing lines are in place for the dosing of the primary coagulant, aluminium sulphate, to raw water.

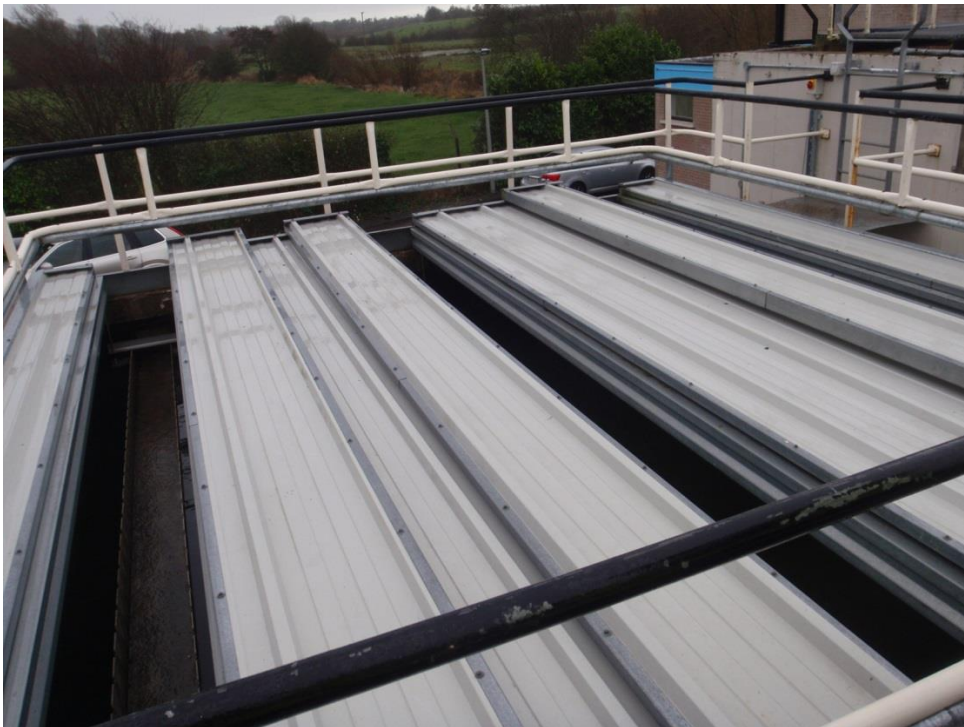
**Photograph 2:** Covered clarifiers.

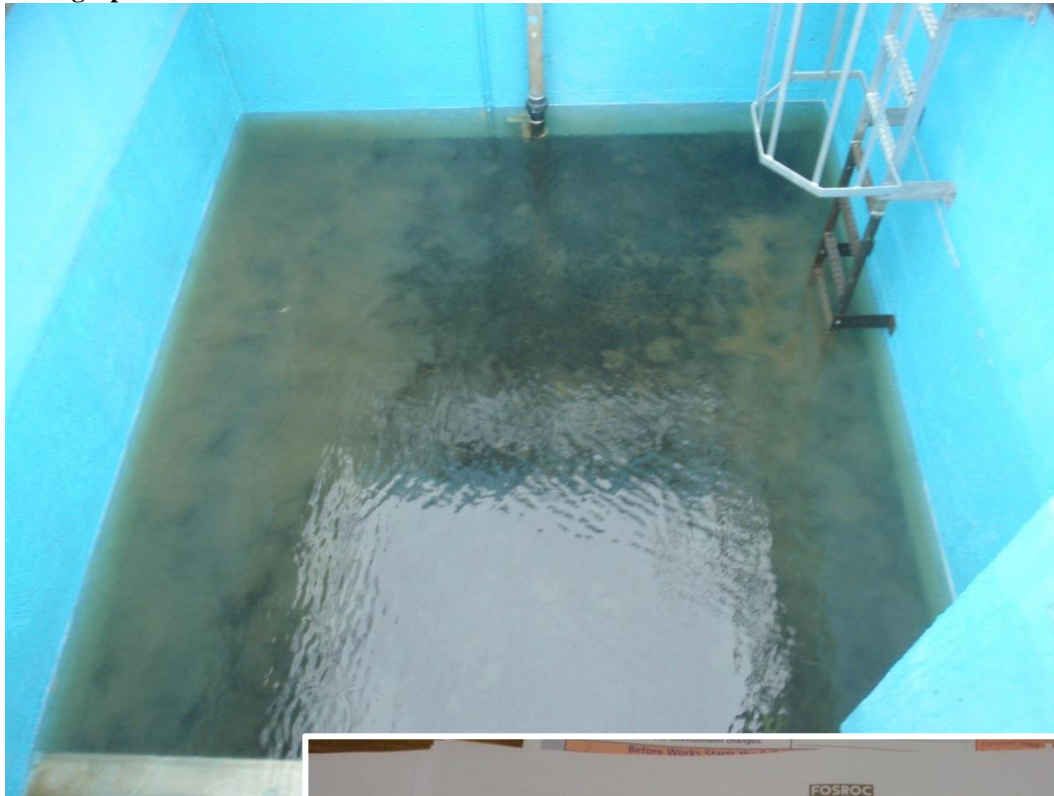
<ul style="list-style-type: none"> <li>a. The auditors examined the three filters, visually, and observed a full backwash cycle in filter No. 3. Backwash water is run to waste.</li> <li>b. IW advised that the filters had been refurbished in January 2015. Refurbishment included the painting of the internal filter walls with turquoise-coloured paint. (See Photograph No. 3.) A Safety Data Sheet for the paint product was later reviewed by the auditors but it did not provide a clear conclusion as to its safety for use in contact with potable water. (See Photograph No. 4)</li> <li>c. Depth measuring gauges were not in place in all of the filters.</li> <li>d. Turbidity monitors were in place on all 3 filters, as well as on raw, settled and final water, and read as follows at the time of inspection: <ul style="list-style-type: none"> <li>Filter No. 1: 0.1 NTU</li> <li>Filter No. 2: 0.02 NTU</li> <li>Filter No. 3: 0.04 NTU</li> </ul> </li> <li>e. On examination of the SCADA in the plant office later in the audit, it was noted by the auditors that during the backwash of one filter, the entire plant volume is directed via to the other two filters resulting in events of elevated turbidity in settled water.</li> </ul>

**Photograph No. 3:** Painted filters.

3. Irish Water should ensure that the minimum depth of filter media (excluding the gravel layer) is no less than 800 mm and that filter media depth markers are in place on all filters to verify this.
4. Irish Water should ensure that any future refurbishment of filters excludes the painting of internal filter walls, as this is not regarded by the EPA as best practice. All products used in contact with drinking water should be used in an approved manner. For example, the paint used during the filter refurbishment at Newcastle West should have been afforded 21 days (at 7°C.) curing time.
5. Irish Water should develop a procedure to prevent the overloading of the operational filter unit(s) when one of the filters is being backwashed and ensure that this is enacted as routine optimal control of the treatment process.

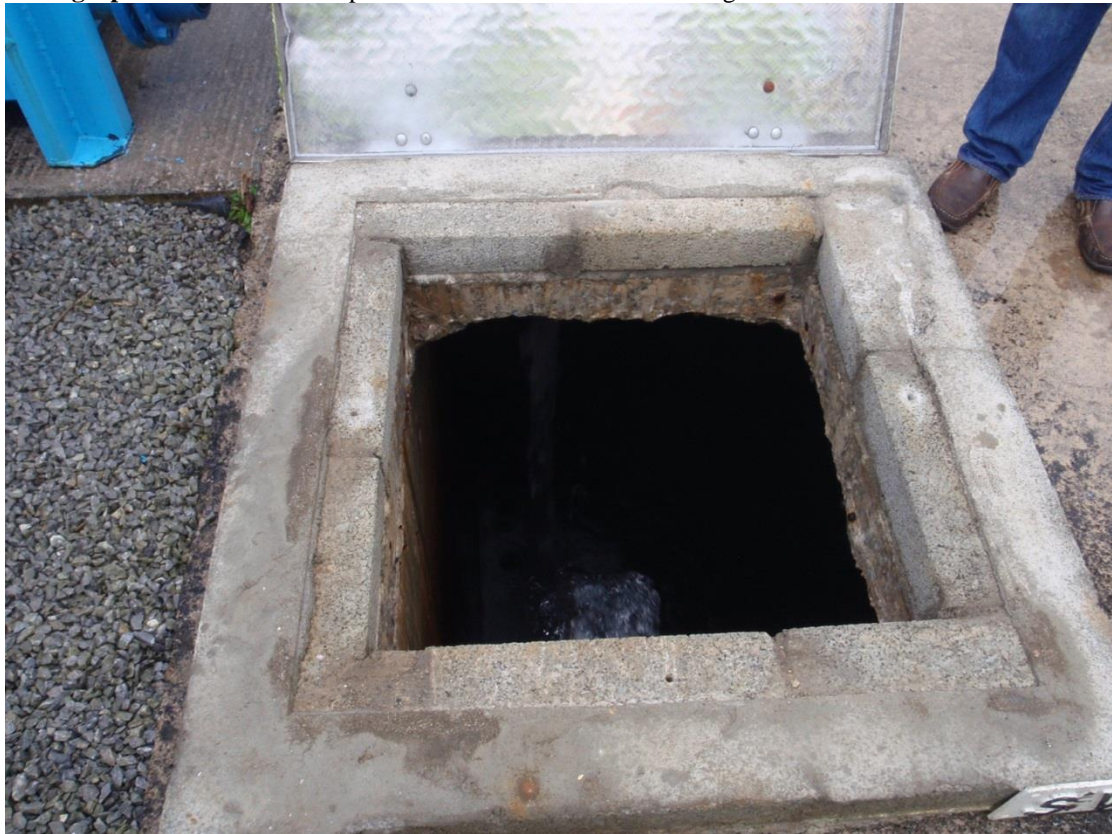
**Photograph No. 5** Unsealed inspection hatch to treated water storage tank.

6. Irish Water should ensure all inspection hatches accessing the treated water storage tank reservoirs are fully sealed when shut.

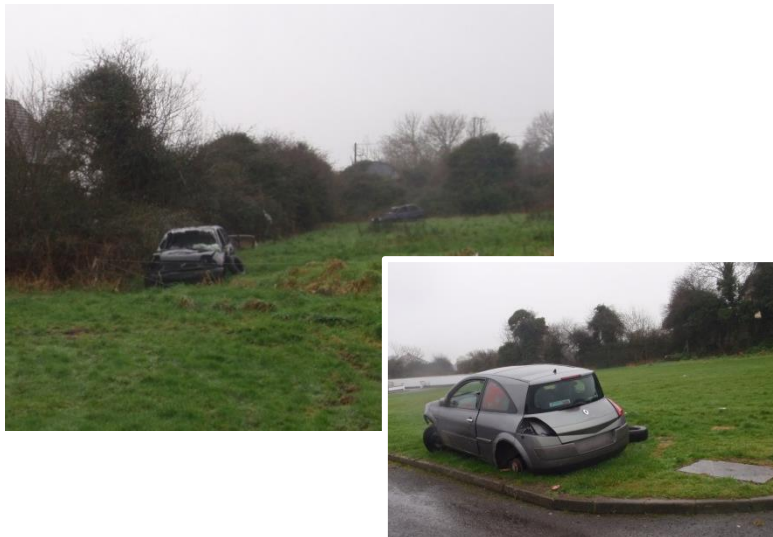
<b>6.</b>	<p><b>Exceedances of the Parametric Values</b></p> <ul style="list-style-type: none"> <li>a. Irish Water and Limerick County Council provided a detailed account of the investigation that has taken place into PAH exceedances in the Ardagh section of the network. The first odour issue arose in 2014 with a subsequent reoccurrence and PAH exceedance in 2016.</li> <li>b. The investigation into the cause of the exceedance is on-going with the installation of a valve in O'Connor Park, Ardagh imminent. Irish Water advised that results of analysis of internal pipe-scrappings would soon be available, also.</li> <li>c. Following conclusion of the closing meeting the auditors drove to the village of Ardagh and viewed the housing estate affected by the PAH exceedances. It was noted that a number of dismantled cars were present on green areas and waste ground in the estate. (See Photograph 6)</li> <li>d. The pesticide exceedances on this supply are subject to Irish Water's action plan for supplies affected by pesticides. At the time of the audit, Irish Water had held the workshop in the Southern Region but had yet to launch a co-ordinated programme of action on the affected supplies.</li> </ul>

**Photograph 6:** Dismantled cars.

7. Irish Water should continue the investigation into the cause of PAH contamination in the Ardagh area of the distribution network and inform the EPA of the investigation's findings as it progresses. Details of any remedial actions should be provided to the EPA, when identified, followed by results of sampling to verify that the contamination issue has been resolved. Clarification should be provided as to whether the abandoned cars have been examined as part of the investigation.
