Drinking Water Audit Report

County:	Longford	Date of Audit:	16 th April 2019
Plant(s) visited:	Ballymahon PWS (Abbeyshrule WTP)	Date of issue of Audit Report:	18 th April 2019
		File Reference:	DW2011/35
		Auditors:	Ms Derval Devaney Mr Daryl Gunning
Audit Criteria:	<ul style="list-style-type: none"> • The <i>European Union (Drinking Water) Regulations 2014 (S.I. 122 of 2014), as amended.</i> • <i>The EPA Handbook on the Implementation of the Regulations for Water Services Authorities for Public Water Supplies (ISBN: 978-1-84095-349-7)</i> • The recommendations specified in the <i>EPA Drinking Water Report.</i> • EPA Drinking Water Advice Notes No.s 1 to 15. • The recommendations in previous audit reports for audits conducted on 20/08/14 and 02/06/17.

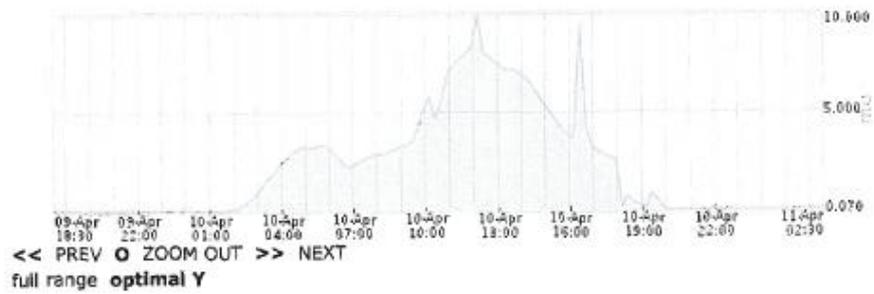
- ii. Once the caretaker became aware of the incident at 11.20 am on 10/04/19, the plant was manually shutdown until 9.30 pm. However, from 2am – 11.20am on 10/04/19 turbidity levels rose to 7.3 NTU in the final water. This resulted in a loss of the *Cryptosporidium* barrier at the plant and it compromised the effectiveness of the disinfection process.

1.	<p>Sludge Carryover to Filters Incident</p> <ul style="list-style-type: none">a. On 15/04/19 Irish Water notified the EPA by telephone at 12.32 pm of an incident involving the carryover of sludge from the clarifiers at 2 am on 10/04/19 and the failure of the plant alarms and automatic shutdown process. The plant was manually shutdown at 11.20 am on 10/04/19.b. An EPA audit had been arranged for 16/04/19 to assess progress with RAL works at the site. Irish Water were informed that the audit would also now cover the incident investigations. On the afternoon of 15/04/19, the EPA notified the HSE of its intention to conduct an audit as a result of the incident and invited the HSE to attend.c. The incident occurred when the sludge bleeds in the clarifiers failed to activate, resulting in the sludge blanket rising in the clarifiers from 2 am on 10/04/19. The turbidity monitors on the settled water are alarmed to text the caretaker if the level reaches 0.4 NTU and shutdown the plant if the level reaches 0.6 NTU. While a turbidity of > 10 NTU was recorded on the turbidity monitors just before 2am on 10/04/19, the alarms did not activate. As a result, the sludge blanket rose in the clarifiers and sludge carried over to the rapid gravity filters. The turbidity monitors on each of the three filters are alarmed to initiate a backwash at 1 NTU. This alarm did not activate. There is a turbidity monitor on the combined final water which shuts down the plant at 0.5 NTU, this alarm failed also. Therefore, inadequately treated water continued to flow from the treatment plant to the Richmond Reservoir and into supply.d. The caretaker arrived onsite on 10/04/19 at approx. 11.20 am and discovered the elevated turbidity readings (7 NTU) in the final water. He stated the last time he received an alarm by text from the plant was on 09/04/19 at 10.05 am. He manually shut down the plant and started to backwash the filters. He also drained down the water in the rising main leading up to Richmond Reservoir. He alerted staff within Longford Co Co of the incident. He took samples of water leaving the Richmond Reservoir at 2.15 pm and 6 pm on 10/04/19 and at 9 am on 11/04/19 for parameters including turbidity, chlorine, aluminium, UVT, Colour. The results of these tests were satisfactory. He turned the plant back on at approx. 9.30 pm on 10/04/19. The caretaker stated he started receiving text alarms at 2.20 pm on 10/04/19.e. Prior to, and on the day of the incident, EPS staff were working onsite as part of the RAL upgrade works. The auditors understand that they were uploading a new programme to the programmable logic controller (PLC) for the new sulphuric acid dosing system, for greater control of the coagulation process.f. Longford Co Co notified Irish Water of the incident by email at 4:24 pm on Thursday 11/04/19. The HSE was not consulted by Irish Water or Longford Co Co at any stage prior to the audit regarding the incident and the potential risk to public health it had posed. The HSE became aware of the detail and seriousness of the incident while on-site during the audit.g. An examination of the SCADA system during the audit showed that the clarified water turbidity rose to > 10 NTU just before 2am and the final water turbidity was above 0.2 NTU from 02.26 am until the plant was shutdown at 11.20 am. This meant the plant's <i>Crypto</i>. barrier was compromised during that 9-hour period. The final water turbidity also rose to > 1 NTU from 3.11 am and steadily increased to 7.3 NTU until such time as the plant was shutdown at 11.20 am. This meant the 1 NTU parametric value for turbidity in the final water leaving the plant was breached for 8 hours and the effectiveness of the disinfection at the plant was compromised during this period (See photo 1). By the day of

Photo 1 Final Water turbidity print out from SCADA during the audit shows turbidity leaving the plant going into supply from 2am – 11.20 am 10/04/19 reaches 7.3 NTU

4. Irish Water should immediately commence a monitoring programme for *Cryptosporidium* and microbiological parameters in the final treated water at Abbeyshrule water treatment plant and its network. Irish Water should also ensure that reactive sampling can be undertaken in a timely manner in response to an incident at the plant.

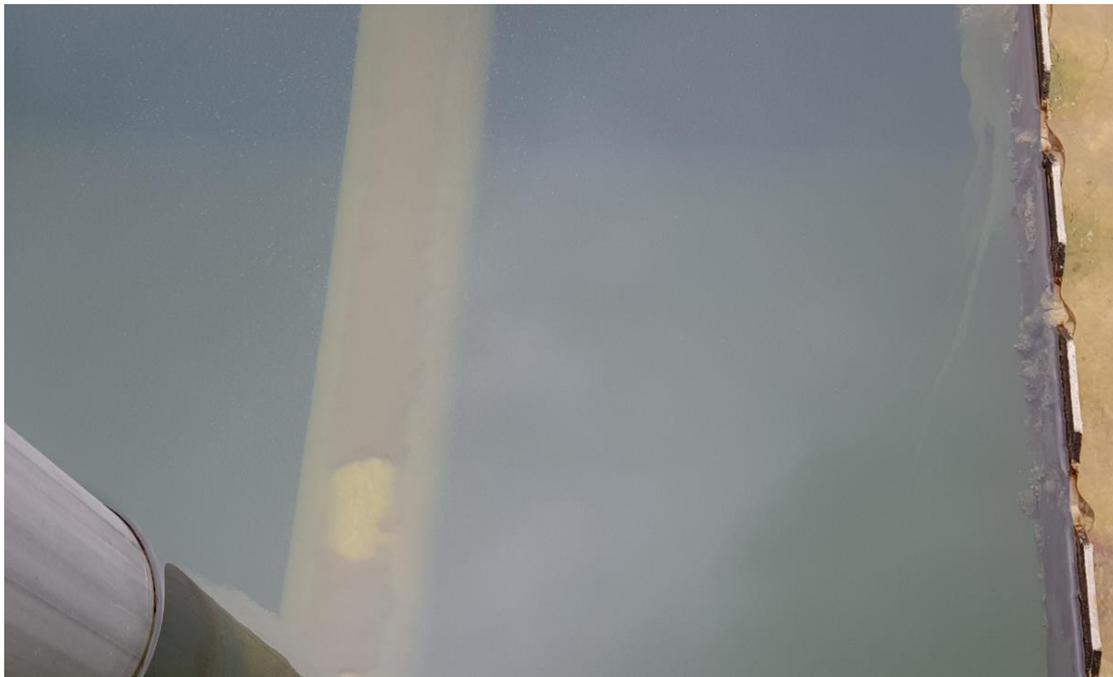
Photo 2 Pin floc evident in clarifer

7. Irish Water should ensure the RAL upgrade works at Abbeyshrule water treatment plant are completed by Q2 2019. Such works should address issues found during the audit - pin floc carryover, algae presence in the clarifiers and potential issues during filter backwash (e.g. media boiling).

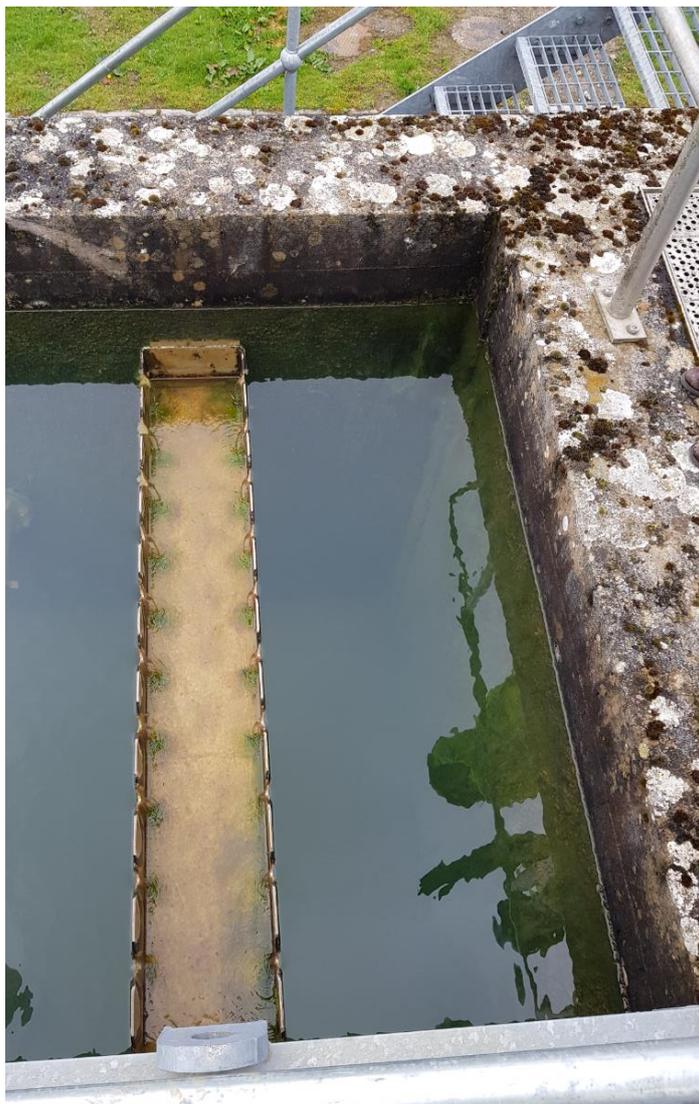
Photo 3 Algae on decanting channels and walls of clarifier

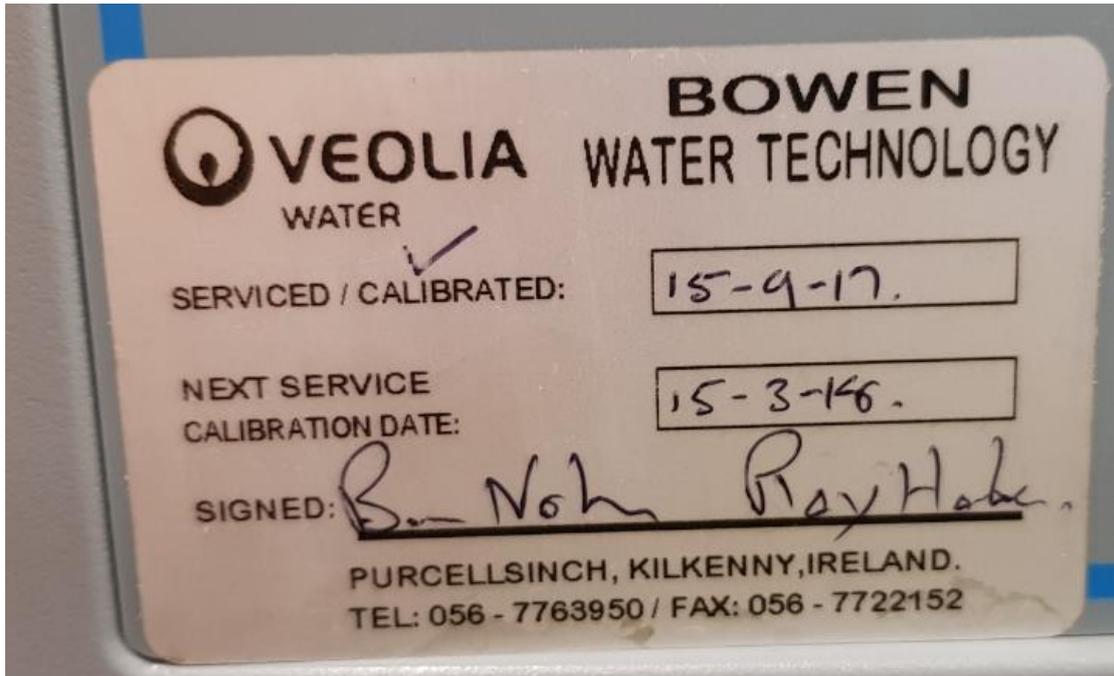
<p>The calibration stickers on the pH and turbidity monitors showed their calibration was overdue, despite Longford Co Co stating that they had been recalibrated by Veolia on 11th November 2018 (See Photo 4). Longford Co Co stated they have increased the calibration frequency of these monitors from 6 to every 3 months.</p> <ul style="list-style-type: none"> e) The filters were upgraded to include new pipework to facilitate a run to waste facility during backwash. The run to waste facility has not yet been activated, as the control philosophy is still in the commissioning phase. f) The filters were inspected but a backwash was not observed. The media in Filter No. 2 appeared to show areas where boiling could be evident during backwash (See Photo 5). This matter was raised in previous EPA audits. g) The Richmond Reservoir was cleaned and leaks repaired. h) Irish Water stated that RAL works are on track to be completed by the end of Q2 2019 and verification of works for removal from the RAL in Q3 2019. <p>Further planned improvement works include the installation of a UVT monitor at the raw water intake. Currently a UVT monitor is in place on the final water only. It is proposed that this raw water monitor will be linked to the coagulant dose to provide automation of the process once a bank of UVT data for raw water is obtained.</p> <p>Hydrocarbon and ammonia online monitors are also due to be commissioned on the raw water intake within the next few weeks to bring greater security to the water supply.</p> <p>In addition, Veolia have been contracted to move the chlorine injection point from the inlet to the outlet of the clearwater tank. The flow meter monitors at the outlet of the tank and rather than the dose being based on a flow at the raw water intake, it will be based where the chlorine dose is being injected post the clear water tank. Irish Water stated contact time is achieved in the rising main entering the Richmond Reservoir and there are no consumers served prior to that reservoir.</p>

Photo 4 Service sticker on clarified water turbidity monitor shows calibration is overdue

5. Irish Water should identify how the protozoal compliance log deficit is to be addressed at Abbeyshrule water treatment plant.
6. Irish Water should confirm that pH and turbidity monitors have been calibrated and their calibration stickers are up-to-date.

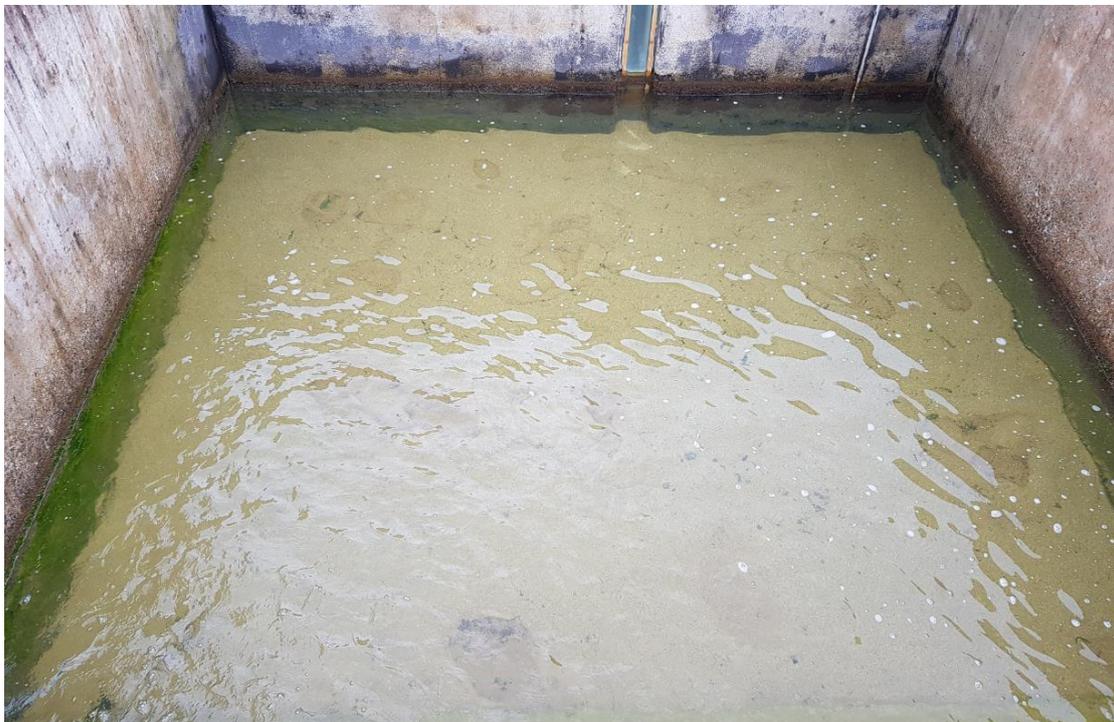
Photo 5 Traces of boils on Filter Media
