Drinking Water Audit Report

County:	Longford	Date of Audit:	2 nd June 2017
Plant(s) visited:	Ballymahon PWS (Abbeyshrule WTP) Scheme Code 2000PUB1005	Date of issue of Audit Report:	13 th June 2017
		File Reference:	DW2011/35
		Auditors:	Mr Darragh Page Ms Derval Devaney
Audit Criteria:	<ul style="list-style-type: none"> • The <i>European Union (Drinking Water) Regulations 2014 (S.I. 122 of 2014)</i>. • The <i>EPA Handbook on the Implementation of the Regulations for Water Services Authorities for Public Water Supplies (ISBN: 978-1-84095-349-7)</i> • The recommendations specified in the <i>EPA Drinking Water Report</i>. • EPA Drinking Water Advice Notes No.s 1 to 15. • The recommendations in the previous audit report dated 20th August 2014.

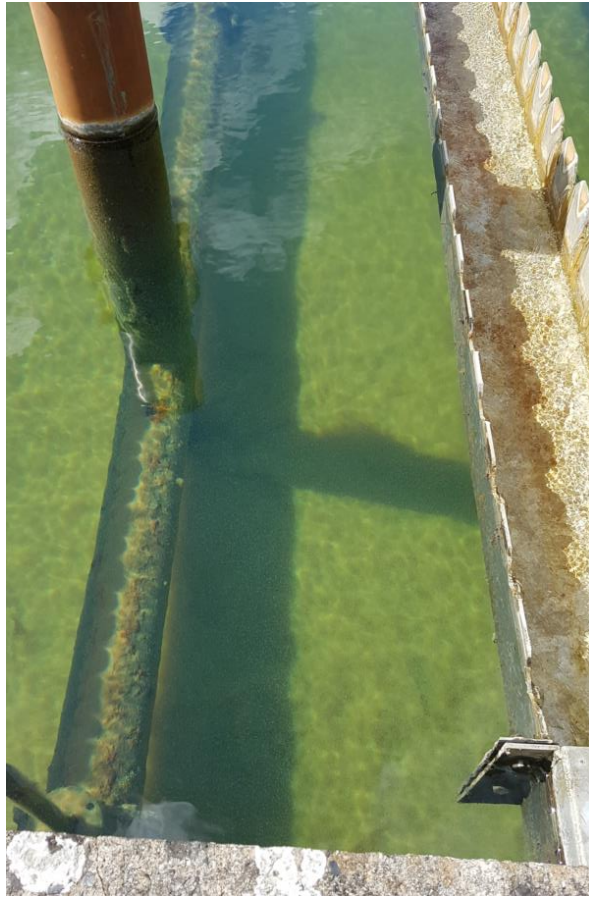
<p>and had uneven flow. This issue was identified at the previous EPA audit and had not been corrected.</p> <ul style="list-style-type: none"> d. Pin floc was present in Clarifier 2 and its downpipes were pitted, rusted, damaged in places (see Photo 1) and in need of replacement. e. Some algae was noted in Clarifier 1. It was stated that the channel length cannot currently be cleaned fully as there are walkways on only one side of each of the two clarifier tanks. This was also identified in the previous EPA audit. f. Irish Water is to commence monitoring from source to tap to determine the THM formation potential (THMFP) and organics removal capacity which is to inform the plant upgrade required. As a result, Irish Water stated that the RAL date, to achieve compliance with the THMs parametric value, has been pushed out by 18 months to December 2018. This project is to be dealt with under Irish Water's Minor Programmes.

Photo 1 Clarifier pipework rusted and pin floc present

3. Irish Water should:
 - a. ensure that the clarifier pipework is repaired and channels are level, free from blockage and that flow into these channels is even;

- b. carry out an investigation to identify the cause of pin floc formation;
 - c. ensure that the clarifier tanks and channels are cleaned regularly to prevent the build-up of algae/ weed growth. Facilities should be provided to carry out this work safely.

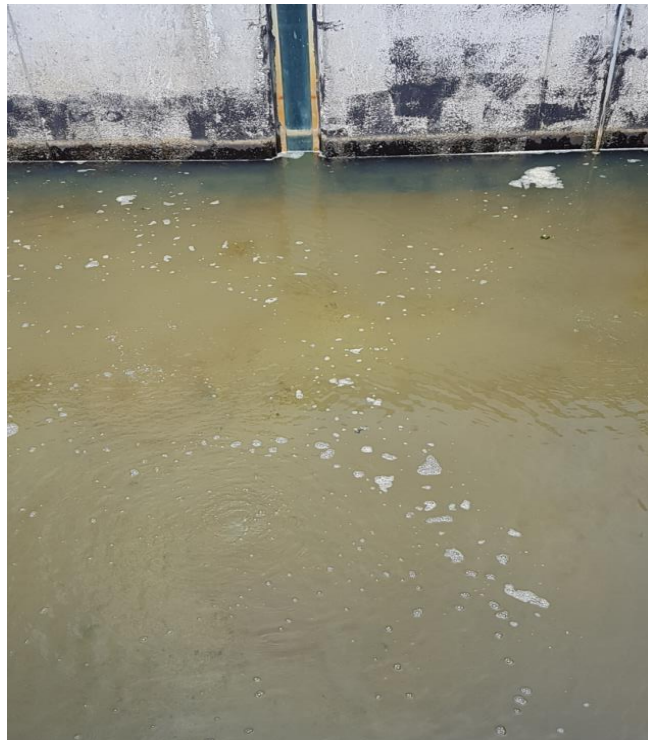
3.	<p>Filtration</p> <ul style="list-style-type: none"> a. There are three rapid gravity filters at the plant. These were refurbished in 2012, including replacement media in all three filters, and replacement pipework/ nozzles in Filter No. 1. b. Filters are normally backwashed on a time basis (every 20 hours), but can be triggered on headloss or if turbidity on the filter outflow rises above 1 NTU. c. Filter 2 was backwashed during the audit on request. An area towards the back right hand side of the filter and middle showed significant boiling (see Photo 2). This was also identified in the previous EPA audit. d. The combined filtered water online turbidity monitor read 0.6 NTU on the day of the audit. e. Upon review of the turbidity concentrations in the final water on SCADA, spikes in turbidity were observed and the cause was not apparent. However it was stated that during the backwash of a filter the other filters receive additional flows.

Photo 2 Boiling evident during backwash in a number of locations at Filter 2

5. Irish Water should investigate the cause of the boils in the filter media during backwash of Filter No. 2 and review the backwash performance of Filters 1 and 3 to identify if there are similar issues present. The cause of spikes in final water turbidity should also be identified. Irish Water should take appropriate action to optimise the operation of the filters to ensure that the final water quality is not affected.
6. Irish Water should review the turbidity trigger level for automatic backwash as the level of 1 NTU is high considering the plants average final water turbidity level.

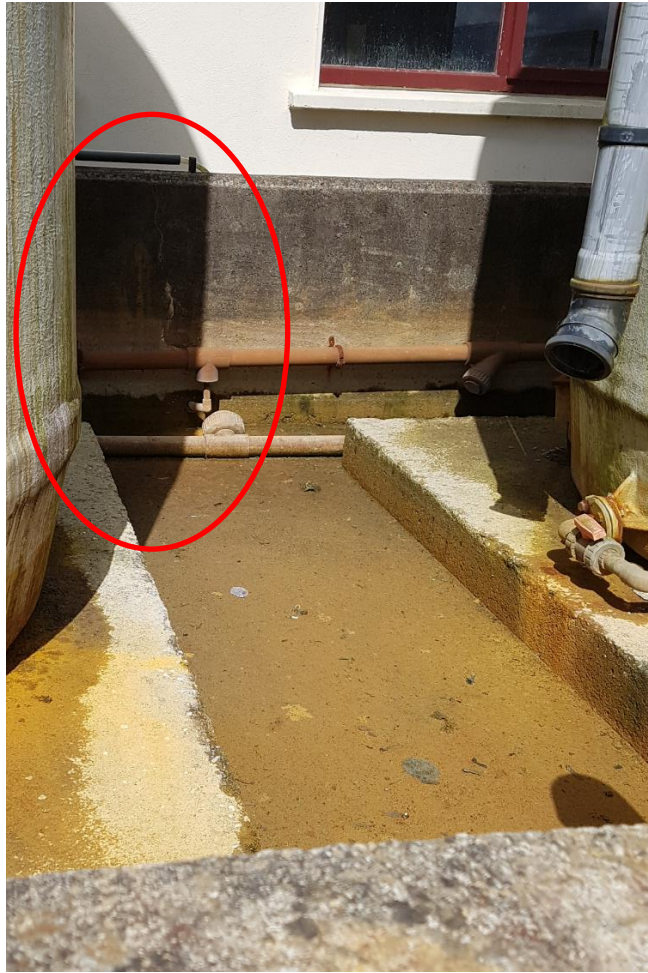
7.	<p>Chemical storage and bunds</p> <ul style="list-style-type: none"> a. The bund wall containing the chemifloc 101 bulk tanks appeared to have a crack in it and pipework penetrating close to its base (see Photo 3).

Photo 3 The Chemifloc 101 bund wall appeared to be cracked and had pipework routed through its wall

7. Irish Water should inspect the bunds in use on-site to ensure they are of sound integrity. Chemicals must be stored in bunded areas capable of containing at least 110% of the volume of chemicals stored therein. Fill points for storage tanks inside the bunds should be within the bunded area. Refer to EPA guidance document –“*IPC Guidance Note on Storage and Transfer of Materials for Scheduled Activities*”.
