# Drinking Water Audit Report

<b>County:</b>	Longford	<b>Date of Audit:</b>	20 <sup>th</sup> August 2014
<b>Plant(s) visited:</b>	Ballymahon PWS Scheme Code 2000PUB1005 Abbeyshrule WTP and Richmond Reservoir	<b>Date of issue of Audit Report:</b>	22 <sup>nd</sup> August 2014
		<b>File Reference:</b>	DW2011/35
		<b>Auditors:</b>	Ms Ruth Barrington Ms Aoife Loughnane
<b>Audit Criteria:</b>	<ul style="list-style-type: none"> <li>• <i>The European Union (Drinking Water) Regulations 2014 (S.I. 122 of 2014).</i></li> <li>• <i>The EPA Handbook on the Implementation of the Regulations for Water Services Authorities for Public Water Supplies (ISBN: 978-1-84095-349-7)</i></li> <li>• <i>The recommendations specified in the EPA Report on <u>The Provision and Quality of Drinking Water in Ireland.</u></i></li> </ul>

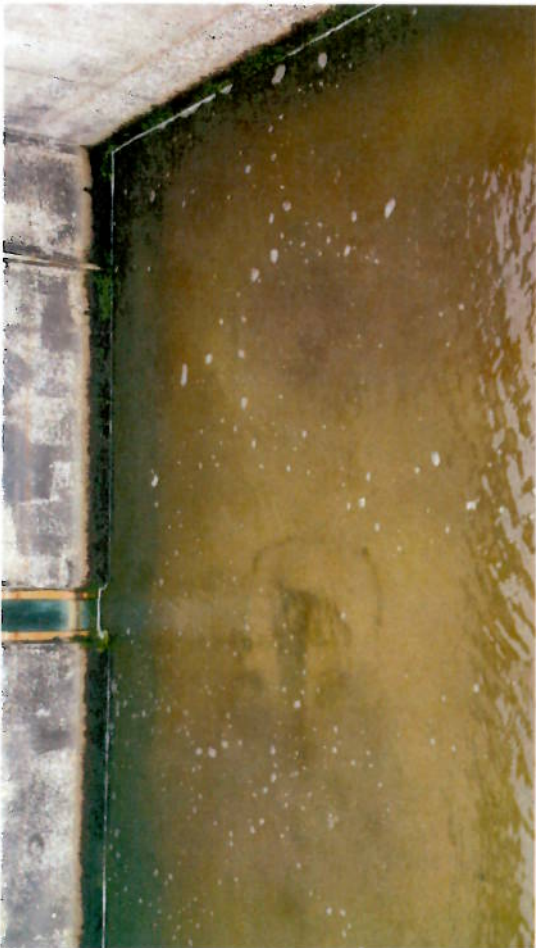
013.jpg

<b>3.</b>	<p><b>Filtration</b></p> <ul style="list-style-type: none"> <li>a. There are three rapid gravity filters at the plant. These were refurbished in 2012, including replacement media in all three filters, and replacement pipework/ nozzles in Filter No. 1.</li> <li>b. Filters are normally backwashed on a time basis, but are triggered additionally if turbidity on the filter outflow rises above 1.5 NTU.</li> <li>c. Filter 2 was backwashed during the audit on request. The backwash in general proceeded well, with the exception of an area towards the back right hand side of the filter which</li> </ul>

<p>showed slight boiling (refer to photograph Ref. 013.jpg) and some sand carryover on the weir. However overall the media level had not visibly decreased since the media replacement.</p>

6. Irish Water should review the filter backwash performance to identify any areas similar to that observed in Filter No. 2 during the audit where a boil in the filter led to sand carry over at the weir. Suitable maintenance should be carried out on areas so identified.
7. Irish Water should review the turbidity trigger level for automatic backwash as the level of 1.5NTU is high.
