# Drinking Water Audit Report

<b>County:</b>	Co. Louth	<b>Date of Audit:</b>	11/07/2019
<b>Plant(s) visited:</b>	Greenmount Water Treatment Plant  Scheme Code 2100PUB1002	<b>Date of issue of Audit Report:</b>	25/07/2019
		<b>File Reference:</b>	DW2019/122
		<b>Auditors:</b>	Ruth Barrington Daryl Gunning
<b>Audit Criteria:</b>	<ul style="list-style-type: none"> <li>The <i>European Union (Drinking Water) Regulations 2014 (S.I. 122 of 2014)</i>, as amended</li> </ul>

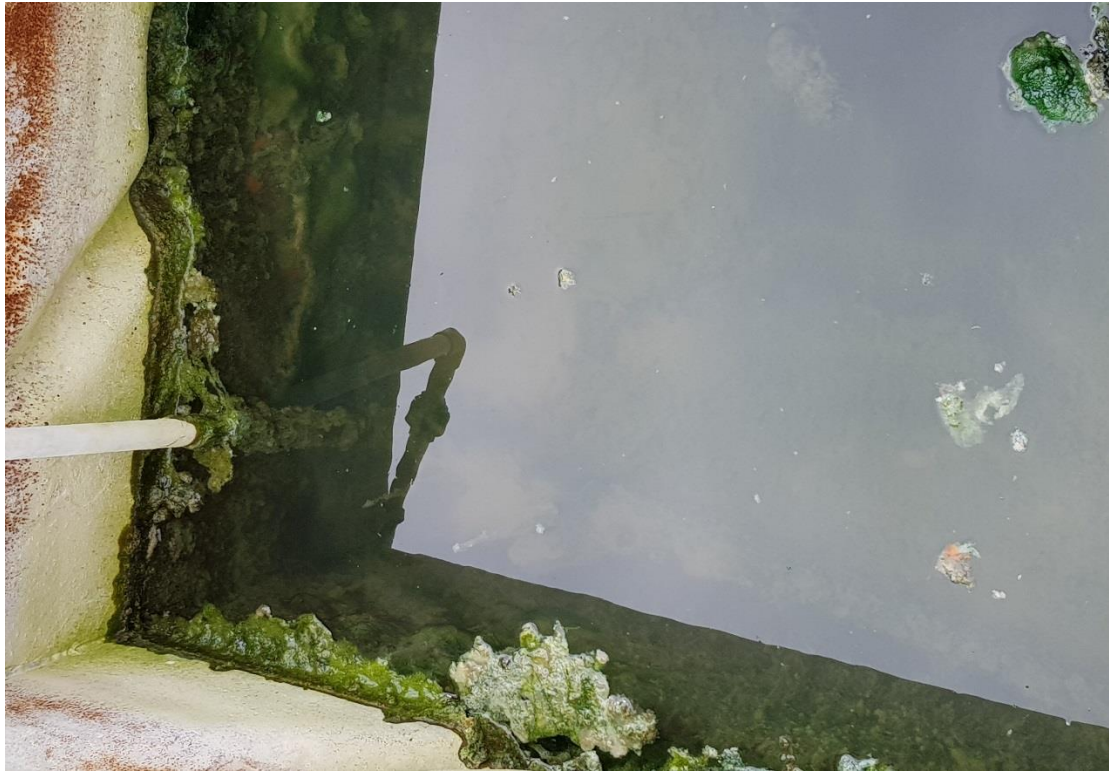
2.	<p><b>Coagulation, Flocculation and Clarification (CFC)</b></p> <ul style="list-style-type: none"> <li>a. There are two CFC streams on-site, at the Old Plant and New Plant. The flocculation tank and clarifier for the Old Plant and the clarifier for the New Plant were examined as part of the audit.</li> <li>b. The flocculation tank was found to have a large amount of floc/ algal build up on the walls (refer to Photo 1. This may indicate that floc is forming and dropping out within the tank rather than remaining in suspension until it reaches the clarifier. The structure of the tank means that routine cleaning is difficult as there is no proper access to all sides of the tank.</li> <li>c. Staff described the chemical dosing processes. There is no mixing mechanism following the addition of the aluminium sulphate dose, other than that which occurs in the pipe. The poly dose is applied along a spreader bar but at the time of the audit it appeared that this was coated with sludge/ algal build up which may affect the dosing process.</li> <li>d. Both clarifiers showed a build up of sludge and algal growth on the walls and channels, the New Plant clarifier being worse, with lumps of material carrying over into the settled water decanting channels (refer to Photos 2-4). Ivy growing on the outside of the New Plant</li> </ul>

Photo 1. Flocculation tank at Old Plant showing build up of floc/ algal material on tank walls.

6. Irish Water should optimise the CFC processes at Greenmount Water Treatment Plant, including the following considerations:
  - a. For coagulant and polyelectrolyte dosing, the dose location, contact time and current lack of mixing post-dosing should be addressed.
  - b. For all stages in the CFC processes, the cleaning and maintenance of tanks, channels and working platforms to be addressed, to prevent the build-up of floc, sludge and algae which was being carried over into clarifier channels during the audit.
  - c. For both Old and New Plants, the design flow and operational flow through the plants to be optimised to ensure the loadings are appropriate and within the design capacity.

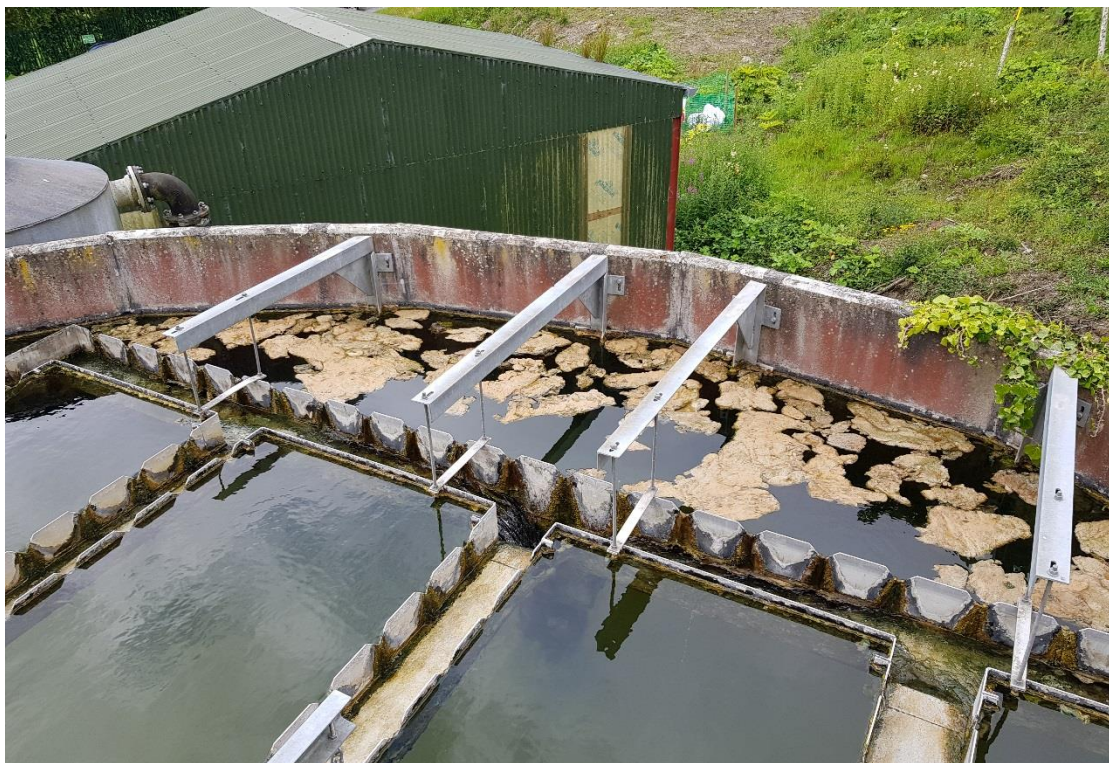
<p>clarifier was hanging over the edge of the tank (refer to Photo 2).</p> <p>e. Access to the New Plant clarifier for cleaning was only possible via the gangway across the diameter of the tank. Being a circular elevated tank, much of the tank wall and the extremities of the clarifier channels are inaccessible for cleaning while the tank is in use. Staff stated that material sloughing off the inside of the tank wall leads to the carryover visible into the decanting channels.</p> <p>f. The water treatment plant had been visited in Q1 2019 by an Irish Water Process Optimisation team. The report from this visit will contain recommendations on coagulation and flocculation processes which will need to be implemented as a matter of urgency. While the results of operational analysis relating to the CFC process examined during the audit were compliant, the risk to the safety of the drinking water supply posed by the observations above is unacceptable.</p>

Photo 2. Build-up of sludge/ algal material in New Plant Clarifier and lack of access for cleaning tank and channels. Also shows ivy overhanging the tank edge.

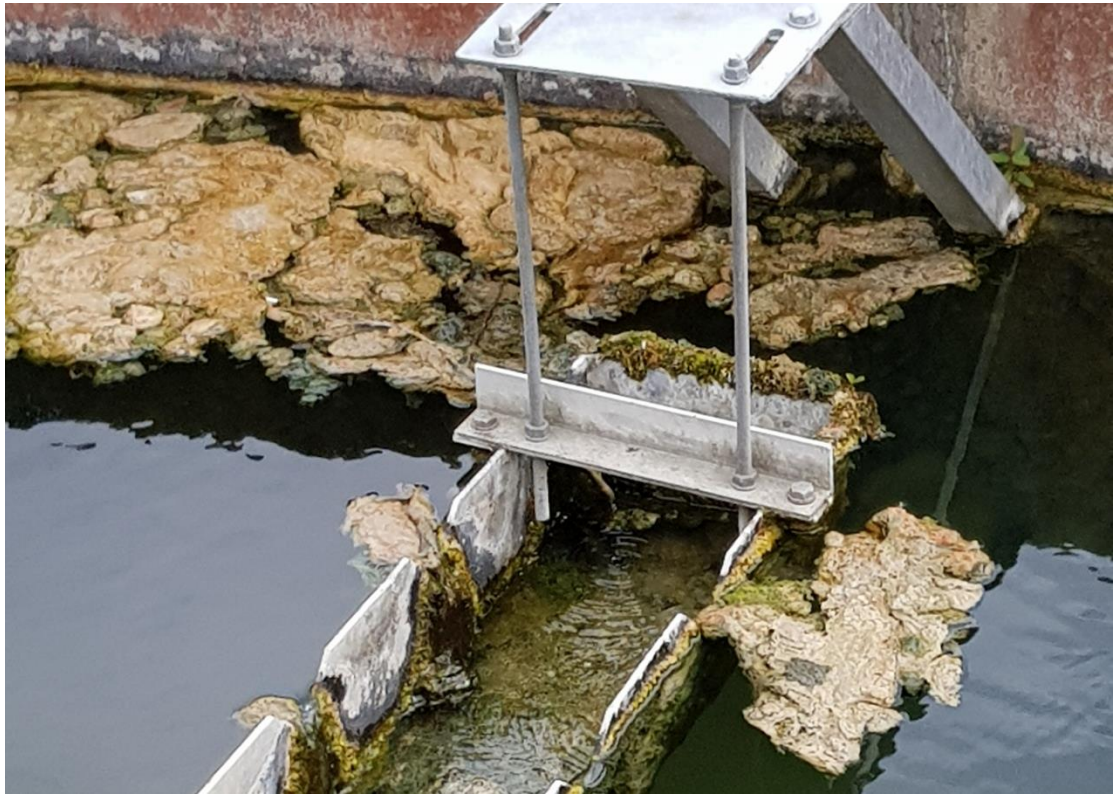
Photo 3. Close up of the sludge/ algal material on water surface and channels at the New Plant clarifier.

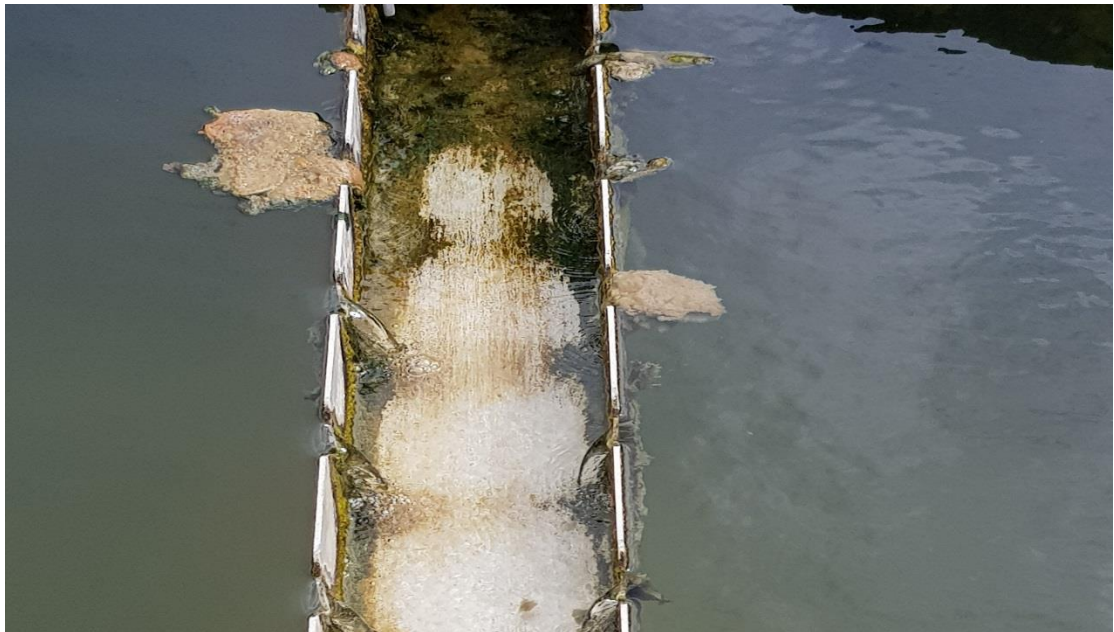
Photo 4. Carryover of sludge/ algal material from New Plant clarifier into settled water decanting channel
