Drinking Water Audit Report

County:	Mayo	Date of Audit:	13 th May 2016
Plant(s) visited:	Ballina Lisglennon Water Treatment Plant	Date of issue of Audit Report:	23 rd May 2016
		File Reference:	DW2013/93
		Auditors:	Ms. Michelle Roche
Audit Criteria:	<ul style="list-style-type: none"> • The <i>European Union (Drinking Water) Regulations 2014 (S.I. 122 of 2014)</i>. • <i>The EPA Handbook on the Implementation of the Regulations for Water Services Authorities for Public Water Supplies (ISBN: 978-1-84095-349-7)</i> • The recommendations specified in the <i>EPA Drinking Water Report</i>. • EPA Drinking Water Advice Notes No.s 1 to 15. • The recommendations in the previous audit report issued 30/09/15.

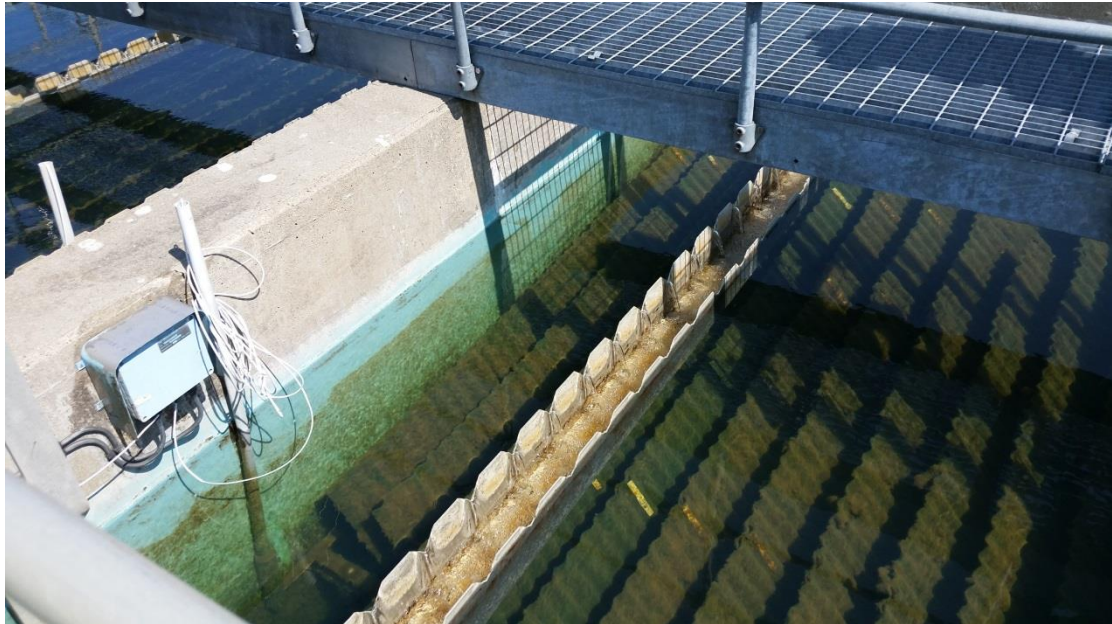
Photograph 1: Floc on walls of clarifier 2
