Drinking Water Audit Report

County:	Mayo	Date of Audit:	16 th October 2018
Plant visited:	Ballycastle Water Treatment Plant (scheme code 2200PUB1005)	Date of issue of Audit Report:	24 th October 2018
		File Reference:	DW2018/178
		Auditors:	Aoife Loughnane
Audit Criteria:	<ul style="list-style-type: none"> • The <i>European Union (Drinking Water) Regulations 2014 (S.I. 122 of 2014)</i>, as amended. • The <i>EPA Handbook on the Implementation of the Regulations for Water Services Authorities for Public Water Supplies (ISBN: 978-1-84095-349-7)</i> • The recommendations specified in the <i>EPA Drinking Water Report</i>. • EPA Drinking Water Advice Notes No.s 1 to 15. • The recommendations in the previous EPA Drinking Water Audit Report (dated 8th March 2013).

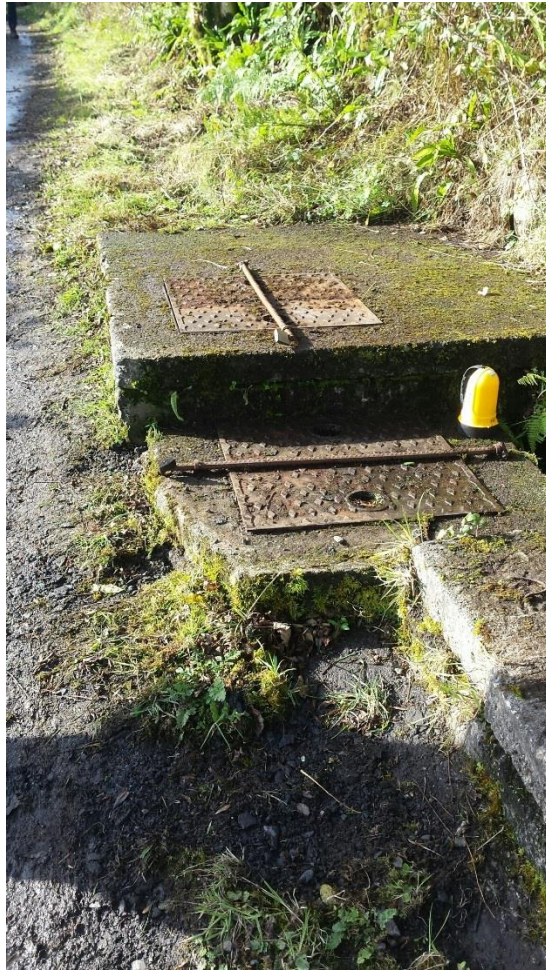
2.	<p>Source Protection</p> <ul style="list-style-type: none"> a. Water is abstracted from a spring source (Ballyknock Spring) which has been in use since the 1940s. b. The spring abstraction is housed in a concrete chamber located on the side of a small rural road which leads to a farmyard (see photo 1). The access manhole to the spring chamber was securely locked. c. The spring chamber is very old and in poor condition. There was a gap in the concrete between the side and lid of the chamber (see photo 2) which presents a risk of surface water ingress to the chamber. d. The land surrounding the spring is non-intensive agricultural land. The zone of contribution (ZOC) to the spring source has been delineated in the EPA's <i>Water Framework Directive, Groundwater Monitoring Programme, Site Information Report on Ballycastle PWS (August 2011)</i>. The ZOC measures 0.8 km² on lands to the north west of the spring chamber, which is made up of a steep hill and pasture land. The soil is poorly drained and is underlain by low permeability subsoil. The hydrogeological information identifies that this site is a <i>PI poor aquifer – bedrock which is generally unproductive except for local zones</i>. The groundwater vulnerability in the ZOC includes areas of extreme vulnerability (rock near surface or karst). e. There are two houses with septic tanks located within 200m of the spring abstraction. These septic tanks have not been inspected, however Mayo County Council has identified them as candidates for inspection under the National Inspection Plan for Domestic Waste Water Treatment Systems due to their proximity to a drinking water source. f. In December 2017, Mayo County Council met with and wrote to 10 landowners to advise them of the required setback distances for landspreading and storage of manure under the <i>European Union (Good Agricultural Practice for the Protection of Waters) Regulations</i> and the requirements of the <i>Sustainable Use of Pesticides Regulations</i>. g. There is a raw water monitoring programme for <i>E.coli</i> (twice monthly), coliform bacteria, turbidity, ammonium, colour, conductivity, pH and UVT (monthly). The 2018 results show that raw water <i>E.coli</i> levels are usually low (0 – 3 MPN/100mls) however there were large spikes on 3 occasions; 291 MPN/100mls on 10/05/18, 126 MPN/100mls on 19/07/18 and 248 MPN/100mls on 19/09/18 (this sample date corresponds to Storm Ali). These results demonstrate the source-pathway linkage for faecal contamination of the spring source, and confirms that the spring is vulnerable to surface water influence.

Photo 1: Spring chamber

2. Irish Water should take immediate action to improve the source protection measures at the spring chamber. Irish Water should ensure that the spring chamber is adequately sealed to prevent the ingress of surface water.

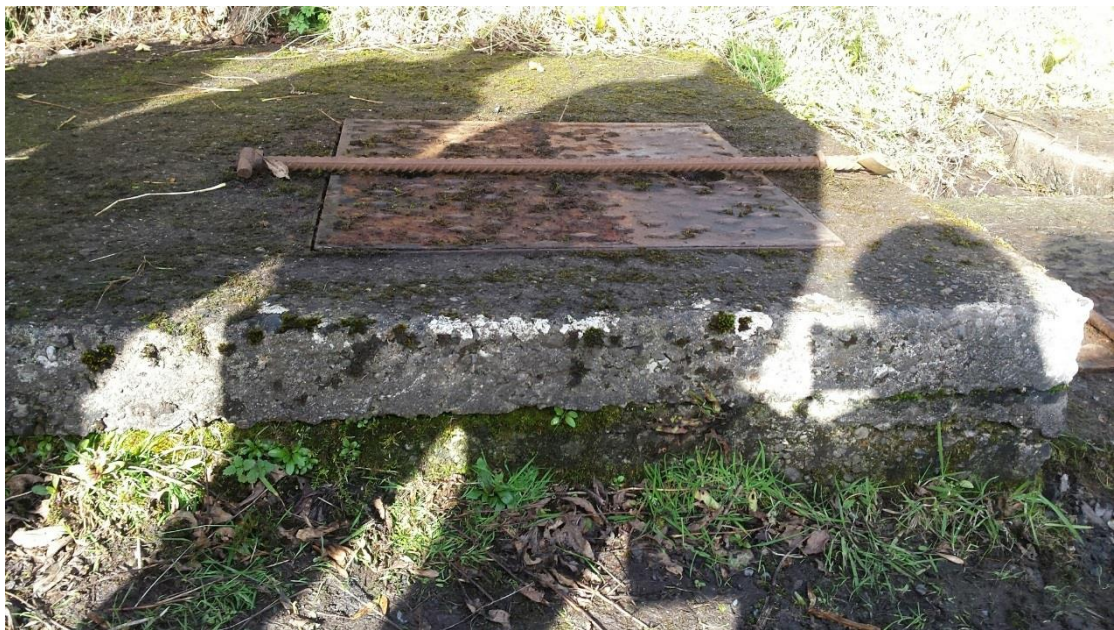
Photo 2: Side of spring chamber showing gap in concrete (potential route of surface water ingress)

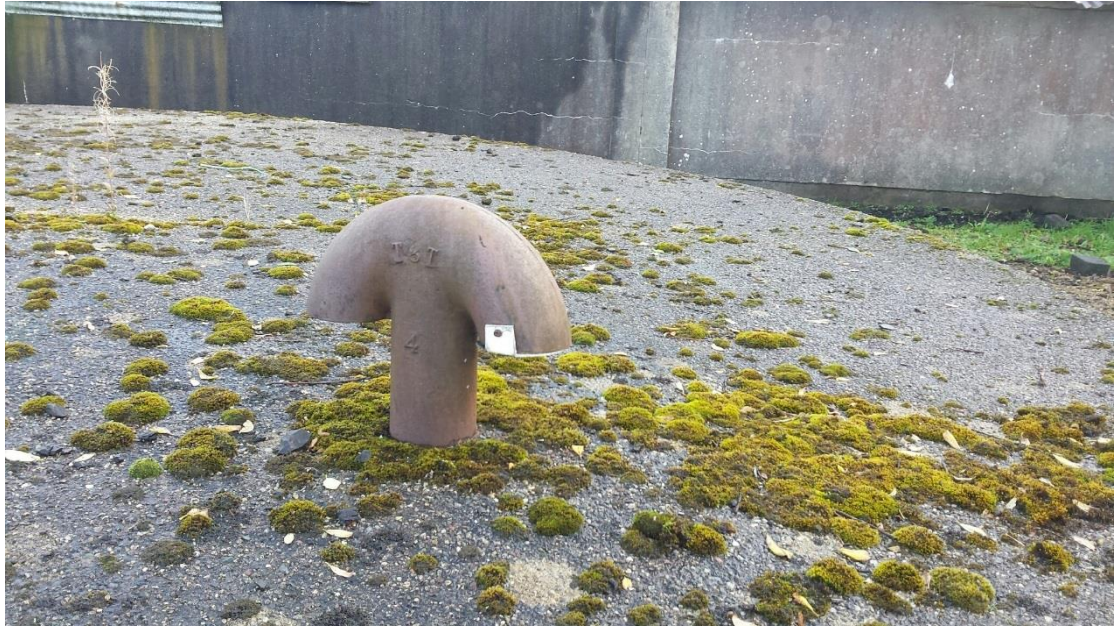
4.	<p>Treated Water Storage</p> <ul style="list-style-type: none"> a. The clear water tank has a capacity of approximately 90 m³. The tank was inspected and cleaned in late 2016. Mesh covers have been installed on the vents since the previous EPA audit. b. Treated water flows by gravity to the Town Hall Reservoir in the centre of Ballycastle. The reservoir was built in 1985 and last cleaned in February 2018. c. One of the vents on the roof of the reservoir had no mesh cover on one side (see photo 3). The overflow pipe from the reservoir was not covered (see photo 4). These present a risk of ingress of vermin or deliberate introduction of contaminants or acts of vandalism. d. The access gate and fencing at the Town Hall Reservoir site was not secure and presents a risk of unauthorised access to the treated water reservoir.

Photo 3: Vent on Town Hall Reservoir – mesh cover missing on one side

5. Irish Water should submit a calculation of the effective chlorine contact time (taking the recently installed curtain baffle in the clear water tank into account), to demonstrate that the first connections are receiving appropriately disinfected drinking water.
6. Irish water should ensure there are at least three people in the cascade system for responding to alarms at the drinking water treatment plant.
7. Irish Water should take action to improve the site security at the Town Hall Reservoir, in particular the access gate and site fencing, to prevent any unauthorised access.
8. Irish Water should ensure that the vents and the overflow pipe outlet on the Town Hall Reservoir are secured against ingress of animals or deliberate introduction of any contaminant or acts of vandalism.

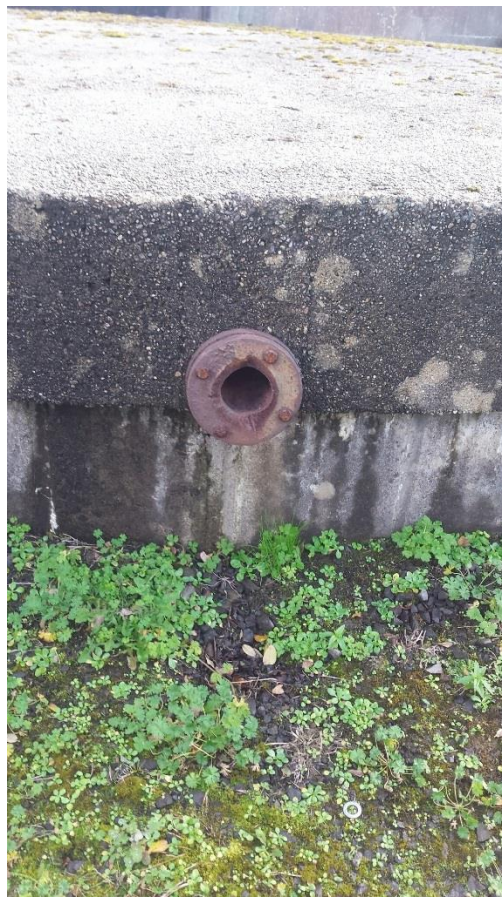
Photo 4: Overflow pipe on Town Hall Reservoir
