# Drinking Water Audit Report

<b>County:</b>	Mayo	<b>Date of Audit:</b>	22 February 2016
<b>Plant(s) visited:</b>	Crossmolina Water Treatment Plant	<b>Date of issue of Audit Report:</b>	3 March 2016
		<b>File Reference:</b>	DW2015/141
		<b>Auditors:</b>	Ms Derval Devaney Ms Michelle Roche
<b>Audit Criteria:</b>	<ul style="list-style-type: none"> <li>• The <i>European Union (Drinking Water) Regulations 2014 (S.I. 122 of 2014)</i>.</li> <li>• The <i>EPA Handbook on the Implementation of the Regulations for Water Services Authorities for Public Water Supplies (ISBN: 978-1-84095-349-7)</i></li> <li>• The recommendations specified in the <i>EPA Drinking Water Report</i>.</li> <li>• EPA Drinking Water Advice Notes No.s 1 to 15.</li> </ul>

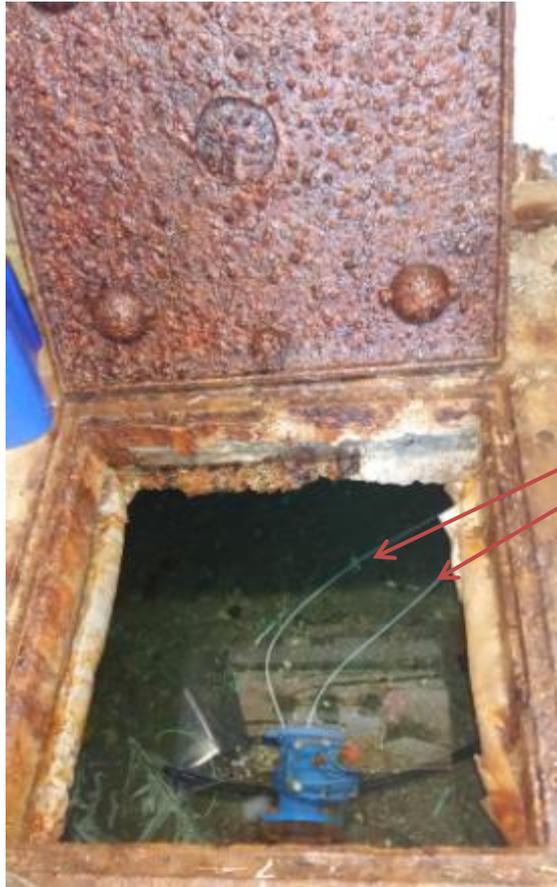
- j. The spring source contained various items of plastic and its cover was rusted (see Photo 1).

Chlorine dose lines to 5" pipe

**Photo 1** Intake area - containing waste such as black piping, plastic bag and tags and rusted cover.

2. Irish Water should take action to ensure that the source is free from contamination by man-made materials (e.g. plastic) and its cover is adequately sealed and is fit for purpose for use in the water treatment process (e.g. free from rust and dirt).

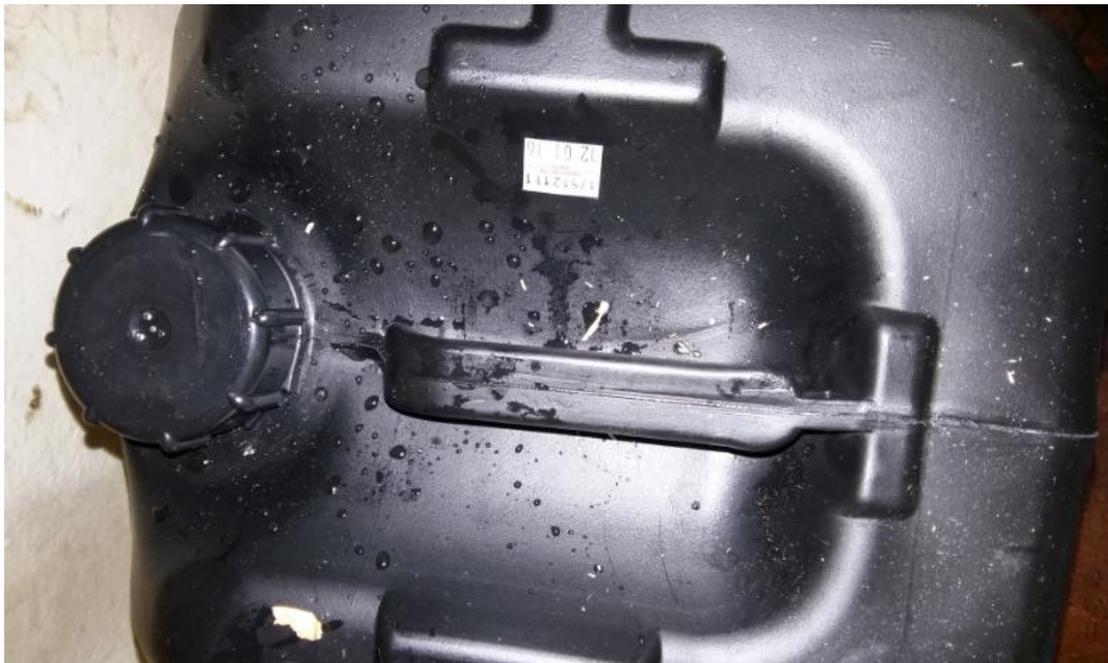
<p><b>4.</b></p>	<p><b>Monitoring and Sampling Programme for treated water</b></p> <ol style="list-style-type: none"> <li>a. Compliance monitoring results were reviewed during the audit and were in compliance with the Drinking Water Regulations, 2014. THMs is monitored 4 times per year and varied from 11 – 18 ug/l. TOC was 1.53 - 1.8 mg/l.</li> <li>b. The caretaker records chlorine residuals monitored in the network in the supply's daily log book. Chlorine is monitored at various points around the town (graveyard, pitch, Mackens) once or twice per week but not always at the end of the network to ensure 0.1 mg/l is being maintained. The chlorine concentrations reviewed during the audit were satisfactory.</li> </ol>
<p><b>5.</b></p>	<p><b>Chemical storage and bunds</b></p> <ol style="list-style-type: none"> <li>a. One drum of sodium hypochlorite is used each week and the drum that was used on the morning of the audit had expired; the use-by date on the drum was 12/01/16 (see Photo 2).</li> </ol>

**Photo 2** Used Sodium Hypochlorite 25L drum with use-by date of 12/01/16.

- 11. Irish Water should put a system in place so that stocks of reagents and chemicals kept on-site are regularly checked to ensure chemicals used in the treatment process are within the use-by date.
