# Drinking Water Audit Report

<b>County:</b>	Mayo	<b>Date of Audit:</b>	13 June 2016
<b>Plant(s) visited:</b>	Kilkelly Drinking Water Treatment Plant (2200PUB1015)	<b>Date of issue of Audit Report:</b>	30 June 2016
		<b>File Reference:</b>	DW2010/126
		<b>Auditors:</b>	Ms. Derval Devaney
<b>Audit Criteria:</b>	<ul style="list-style-type: none"> <li>• The <i>European Union (Drinking Water) Regulations 2014 (S.I. 122 of 2014)</i>.</li> <li>• The <i>EPA Handbook on the Implementation of the Regulations for Water Services Authorities for Public Water Supplies (ISBN: 978-1-84095-349-7)</i></li> <li>• The recommendations specified in the EPA Report on <i>The Provision and Quality of Drinking Water in Ireland</i>.</li> <li>• The Recommendations specified in the previous Audit report of 8<sup>th</sup> October 2010</li> </ul>

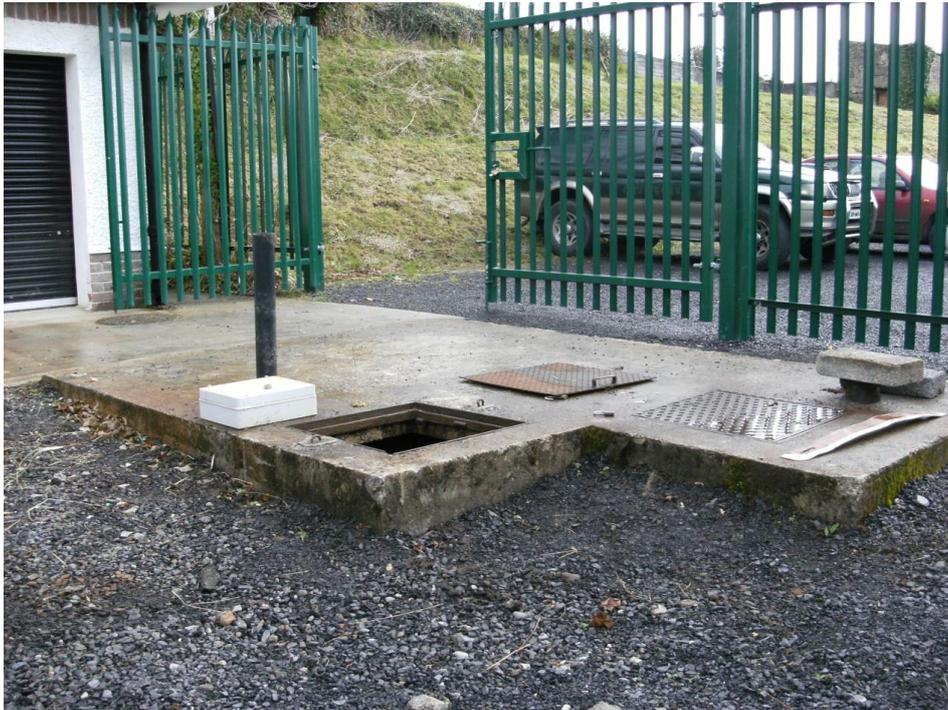
<p><b>1.</b></p>	<p><b>Source Protection</b></p> <ol style="list-style-type: none"> <li>a. The spring source flows directly into a holding tank where it is fed by gravity to a raw water sump (see Photo 1). There is a level sensor on the raw water sump which cuts the pump off at 3.25 meters and re-starts at 3 meters. There are 2 abstraction pumps, one duty and one stand-by which alternate. Water is abstracted at the same pumping rate - 31.5 m<sup>3</sup>/hr was displaying on the SCADA screen on the day of the audit. The caretaker stated that the pumps operate 20 to 21 hours per day.</li> <li>b. The two concrete covered intake areas which tapped into the spring source on-site are no longer in use. Piping the spring source directly to the treatment plant was a recommendation of the previous audit report.</li> <li>c. The entire spring intake area is fenced off and therefore protected from animal grazing/access.</li> <li>d. Raw water data is being monitored to assess its quality and trends to ensure adequate treatment is being provided and to ensure source protection measures are adequate. Irish Water stated that a pH, turbidity and UVT monitor is to be installed on the raw water source as part of the Disinfection Programme which is being rolled out in Co Mayo this year to determine if treatment is adequate and if additional controls are necessary.</li> <li>e. The Kilkelly spring source is part of the EPA's National Groundwater Monitoring Programme and while a Zone of Contribution (ZOC) was delineated in 2011, additional measures (e.g. stream flow measurements as suggested in that report) are required to verify this mainly desk-based ZOC delineation.</li> <li>f. This spring is on the EPA's Groundwater Monitoring Programme and quarterly results show faecal coliforms are persistently present in this source. This would indicate the spring has a potential link with a surface water source(s).</li> <li>g. Article 17 of the GAP Regulations (S.I. 610 of 2010) <i>inter alia</i> regulates the</li> </ol>

Photo 1: Spring source intake sump

- a) Irish Water should examine the EPA's Water Framework Directive Groundwater Monitoring Programme Site Information report for the Kilkelly PWS with a view to further determining and validating the Zone of Contribution (ZOC).

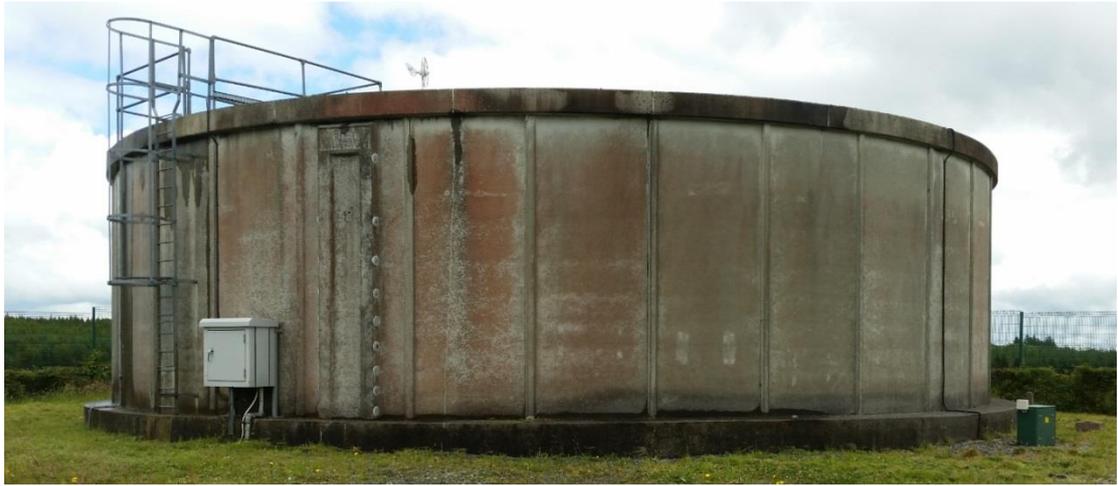
<p><b>3.</b></p>	<p><b>Treated Water Storage</b></p> <p>a. The 700 m<sup>3</sup> reservoir (see Photo 3) 2.4 km from the plant was visited.</p> <p>b. Pumping to the reservoir ceases once a pre-determined reservoir level is reached and pumping re-commences once another pre-determined level is met. There is an overflow pipe on the reservoir.</p> <p>c. There SCADA system at the plant displays chlorine readings at the reservoir, water levels, pressure, pumping rates, etc.</p>

Photo 3: New reservoir 2.4 km from treatment plant.
