# Drinking Water Audit Report

<b>County:</b>	Mayo	<b>Date of Audit:</b>	13 June 2017
<b>Plant(s) visited:</b>	Knock Airport PWS (2200PUB1036)	<b>Date of issue of Audit Report:</b>	30 June 2016
		<b>File Reference:</b>	DW2010/145
		<b>Auditors:</b>	Ms. Derval Devaney
<b>Audit Criteria:</b>	<ul style="list-style-type: none"> <li>• The <i>European Union (Drinking Water) Regulations 2014 (S.I. 122 of 2014)</i>.</li> <li>• <i>The EPA Handbook on the Implementation of the Regulations for Water Services Authorities for Public Water Supplies (ISBN: 978-1-84095-349-7)</i></li> <li>• The recommendations specified in the EPA Report on <i>The Provision and Quality of Drinking Water in Ireland</i>.</li> <li>• The Recommendations specified in the previous EPA Audit report of 8<sup>th</sup> October 2010.</li> </ul>

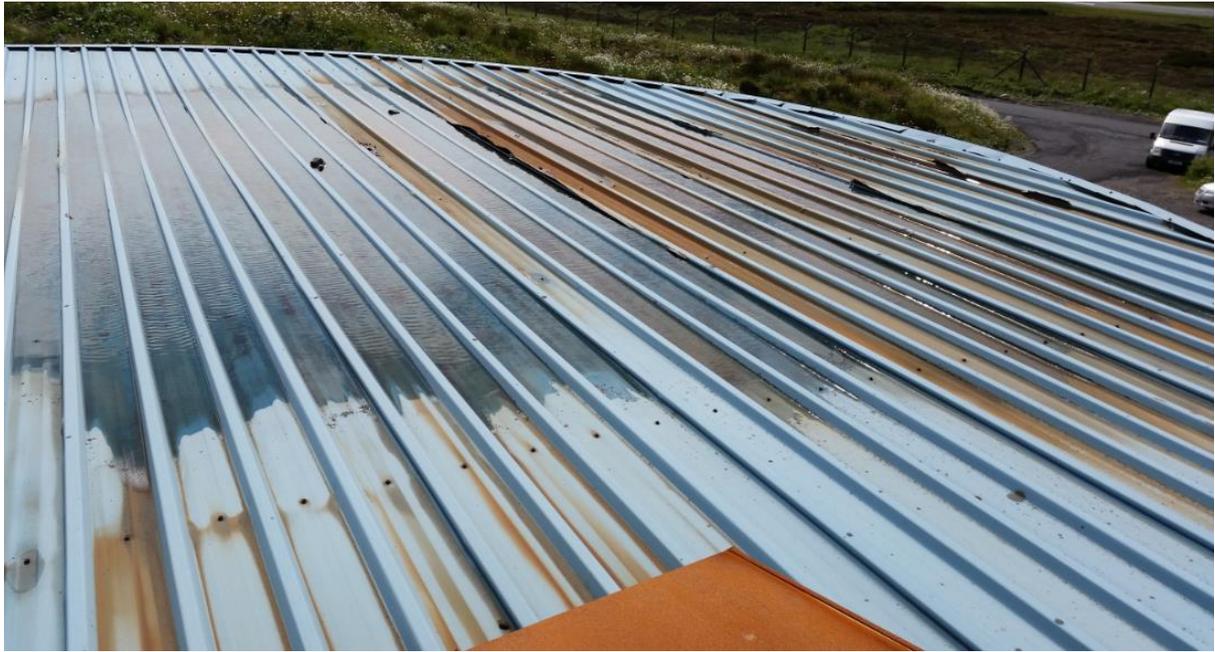
<p><b>3.</b></p>	<p><b>Treated Water Storage</b></p> <ul style="list-style-type: none"> <li>a. Treated water is stored in a reservoir located on the Knock Airport site. The site is exposed and prone to elevated winds, as a result some of the roof's sheeting was compromised (see Photo 2).</li> </ul>
<p><b>4.</b></p>	<p><b>Monitoring and Sampling Programme for treated water</b></p> <ul style="list-style-type: none"> <li>a. The HSE carry out check compliance sampling of the treated water in the network (at the airport) and ELS carry out audit compliance sampling. The auditor reviewed the compliance (check and audit) monitoring results from 2012-2016 and were found to be satisfactory. The historic low chlorine residual levels in the airport (e.g. at the kitchen sink tap) evident from 2007, as discussed during the EPA's 2010 audit, have been addressed by Mayo County Council and the Airport Authority. Irish Water confirmed that there is now no discrepancy in chlorine residual results between the ground and top floor of the airport building and since 2012 all results are &gt; 0.1 mg/l residual chlorine.</li> <li>b. There was no audit sample from ELS in the file for 2015. Irish Water stated that there are usually 2 audit samples taken per year and would investigate whether the samples were taken.</li> <li>c. The turbidity meter on the source water was malfunctioning and not providing a reading even though this monitor was last calibrated within its annual timeframe on 18/12/15. Irish Water stated a call has been logged with CSL to service the instrument and as an interim measure the caretaker is taking manual daily turbidity readings since the monitor has malfunctioned. The turbidity was 0.24 NTU post the reservoir on the day of the audit (monitored by handheld meter).</li> <li>d. The pH was 7.24 on the online monitor post the reservoir on the day of the audit and the flow meter read 46 m<sup>3</sup>/d.</li> </ul>

**Photo 2 Reservoir roof (Reservoir within Airport Boundary)**

3. Irish Water should ensure that the service reservoir is inspected on a regular basis and any maintenance and repairs required (e.g. to its roof structure) are completed as soon as possible after the need has been identified.
