County:	Mayo	Date of Audit:	2 September 2015
Plant(s) visited:	Lisglennon Water Treatment Plant	Date of issue of Audit Report:	30 September 2015
		File Reference:	DW201/93
		Auditors:	Ms Derval Devaney
Audit Criteria:	<ul style="list-style-type: none"> • The <i>European Union (Drinking Water) Regulations 2014 (S.I. 122 of 2014)</i>. • <i>The EPA Handbook on the Implementation of the Regulations for Water Services Authorities for Public Water Supplies (ISBN: 978-1-84095-349-7)</i> • The recommendations specified in the <i>EPA Drinking Water Report</i>. • The recommendations in any previous audit reports.

MAIN FINDINGS

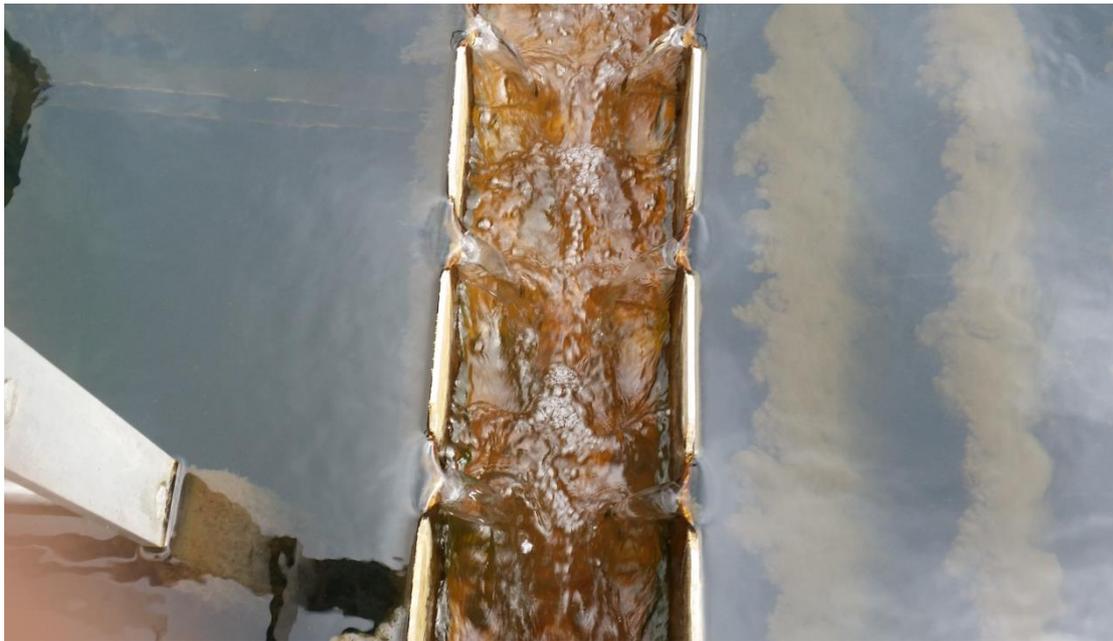
2.	<p>Coagulation, Flocculation and Clarification</p> <ul style="list-style-type: none"> a. There is a static mixer (with baffles in the pipeline) in the incoming raw water line from the water tank to the plant where aluminium sulphate is injected on a flow proportional basis. b. It was stated that jar tests are not carried out regularly and a change in dose is initiated with raw water colour changes. c. The polyacrylamide, Gokem A225 10% solution is dosed 10 minutes later into three separate tanks. d. There are 3 clarifiers which had lamellae plates upgraded 3 years ago and are cleaned once/year. The clarifiers required cleaning and pin-floc was observed in the water entering the channels (see photo 1). e. The upflow is 3.3m/hr and there is a 90 second sludge bleed every 30 minutes.

Photo 1 Pin floc and sludge build up on clarifier

1. Irish Water should prevent the loss of raw water from the onsite raw water tank at Lislennon WTP by automating the pumping regime and linking it to water level sensors in the tank to eliminate overflow.
2. Irish Water should undertake a review of the coagulation process at the water treatment works to investigate cause of pin floc formation and ensure there is adequate control of this treatment stage. Jar

testing, use of dosage charts or tables should be in place to determine the correct amount of chemicals to use in the process when raw water quality changes. Irish Water should take account of the recently published EPA Advice Note 15: Optimisation of Chemical Coagulation Dosing at Water Treatment Works available online at <http://www.epa.ie/pubs/advice/drinkingwater/dwadvicenote15.html>.

4. Irish Water should carry out cleaning and any necessary maintenance on the clarifiers and filters including: (a) replace filter media, (b) review filter backwash process to ensure backwashing / air scouring systems and underdrains are operating optimally, (c) put in place the facility to ensure filters are run to waste for an appropriate period of time or that there is a delayed or slow start when the filter is brought back into use and (d) ensure there is a programme in place for maintenance and cleaning work to be carried out as required on both the filters and clarifiers.
