Drinking Water Audit Report

County:	Mayo	Date of Audit:	21 February 2014
Plant(s) visited:	Lough Mask Water Treatment Plant	Date of issue of Audit Report:	04 March 2014
		File Reference:	DW2007/464
		Auditors:	Ms Derval Devaney Mr Darragh Page
Audit Criteria:	<ul style="list-style-type: none"> • The <i>European Communities (Drinking Water) (No. 2) Regulations, 2007</i>. • The <i>EPA Handbook on the Implementation of the Regulations for Water Services Authorities for Public Water Supplies (ISBN: 978-1-84095-349-7)</i> • The recommendations specified in the EPA Report on <i>The Provision and Quality of Drinking Water in Ireland</i>. • The recommendations in any previous audit reports.

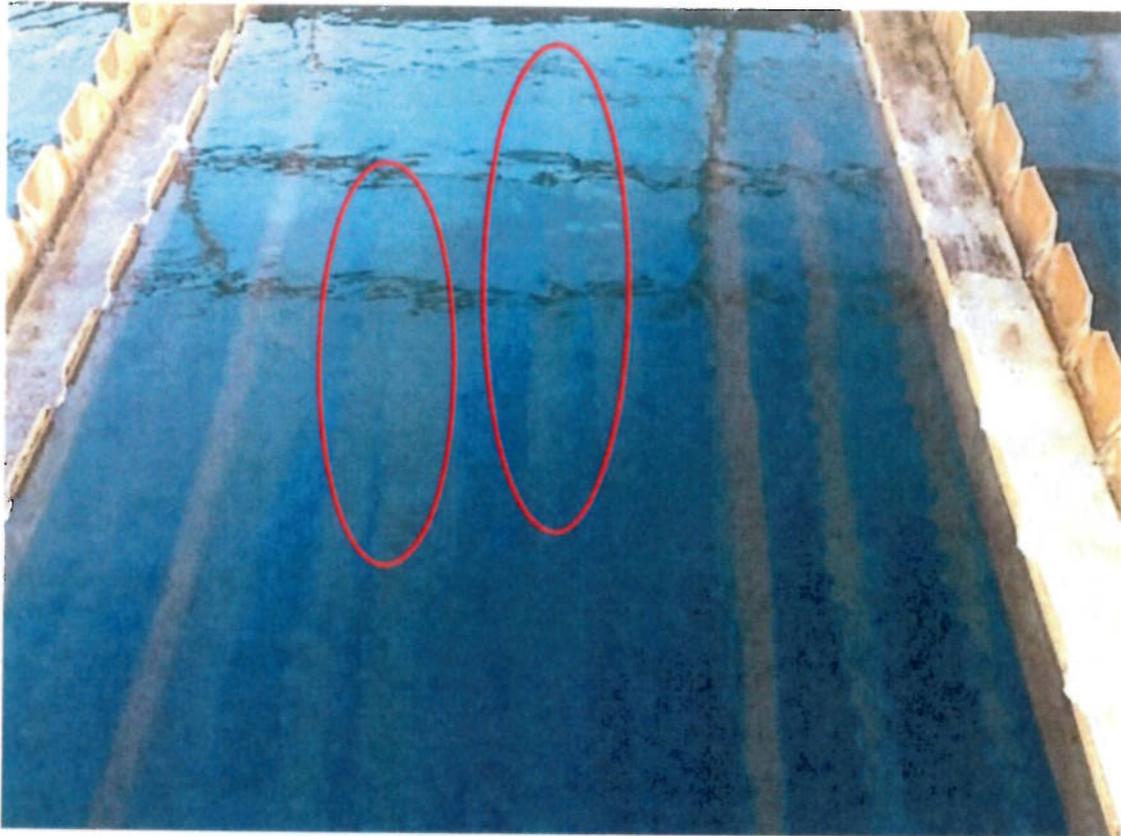
Photo 1 Broken Lamella plates in clarifier

4. Irish Water should address the coagulation issue as a matter of priority and ensure that by-passing of the coagulation / flocculation processes at the water treatment works is not allowed to occur once this issue is addressed.
5. Irish Water should review the chemical dosing arrangements for coagulation with a view to investigating if pH correction can bring about efficiencies in chemical use and waste generation and improved final water quality.
6. Irish Water should repair the damaged lamella plates in the clarifiers.
