Drinking Water Audit Report

County:	Mayo	Date of Audit:	15 th May 2015
Plant(s) visited:	Lough Mask RWSS	Date of issue of Audit Report:	20 th May 2015
		File Reference:	DW2007/464
		Auditors:	Mr. Darragh Page
Audit Criteria:	<ul style="list-style-type: none"> • The <i>European Union (Drinking Water) Regulations 2014 (S.I. 122 of 2014)</i>. • The <i>EPA Handbook on the Implementation of the Regulations for Water Services Authorities for Public Water Supplies (ISBN: 978-1-84095-349-7)</i> • The recommendations specified in the <i>EPA Drinking Water Report</i>. • The recommendations in any previous audit reports.

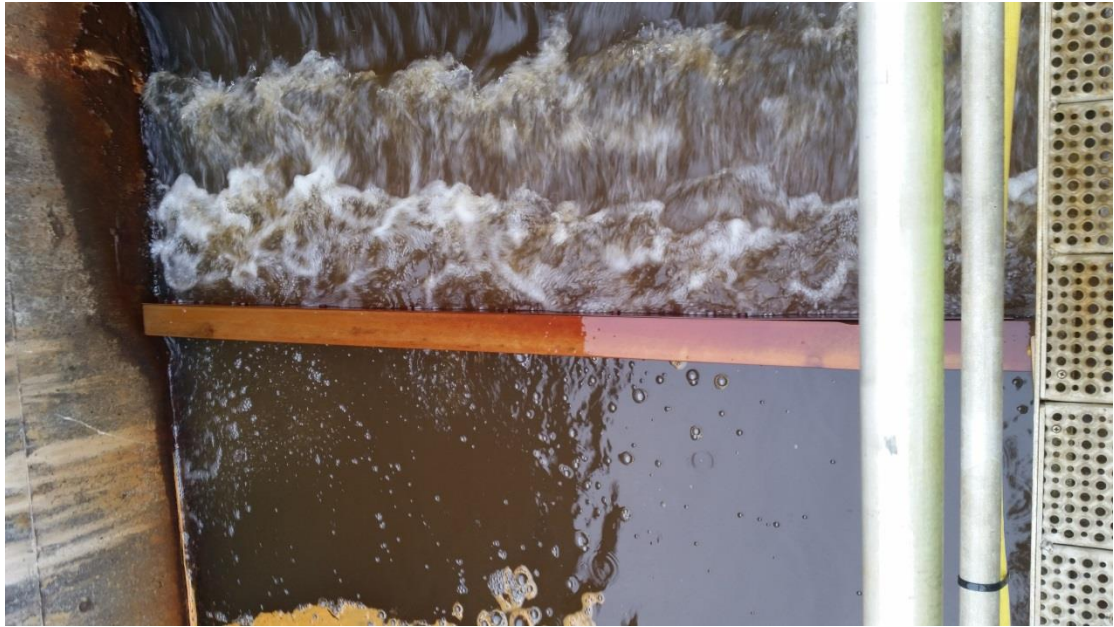
Photo 1. Bar Installed in Chemical Mixing Chamber to Improve Mixing.

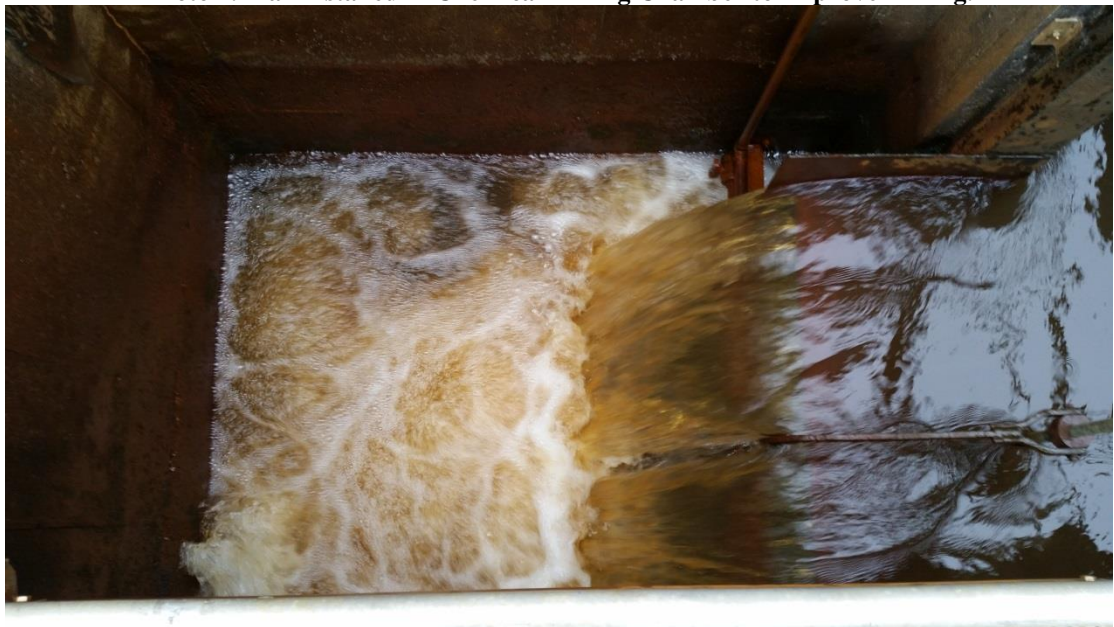
The chemical mixing chamber is not suitable and requires improvement. While improvements have been made further improvements in the immediate to short term, such as preventing possible shearing of the floc from the weir, are necessary to optimise floc formation and reduce the challenges to the filters. A full assessment of the chemical dosing chamber is required to ensure that it suitable for current and future use.

Photo 2. Weir following ferric and poly dosing.

2. Irish Water should carry out a full review of the chemical coagulation stage of the plant and outline what actions are to be taken to address the issues identified. In particular, the report should include what actions are to be taken to:
 - a. Prevent shearing of the floc at the weir.
 - b. Eliminating the dead end in the mixing chamber.
 - c. Ensure that the chemical dosing and mixing stage is optimised and appropriate for the throughput of the plant.
3. Irish Water should carry out an investigation to identify the cause of pin floc formation. In this regard Irish Water shall consult Table 2 on Page 41 of the EPA publication “*Water Treatment Manual: Coagulation, Flocculation and Clarification*” and investigate the use of polyelectrolyte and pH correction in line with the designed plant’s operating procedures.

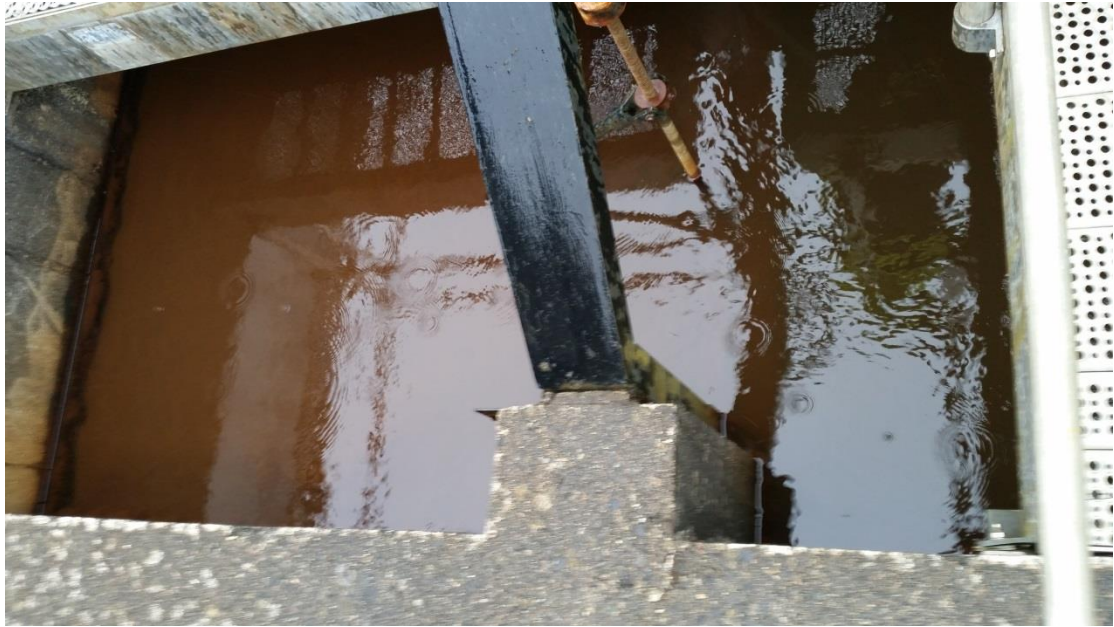
Photo 3. “Dead Zone” in mixing chamber (note sludge build up).

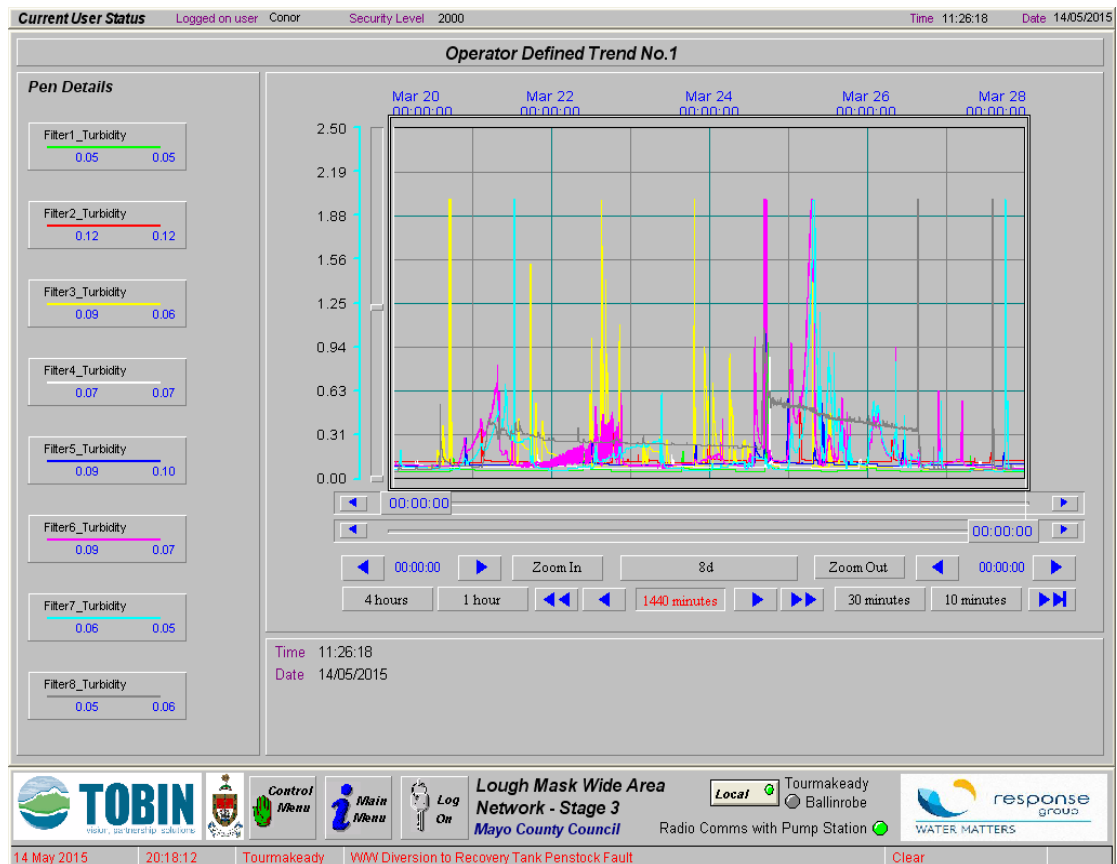
Photo 5. Turbidity Readings from Filters No1 to 8 during the period 20th-28th March 2015.

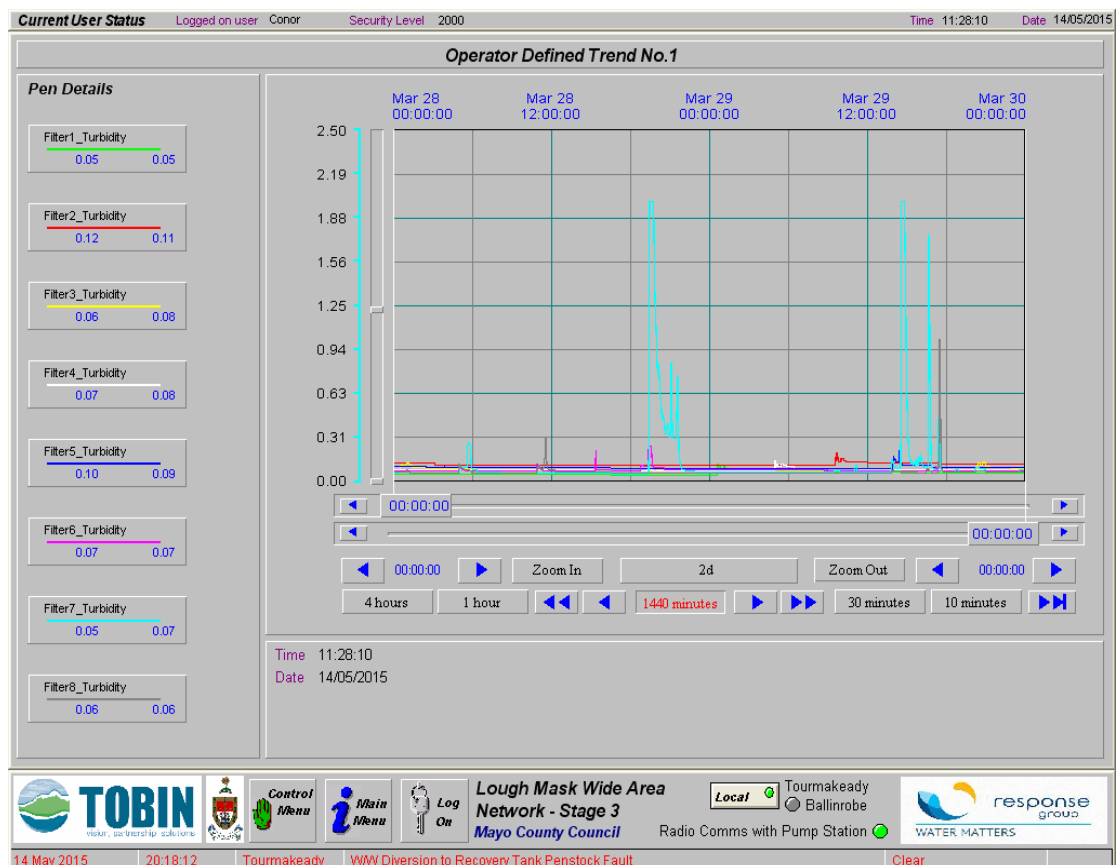
There are significant operational issues at the Lough Mask Water Treatment Plant that present a risk of filter breakthrough which could result in *Cryptosporidium* entering the supply if present in the raw water. Specifically, SCADA controls and operation of the filters requires urgent attention as it is clear that there are regular occurrences of elevated turbidity breakthrough on various filters (but most notably filter no.7).

Photo 6. Turbidity Readings from Filters No1 to 8 during the period 28th-30th March 2015 (note the poor performance of filter no. 7).

4. Irish Water should carry out the necessary remedial works to the filter controls to ensure that incidents of breakthrough on the filter are minimised. These works should include a review of

alarms and control of alarms, filter levels and loads. Irish Water should outline what actions are to be taken to address the issues identified during the audit.

5. Following the remedial works to the filter controls Irish Water should implement revised procedures for the management of the filters including details of when filters should run to waste or are backwashed to prevent a risk of *Cryptosporidium* breakthrough.
