Drinking Water Audit Report

County:	Mayo	Date of Audit:	23 February 2016
Plant(s) visited:	Swinford WTP	Date of issue of Audit Report:	7 March 2016
		File Reference:	DW2014/14
		Auditors:	Ms Derval Devaney Ms Michelle Roche
Audit Criteria:	<ul style="list-style-type: none"> • The <i>European Union (Drinking Water) Regulations 2014 (S.I. 122 of 2014)</i>. • <i>The EPA Handbook on the Implementation of the Regulations for Water Services Authorities for Public Water Supplies (ISBN: 978-1-84095-349-7)</i> • The recommendations specified in the <i>EPA Drinking Water Report</i>. • EPA Drinking Water Advice Notes No.s 1 to 15. • The recommendations in previous audit reports.

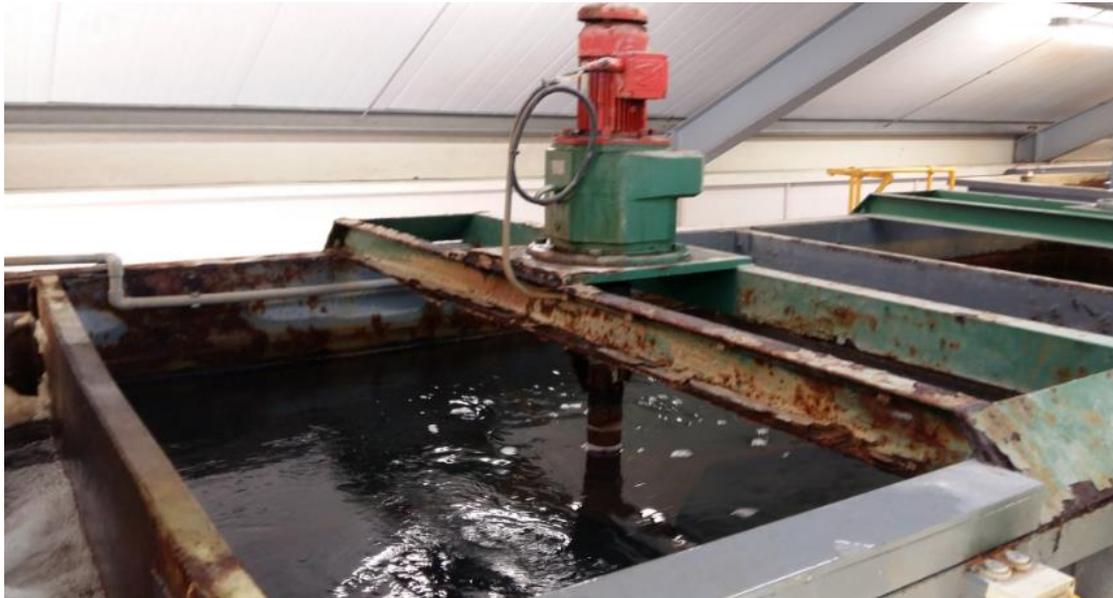
Photo 1 Rust on 1st contact tank

- (d) ensure the contact tank is inspected and maintained on a regular basis so that it is free from rust and structurally sound.

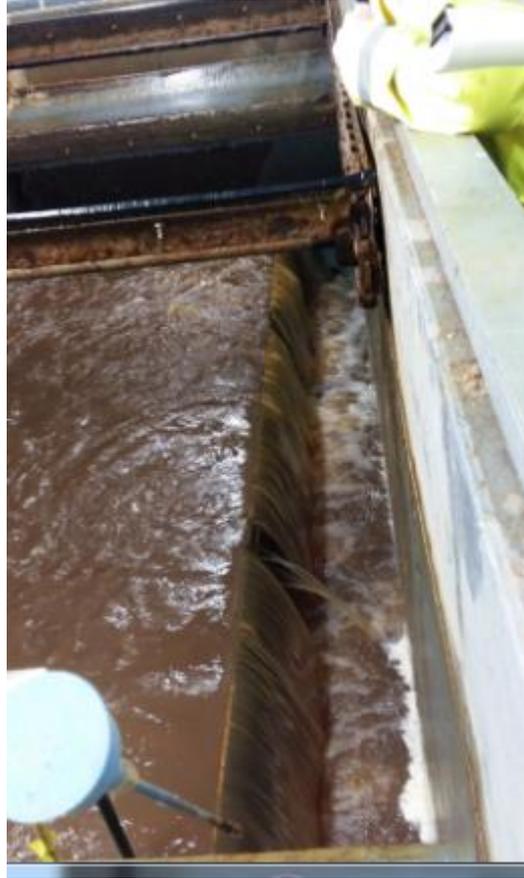
Photo 3 Backwash on DAFF Unit No 1 – water escapes via gap in weir

- 5. Irish Water should investigate if the backwash water escaping through a gap in the raised weir wall of DAFF unit No. 1 during the initial backwashing period is causing a loss of filter media or preferential flow and/or uneven scouring during backwash.
- 6. Irish Water should review the suitability of the current location of the final water turbidity monitor (post the reservoir) to ensure it affords the caretaker time to react in the event of excessive turbidity in the final water.
- 7. Irish Water should review the operation of the filters to ensure that the levels of turbidity in the filtered water are as low as possible and no greater than 0.5 NTU. If there is a risk of the presence of *Cryptosporidium* in the raw water, then the turbidity of the filtered water should not exceed 0.2 NTU.
