Drinking Water Audit Report

County:	Mayo	Date of Audit:	8 th May 2015
Plant(s) visited:	Knappaghbeg Water Treatment Plant	Date of issue of Audit Report:	12 th May 2015
		File Reference:	DW2015/62
		Auditors:	Mr. Darragh Page
Audit Criteria:	<ul style="list-style-type: none"> • The <i>European Union (Drinking Water) Regulations 2014 (S.I. 122 of 2014)</i>. • The <i>EPA Handbook on the Implementation of the Regulations for Water Services Authorities for Public Water Supplies (ISBN: 978-1-84095-349-7)</i> • The recommendations specified in the <i>EPA Drinking Water Report</i>. • The recommendations in any previous audit reports.

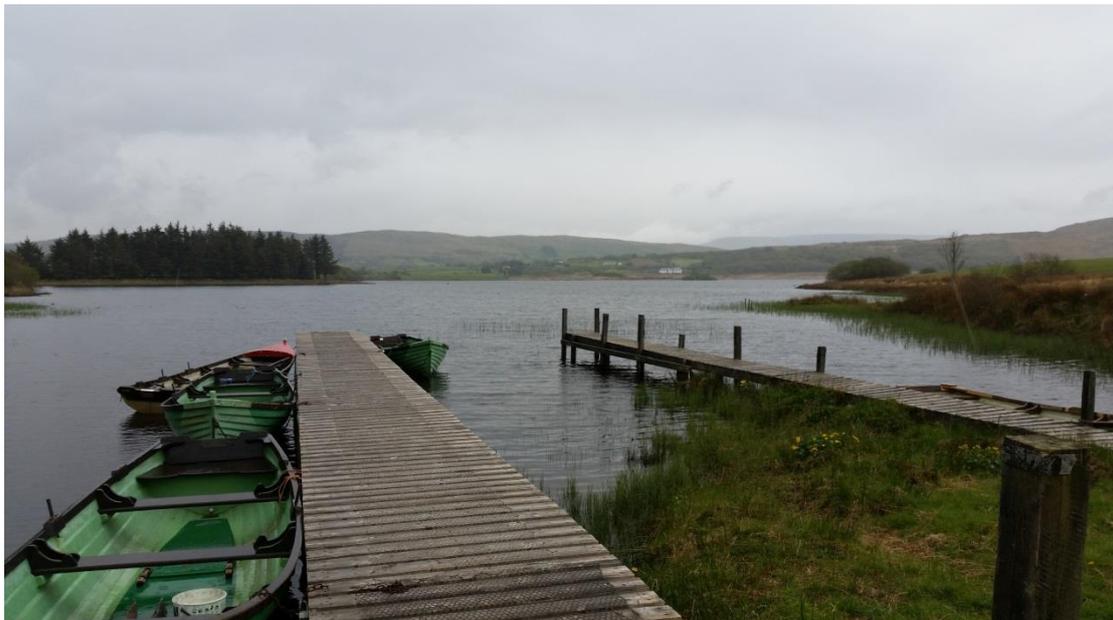
Photo 1. Moher Lough.

1.	<p>Source Protection</p> <ol style="list-style-type: none"> a. The source of the Wesport PWS is Moher Lough (see Photo 1). b. Mayo County Council stated that they had communicated with all residents/farmers within the zones defined in the Good Agricultural Practice Regulations in 2011. Farm surveys were carried out in February 2011 and issues were followed up at the time. c. There has been no survey of the catchment since the outbreak was detected and neither Irish Water or Mayo County Council had assessed the catchment to determine if there were any current sources of contamination. d. IW stated that there was an algal bloom on the lake (<i>Asterionella formosa</i>). <i>Asterionella</i> is a diatom that naturally occurs and is generally unrelated to nutrient or pollutant levels in the freshwater.

1. Irish Water should ensure that a catchment survey of Moher Lake is carried out to identify any potentially sources of pollution.
2. Irish Water should ensure that daily monitoring of the raw and treated water for *Cryptosporidium* is continued for the duration of the outbreak (as determined by the HSE). Also arrangements should be made to carry out daily *Cryptosporidium* monitoring on the treated water from network at Sandyhill Reservoir. Following this Irish Water should continue with weekly monitoring of the raw and treated water, unless a case can be made by Irish Water based on site specific risk assessment for less frequent monitoring.

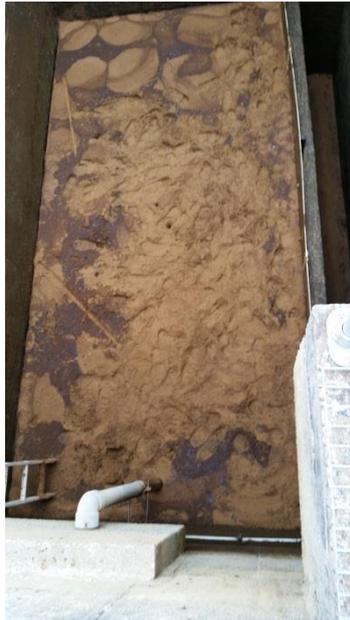
<p>3.</p>	<p>Filtration</p> <ul style="list-style-type: none"> a. There are 2 no. rapid gravity filters at the Knappaghbeg Water Treatment Plant. These filters were refurbished in 2009. An assessment of the filters was ongoing by an external contractor on behalf of Irish Water at the time of the audit in response to the imposition of the precautionary boil water notice. b. The media depth was 600 mm. There was evidence of significant media loss over the weir (see Photo 2). Irish Water or Mayo County Council were not able to provide information on the design depth of the media. This information should be available and checks should be carried out on the depth of the media to ensure that it is within the design specification. c. The filters are backwashed consecutively every day in the morning. While one filter is being backwashed the volume of water to the second filter doubles. This appears to cause an increase in turbidity levels to approx. 0.2 NTU which is above the normal background levels (see Photo 3). d. The filters are run to waste for a period of 15 mins after backwashing, however, the turbidity levels remain elevated at approx. 0.2 NTU after this 15 min period in filter no. 1 (see Photo 3) due to the doubling of the loading of the filter while filter no. 2 is being backwashed. This may present a risk of filter breakthrough. e. During normal operation the performance of the filters is generally good with turbidity levels usually at 0.05 NTU. f. There were a few incidents where the final turbidity exceeded 1.0 NTU and these are described in more detail in Section 6 below.

Photo 2. Filter Drained Down (Note: sand in the weir)

3. Irish Water should investigate the cause of the loss of filter media from the filters into the filter channel and take appropriate action to prevent this loss of media.

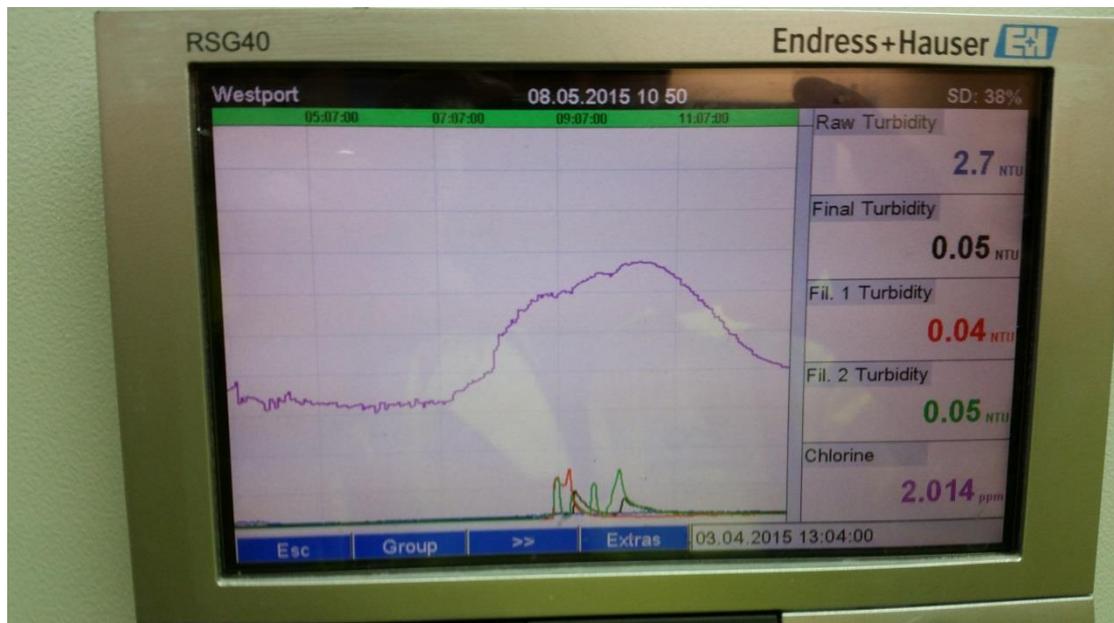
<p>c. The final water turbidity exceeded 1.0 NTU on a small number of occasions. Details of these occurrences and the causes are outlined below:</p> <ul style="list-style-type: none"> i. 13th March 2015- Levels of turbidity started rising from a background level of <0.1 NTU at 10:17 and was above 1.0 NTU between 11:16 and 11:27. Turbidity levels fell back below 0.1 NTU after 12:13. IW and MCC stated that this was due to the washing of the settling tank at 10:20 and that no flow during this period entered into supply. However, as flow data is not continuously recorded it was not possible to verify this. ii. 21st March 2015 – Levels of turbidity started rising from a background level of <0.1 NTU at 15:14 and was above 1.0 NTU between 18:39 and 18:48. Turbidity levels returned back below 0.1 NTU at 19:58. No explanation of the cause of these elevated levels was provided. iii. Other incidents of where the turbidity rose above 1.0 NTU were instantaneous readings (i.e. present for 1 min or less) and therefore likely to be anomalous readings. <p>d. The results from the chlorine monitor were examined and indicated that the chlorine dose fluctuates significantly for the reasons outlined in Section 4. An analysis of the data from the chlorine monitor indicates that:</p> <ul style="list-style-type: none"> i. Chlorine levels leaving the plant were stable between 1.7 and 2.0 mg/l from 1st March to 23rd March 2015. After this period the chlorine levels fluctuated. ii. Chlorine levels rose above 3 mg/l on 25th and 26th March and again during the period 30th March to 9th April to levels of up to 5 mg/l. MCC stated that this was due to increased chlorine demand in the network between the water treatment plant and the Sandyhill reservoir and the difficulty MCC experienced in maintaining a satisfactory chlorine residual up to the reservoir. A leak was detected in the main which was repaired on the 10th April 2015. However, MCC stated that ingress at this point was unlikely as it was a small crack in the pipe at a point where the pressure in the pipe was 30 psi. The main was drained down and flushed before being brought back into use. This resulted in a significantly lower chlorine demand on the treated water and chlorine leaving the plant was reduced to 1.7 mg/l and has remained at this level since. iii. The alarm setting on the chlorine monitor at the clear water tank is 0.5 mg/l. The trends on the monitor indicate that levels drop below 0.5 mg/l on occasion for brief periods. This is preceded by a downward trend which corrects itself within a short space of time (see Photo 4 as an example). This occurred on numerous occasions with levels dropping below 0.5 mg/l for brief periods on 13 separate days during the period 1st March to 8th May 2015. No explanation for this was available. <p>e. Monitoring for <i>Cryptosporidium</i> is undertaken at the plant. Two samples were analysed in 2015 prior to the audit. Both samples, on 26th February 2015 and 11th March 2015 were free of any oocysts. A <i>Cryptosporidium</i> rig was installed at the plant on 6th May and a sample was with the lab for analysis. A second rig was set up on the raw water and the sample from this rig and the treated water rig was taken for analysis by MCC during the audit. Results were to be available over the weekend. Daily <i>Cryptosporidium</i> sampling is planned at the plant.</p> <p>f. Monitoring in the distribution network at 5 locations took place on 10th April following repair and flushing of the main. The results were reviewed and were compliant. However, in three of the five results the Dissolved Organic Carbon (DOC) was higher than the Total Organic Carbon (TOC). No explanation for this anomaly was provided.</p>

Photo 3. Screen shot of the raw, filtered and final turbidity and chlorine.

6. Irish Water should provide an explanation for the peak in turbidity in the final water on 21st March 2015.
7. Irish Water should continuously record the flow of treated water from the plant so that it can verify that the design criteria of the plant is not exceeded and verify when the treated water contains elevated levels of turbidity that such water is not entering into supply.

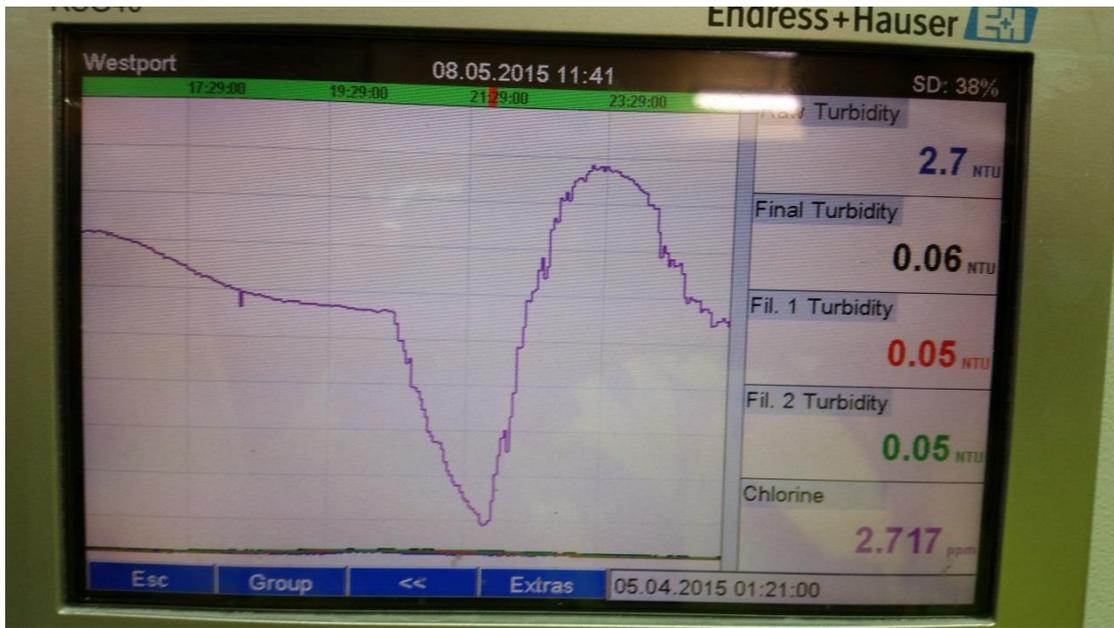
<p>4.</p>	<p>Chlorination and Disinfection</p> <ul style="list-style-type: none"> a. Filtered water is disinfected using sodium hypochlorite. b. The target dose is determined based on ensuring a free residual chlorine level of 0.85 mg/l at the inlet of the reservoir which has been found to ensure 0.5 mg/l at the outlet of the reservoir and 0.2 mg/l at the extremities of the network. c. The dose at the plant varied significantly over the period reviewed (i.e. 1st March to 8th May 2015). The results from the chlorine monitor indicate that the average chlorine levels in final water leaving the clear water tank were normally around 1.75 mg/l but the levels were as high as 5 mg/l on occasion. d. MCC stated that the chlorine dose was adjusted to ensure 0.85 mg/l at the reservoir and at times the chlorine demand rose significantly necessitating a higher dose at the plant. The increased chlorine demand did not coincide with poor water quality leaving the plant. MCC also stated that once water entered the reservoir, the chlorine demand was relatively stable. MCC stated that chlorine demand between the plant and the Sandyhill reservoir can rise significantly but they had no explanation for this. e. There was a recent leak on the main that was repaired prior to 10th April 2015. At this time the main was drained down, repaired and flushed. This led to a dramatic drop in chlorine demand. However, MCC stated that it was unlikely that anything was ingressing at the point of the leak as the pipe was under 30 psi pressure at that point. f. Further analysis of the chlorine levels leaving the plant is outlined in Section 6.

Photo 4. Screen Shot of the Chlorine Monitor Trend.

9. Irish Water should investigate the reasons for the activation of the chlorine monitor alarm as described in Section 6(d)(iii) and provide an explanation of same to the EPA.
10. Irish Water should investigate the reasons for the increased chlorine demand that occurred during 23rd March and 10th April 2015 and submit a report to the EPA outlining the actions that are to be taken to prevent a reoccurrence.
