Site Visit Report

Name of Installation	Batterstown
Organisation	Irish Water
Scheme Code	2300PUB1068
County	Meath
Site Visit Reference No.	SV18391

Issue Date	06/11/2019
Prepared By	Daryl Gunning

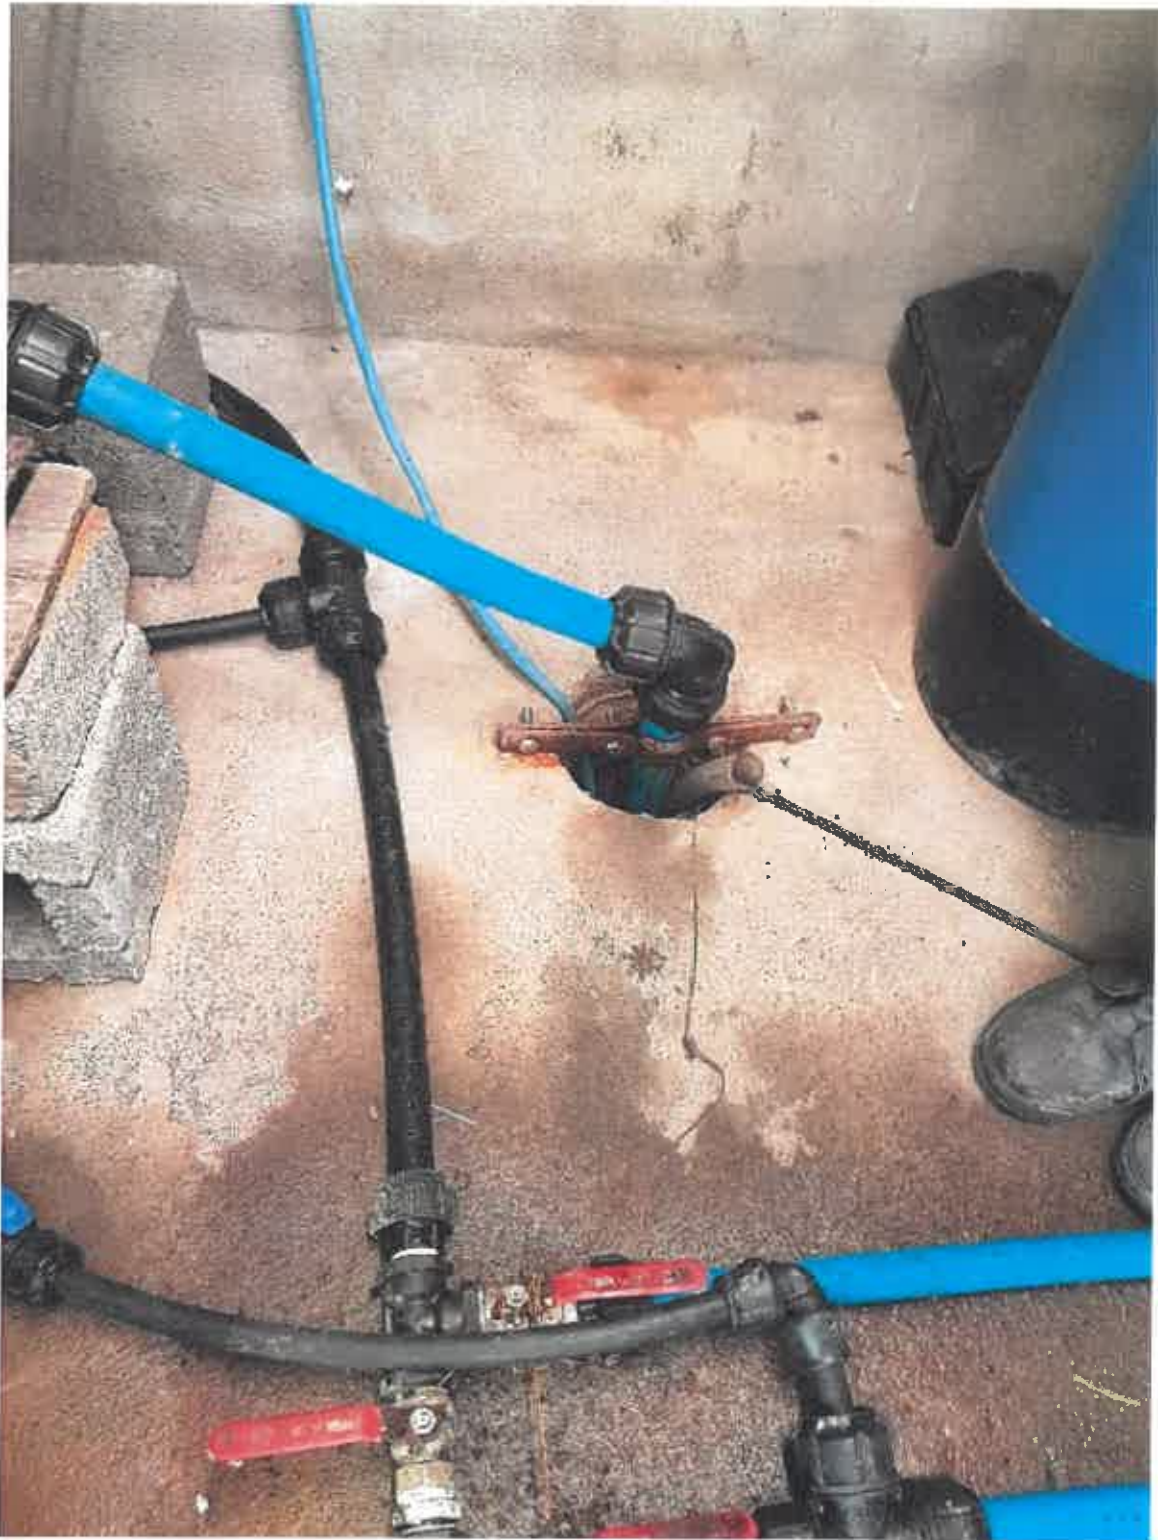
Answer
1.1 Is the abstraction source(s) adequately protected against contamination?	No
Comment The audit found that the borehole was not capped and is vulnerable to contamination (see picture 1). Source protection risks include vehicle storage, home heating systems, and creosote sleepers.

Subject	Batterstown Audit Recommendations	Due Date	04/12/2019
Action Text	<p>Recommendations</p> <ol style="list-style-type: none">1. Irish Water should ensure that the well-head is capped and that the pump can be accessed for maintenance and/or inspection.2. Irish Water should ensure that automatic shutdown is installed on the UV system to prevent inadequately disinfected water being supplied to consumers.3. If there are no future plans to rationalise this supply, Irish Water should include Batterstown water treatment plant on their disinfection programme to ensure effective treatment, monitoring, and management of the water treatment plant. <p>Follow-Up Actions required by Irish Water</p> <p>During the audit, Irish Water representatives were advised of the audit findings and that action must be taken as a priority by Irish Water to address the issues raised.</p> <p>This report has been reviewed and approved by Aoife Loughnane, Drinking Water Team Leader.</p> <p>Irish Water should submit a report to the Agency on or before 4th December 2019 detailing how it has dealt with the issues of concern identified during this audit.</p> <p>The report should include details on the action taken and planned to address the various recommendations, including time frame for commencement and completion of any planned work.</p> <p>The EPA also advises that the findings and recommendations from this audit report should, where relevant, be addressed at all other treatment plants operated and managed by Irish Water.</p> <p>Please quote the Action Reference Number DW2018/61 in any future correspondence in relation to this Report.</p>
