# Drinking Water Audit Report

County:	Meath	Date of Audit:	9 <sup>th</sup> February 2018	
Plant(s) visited:	Summerhill Road Booster Station, Dunboyne	Date of issue of Audit Report:	14 <sup>th</sup> February 2018	
		File Reference:	DW2018/15	
		Auditors:	Ms Michelle Roche	
			Ms Aoife Loughnane	
Audit Criteria:	The European Union (Drinking Water) Regulations 2014 (S.I. 122 of 2014), as amended.			
	• The EPA Handbook on the Implementation of the Regulations for Water Services Authorities for Public Water Supplies (ISBN: 978-1-84095-349-7)			
	• EPA Drinking Water Advice Note No. 3 E. coli in Drinking Water.

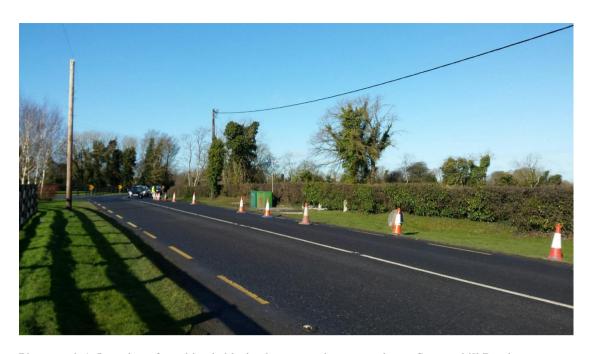
- c. The location of the booster station is dangerous in terms of access and health and safety. The station is in an underground chamber at the side of a busy road, coming off a bend (Photograph 1 and 2). Water ingress and damp conditions in the underground chamber create a difficult environment for maintaining pumps and monitoring equipment.

Photograph 1: Location of combined chlorine booster and pump station at Summerhill Road, Dunboyne.
