# Drinking Water Audit Report

| <b>Plant(s) visited:</b> | Liscarton Water Treatment Plant | <b>Date of issue of Audit Report:</b> | 14/03/2017 |
| | Navan Mid-Meath PWS (Scheme Code 2300PUB1016) | <b>File Reference:</b> | DW2008/363 |

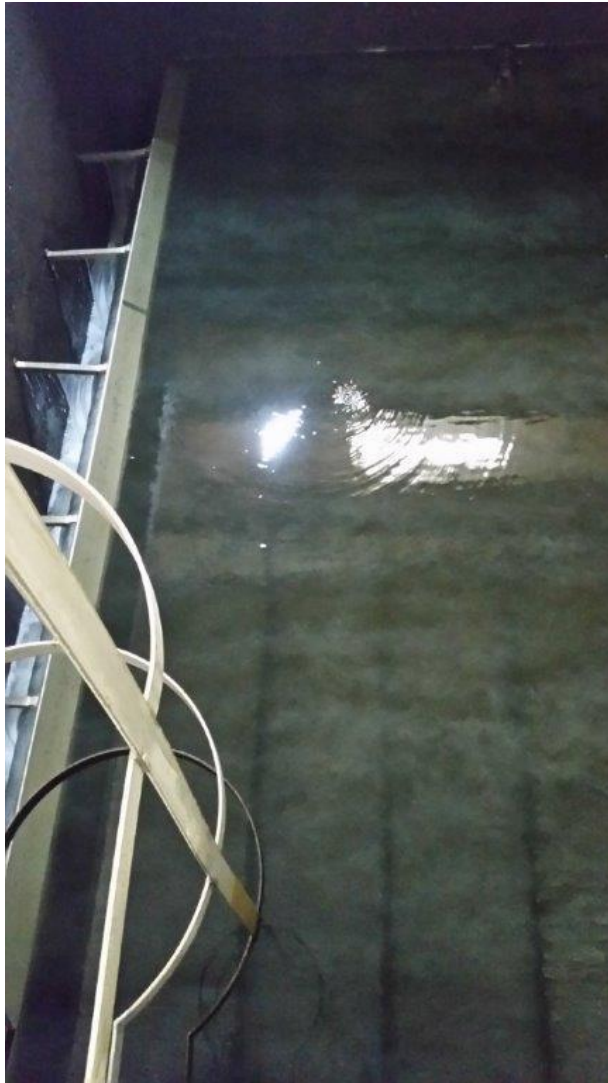
| <p><b>2.</b></p> | <p><b>Filtration</b></p> <ul style="list-style-type: none"> <li>a. Filtration is comprised of three rapid gravity filters. Backwashing is initiated twice a week and all three filters are backwashed on the same day. The caretaker waits 13 minutes after the backwash before returning the filter to service. There is no run to waste facility at the plant.</li> <li>b. A backwash of all the filters was manually triggered during the audit. At filter No. 3, the inspectors observed the air scour at different strengths on each side of filter. The side nearest the weir had much more disturbance/boiling. The air bubbles continued in filter No. 3 even after the air/water scour was complete. Filter Nos.1 and 2 had bubbles closer to the edges of the weir after the air/water scour in the filter. This is shown in Photograph Ref. 1.</li> <li>c. The bubbling observed on each filter suggests that there is a risk of filter breakthrough which may pose a <i>Cryptosporidium</i> risk.</li> <li>d. The weir height has been increased since the previous EPA audit to prevent carry-over of the sand media and appears to be working well.</li> <li>e. New air blowers were also provided since the previous audit.</li> <li>f. The sand media was last changed in 2005. A recent filter assessment, not examined during the audit, was said by staff to indicate a need for media replacement.</li> </ul> |

**Photograph No. 1:** Bubbles in the filter (seen across each filter.)

2. Irish Water should put in place a programme for the replacement of the filter media.
3. Irish Water should investigate the cause of the bubbling in areas of the filter media in each of the filters and should take appropriate action to optimise the operation of the filters, so that the air/water backwash is even across the filter and that the air line holes are fully functional and not blocked or damaged.

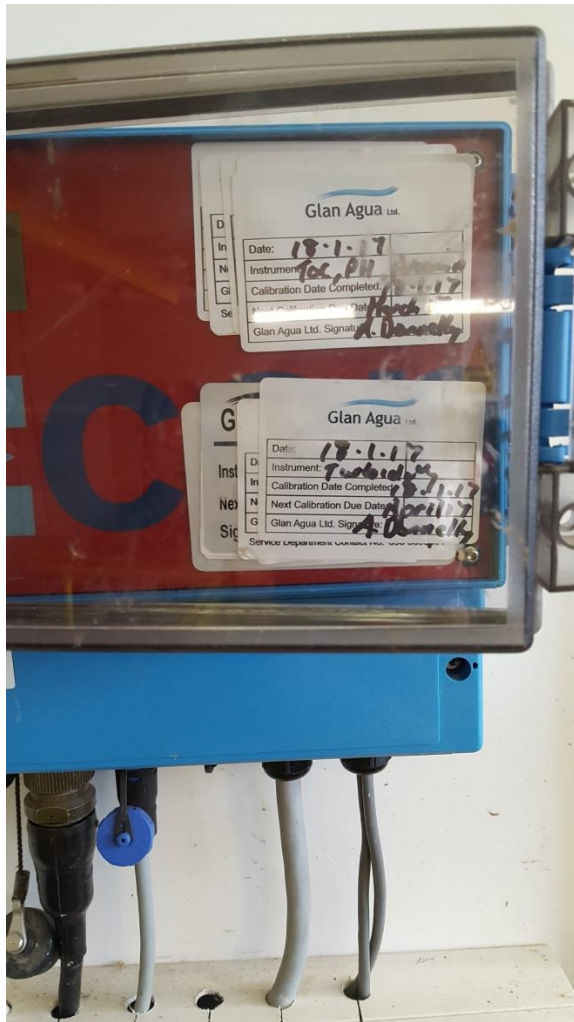
| <p><b>5.</b></p> | <p><b>Management and Control</b></p> <ul style="list-style-type: none"> <li>a. Irish Water indicated that upgrade works to this plant would be completed by Q4 2018.</li> <li>b. Turbidity monitor No. 3 had an out of date calibration sticker (Photograph Ref. No. 2).</li> <li>c. Low chlorine alarms text out to two contact persons, the engineer and caretaker. There is no cascade system in place to react to the alarms but negotiations are in place for setting this up.</li> <li>d. An incident where a low chlorine alarm was triggered on 13<sup>th</sup> January 2017 was discussed during the audit. One of the factors identified as contributing to increased chlorine demand at the Proudstown Reservoir is a stuck valve at the reservoir, which is thought by staff to lead to a zone of low mixing in the reservoir.</li> </ul> |

**Photograph No. 2:** Turbidity monitor no. 3, out of date calibration sticker.

5. Irish Water should implement a cascade system for response to critical plant alarms.
6. Irish Water should ensure that the two additional filter outlet turbidity monitors (for Filter Nos. 2 and 3) are installed as a priority and procedures are in place to ensure equipment is calibrated.
7. Irish Water should consider the items discussed during the audit for inclusion in the scope of the interim upgrade. These included the following:
