Drinking Water Audit Report

County:	Co. Monaghan	Date of Audit:	6 th May 2014
Plant(s) visited:	Togan Water Treatment Plant (Monaghan WSS) Scheme Code 2400PUB1024	Date of issue of Audit Report:	27 th May 2014
		File Reference:	DW2014/212
		Auditors:	Ms Ruth Barrington
Audit Criteria:	<ul style="list-style-type: none"> • The European Union (Drinking Water) Regulations 2014 (S.I. 122 of 2014). • The EPA Handbook on the Implementation of the Regulations for Water Services Authorities for Public Water Supplies (ISBN: 978-1-84095-349-7) • The recommendations specified in the EPA Report on <i>The Provision and Quality of Drinking Water in Ireland</i>.

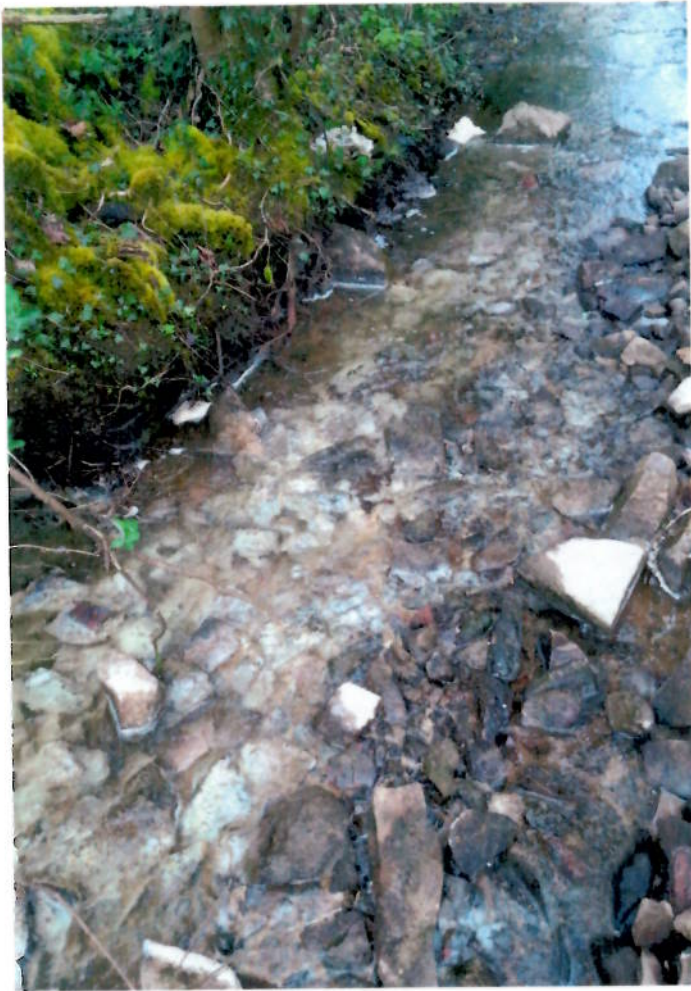
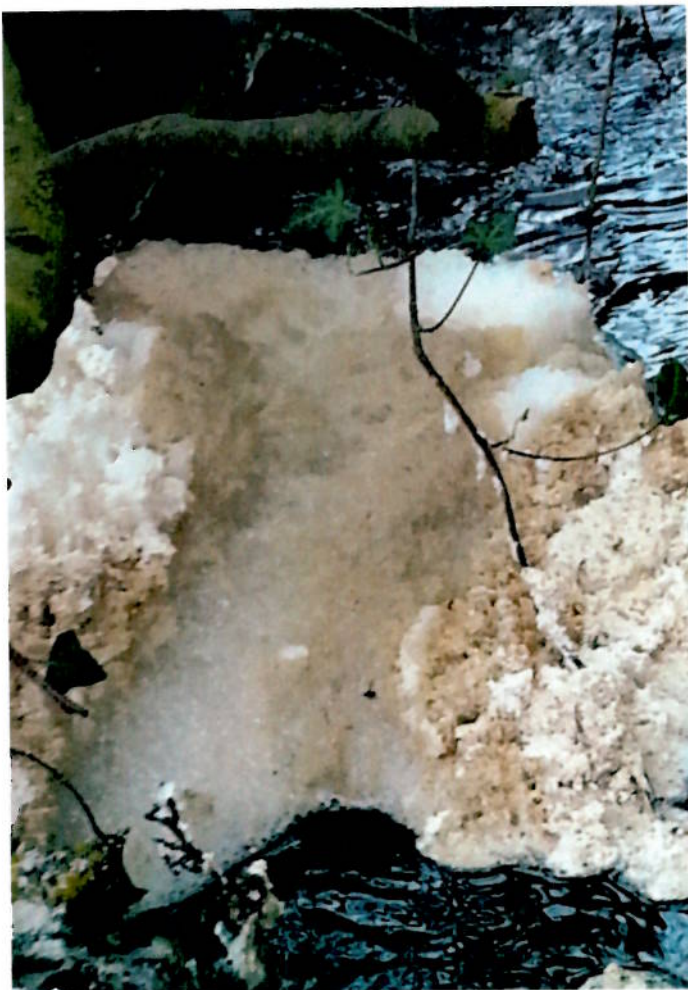
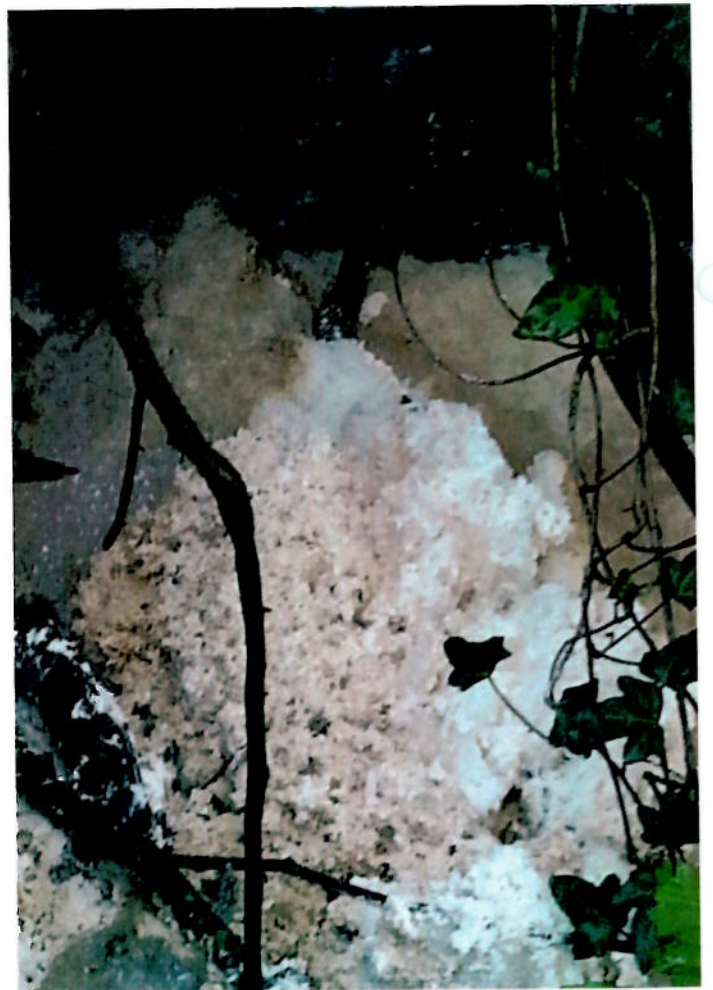
2.	<p>Sequence of Events and Incident Response</p> <p>a. On Monday 28th April 2014 a bulk delivery of 18 tonnes of aluminium sulphate was received at the plant into the bunded aluminium sulphate tank.</p> <p>b. On the afternoon of Monday 28th April, Monaghan County Council received a call from IFI that there had been a discharge into the stream, visible due to foaming at the water surface and staining of the stream bed.</p> <p>c. Also on Monday 28th April, the caretaker and staff from Water Services, Monaghan County Council, were investigating the possibility of a leak from the bulk tank in a concreted area between the tank and the plant buildings.</p> <p>d. The EPA was informed via a telephone call from a member of the public on 30th April 2014 of yellow foam in the stream 40-50m downstream from the drinking water treatment plant. This complaint was brought to the attention of Irish Water and Monaghan County Council on the same day.</p> <p>e. On 1st May 2014, following a conversation between Ms Barrington and Ms Bernie O’Flaherty of Monaghan County Council’s Environment Section, Ms Barrington advised Irish Water of the requirement to notify the incident. A notification was received on 8th May 2014, two days after the audit.</p> <p>f. On the 1st May 2014, Monaghan County Council Water Services and Environment Section staff together with Irish Water staff were on-site investigating the incident. The amount of aluminium sulphate lost from the bulk tank was estimated by Water Services to be 1-1.5 m³ of 8% solution aluminium sulphate.</p> <p>g. Inland Fisheries Ireland (IFI) staff and Mr Gerry Crawley (EPA Regional Laboratory Monaghan) were also present on 1st May 2014 to investigate the incident. Samples were taken from the stream by both IFI and EPA.</p> <p>h. At the time that Mr Crawley, EPA, was on-site on 1st May 2014, the drain to the stream had been capped at either end. Foam and staining of the stream bed was still visible as shown in</p>

<p>the fifth, seventh and eighth of the photographs taken by Mr Crawley on 1st May 2014. Results of water samples taken by Mr Crawley from the stream are also attached with this report. These show elevated levels of aluminium particularly in the area of the stream where foaming was evident, approximately 300m downstream of the plant.</p> <ul style="list-style-type: none"> i. At the time of Mr Crawley's visit to the plant, the area of surface water drain which had carried the discharge had been isolated and capped (refer to the third, fourth, sixth and ninth of Mr Crawley's photographs). j. At the time of the audit, white staining was still evident on the stream bed immediately downstream of the plant (refer to photograph Ref. No. 035.jpg). k. According to Ms Ailish Keane, IFI, when contacted by Ms Barrington on 13th May 2014, the IFI survey on 1st May 2014 discovered a fish kill involving several different species (e.g. sticklebacks, eels, and pike) downstream of the discharge. Ms Keane said that IFI had written to Irish Water advising them of the fish kill. l. Irish Water indicated that a biological survey of the stream would be undertaken, to assess the damage to the aquatic fauna and inform relevant remediation.

6. The WSA should report to the EPA on the incident follow up, including planned works to be taken on foot of the drainage survey report, development of procedures, biological survey of the stream and planned remediation.

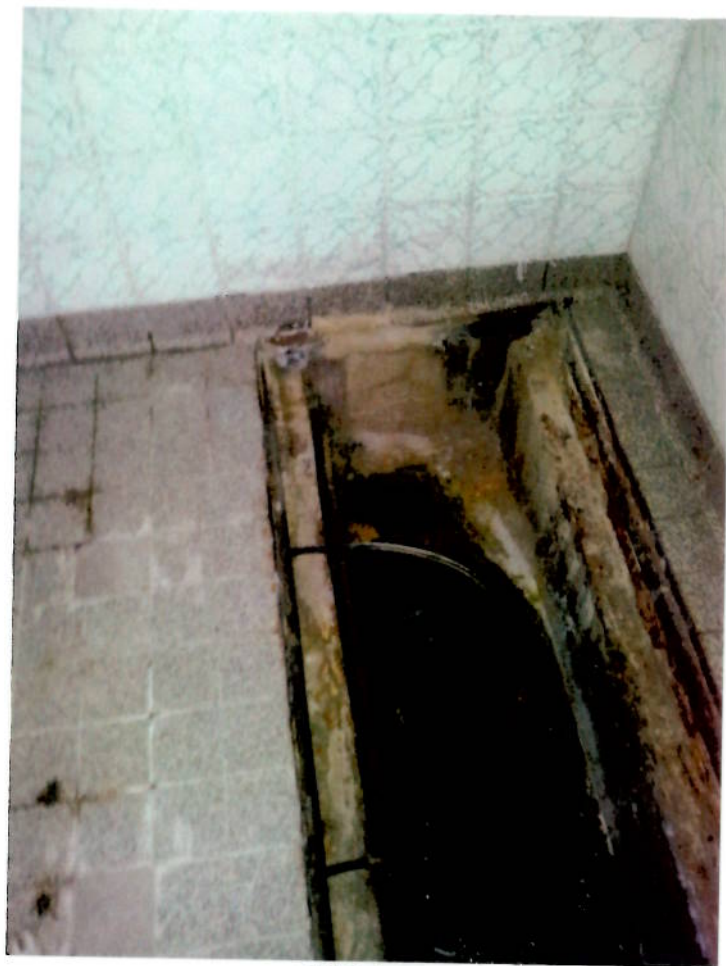
029.jpg

4.	<p>Hygiene and Housekeeping</p> <ul style="list-style-type: none"> a. During the follow up investigation, Monaghan County Council and Irish Water had also become aware that drains in the chemicals make-up room led to surface water (refer to photograph Ref. No. 0.29.jpg). When this room was being cleaned, washings which could contain aluminium sulphate or polyelectrolyte from spillages around the day tanks would enter surface waters. b. During the audit, works were going on to divert these drains so that all washings would be contained in the washwater tank rather than entering surface water (refer to photograph Ref. No. 030.jpg).

4. The WSA should develop and implement a procedure for use on site in relation to the reconfigured drainage system in the chemicals make-up and bund areas, to ensure that any chemical spillages directed to the washwater tank are dealt with appropriately.
