Drinking Water Audit Report

County:	Offaly County Council	Date of Audit:	18/11/16
Plant(s) visited:	Tullamore Public Water Supply – Clonaslee WTP	Date of issue of Audit Report:	23/11/16
		File Reference:	DW2007/343
		Auditors:	Ms. Aoife Loughnane Ms. Criona Doyle
Audit Criteria:	<ul style="list-style-type: none"> • The <i>European Union (Drinking Water) Regulations 2014 (S.I. 122 of 2014)</i>. • <i>The EPA Handbook on the Implementation of the Regulations for Water Services Authorities for Public Water Supplies (ISBN: 978-1-84095-349-7)</i> • The recommendations specified in the <i>EPA Drinking Water Report</i>. • EPA Drinking Water Advice Notes No.s 1 to 15. • The recommendations in any previous audit reports.

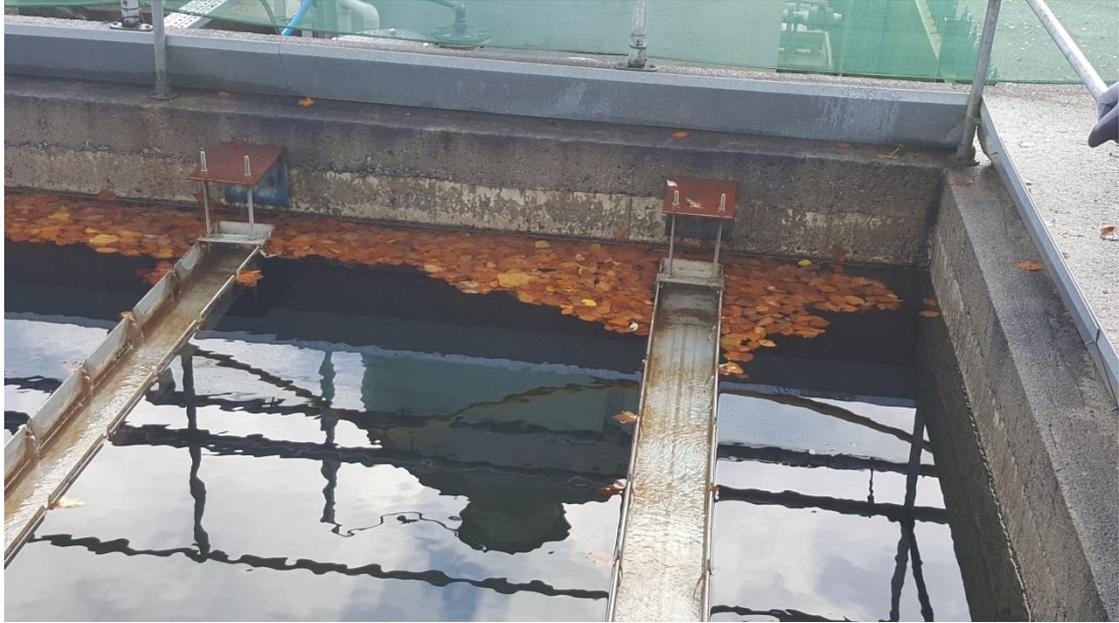
<p>observed on the outer sides of the decanting channels.</p> <ul style="list-style-type: none"> h. Leaves were visible on the surface of the clarifier at the time of the audit despite the caretaker have cleaned the top surface earlier that morning (Photograph No. 1). The leaves had passed through the large inlet screens and pipework. Irish Water indicated that the installation of a new fine screen (6mm) is proposed at the raw water inlet stack. i. There are 5 no. sludge bleed points in operation. The level of sludge in clarifier determines the frequency of bleeds. On date of the audit bleeds were occurring for 220 seconds every 15 minutes.

Photograph No. 1: Leaves on surface of Clarifier

3. Irish Water should ensure that the clarifier tank and decanting channels are cleaned regularly to prevent the build up of sludge. Irish Water should put measures in place to prevent leaves / debris entering the clarifier.

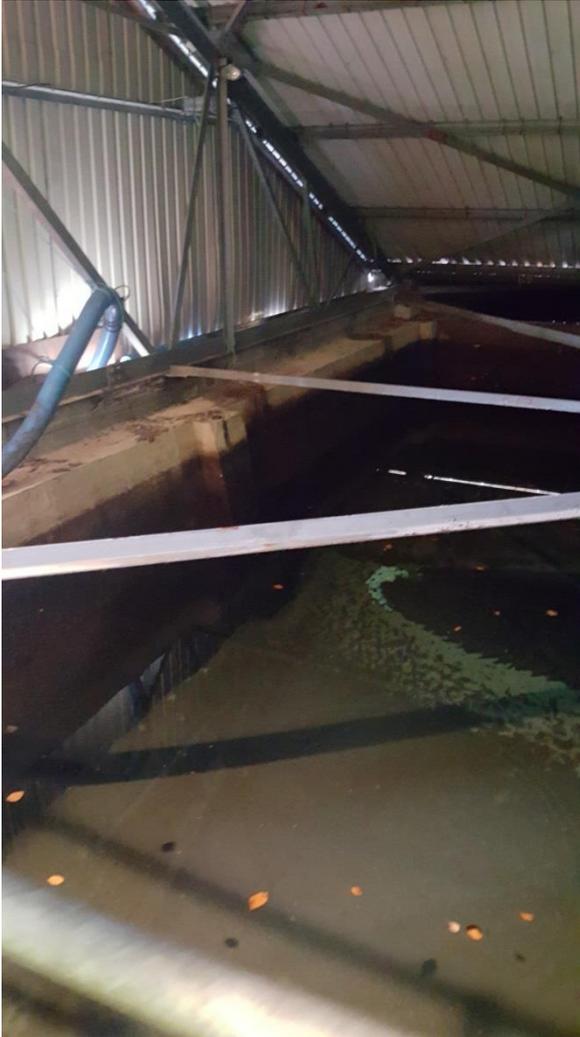
5.	<p>Treated Water Storage and Distribution Network</p> <ul style="list-style-type: none"> a. Vermin bait traps are no longer used on site. b. The treated water is stored in 6 no. cells which were the original sand filters. The converted filters are covered by a corrugated iron roof structure. There are gaps in the cladding which may facilitate the entry of vermin and debris. Leaves were observed in the reservoir (Photograph No. 2). c. The reservoir was last cleaned in approximately 2008.

Photograph No. 2: Leaves in the Treated Water Reservoir

7. Irish Water should undertake cleaning of the cells in the onsite reservoir. Remedial works should be undertaken to ensure there is no potential for the ingress of vermin, debris or other potential contaminants to the reservoir.

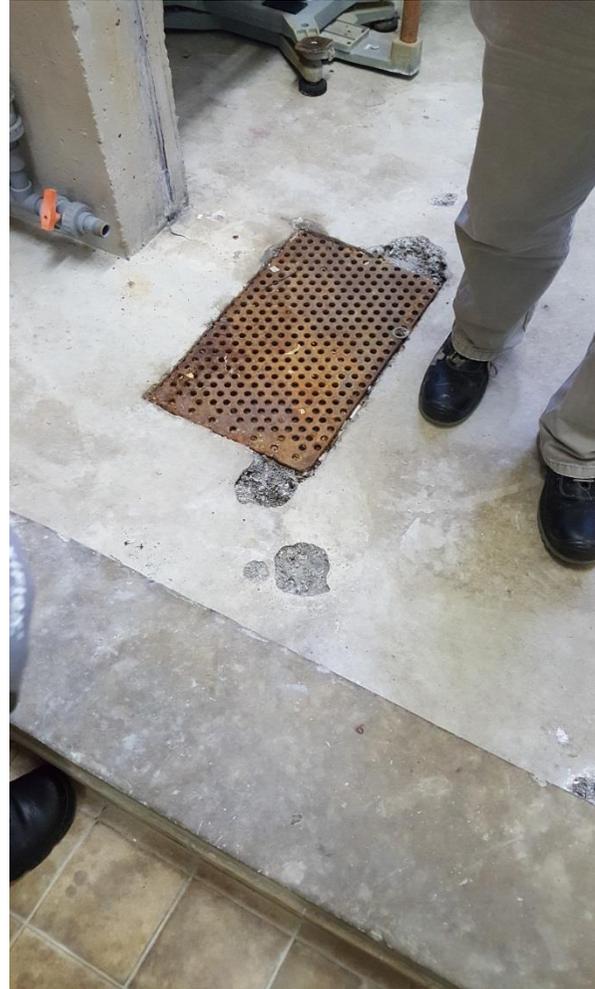
7.	<p>Chemical storage and bunds</p> <ul style="list-style-type: none"> a. There are 2 no. hydrofluorosilic acid storage tanks in the fluoride dosing room. A drainage grate is present on the floor of the bund through which any spills drain to the underground storage tank (Photo No. 3). The fill point is located outside the building and the tanks are fitted with automatic shut off valves. b. The aluminium sulphate is stored in a double skinned tank (internal bund). A double skinned day tank is also provided. The dosing lines are also banded. c. The sodium hypochlorite tank is also double skinned.

Photograph No. 3: Drainage grate on floor of Hydrofluorosilic Acid Bund

9. Irish Water should undertake integrity testing of the underground tank which collects spills from the hydrofluorosilic acid storage room.
