Drinking Water Audit Report

County:	Roscommon	Date of Audit:	18 th September 2015
Plant(s) visited:	Ballyfarnon, Arigna Drinking Water Treatment Plant (serving Ballyfarnon, Arigna, Keadue and Rover areas)	Date of issue of Audit Report:	14 th October 2015
		File Reference:	DW2008/163
		Auditors:	Ms Yvonne Doris
Audit Criteria:	<ul style="list-style-type: none"> • The <i>European Union (Drinking Water) Regulations 2014 (S.I. 122 of 2014)</i>. • The <i>EPA Handbook on the Implementation of the Regulations for Water Services Authorities for Public Water Supplies (ISBN: 978-1-84095-349-7)</i> • The recommendations specified in the <i>EPA Drinking Water Report</i>. • The recommendations in any previous audit reports.

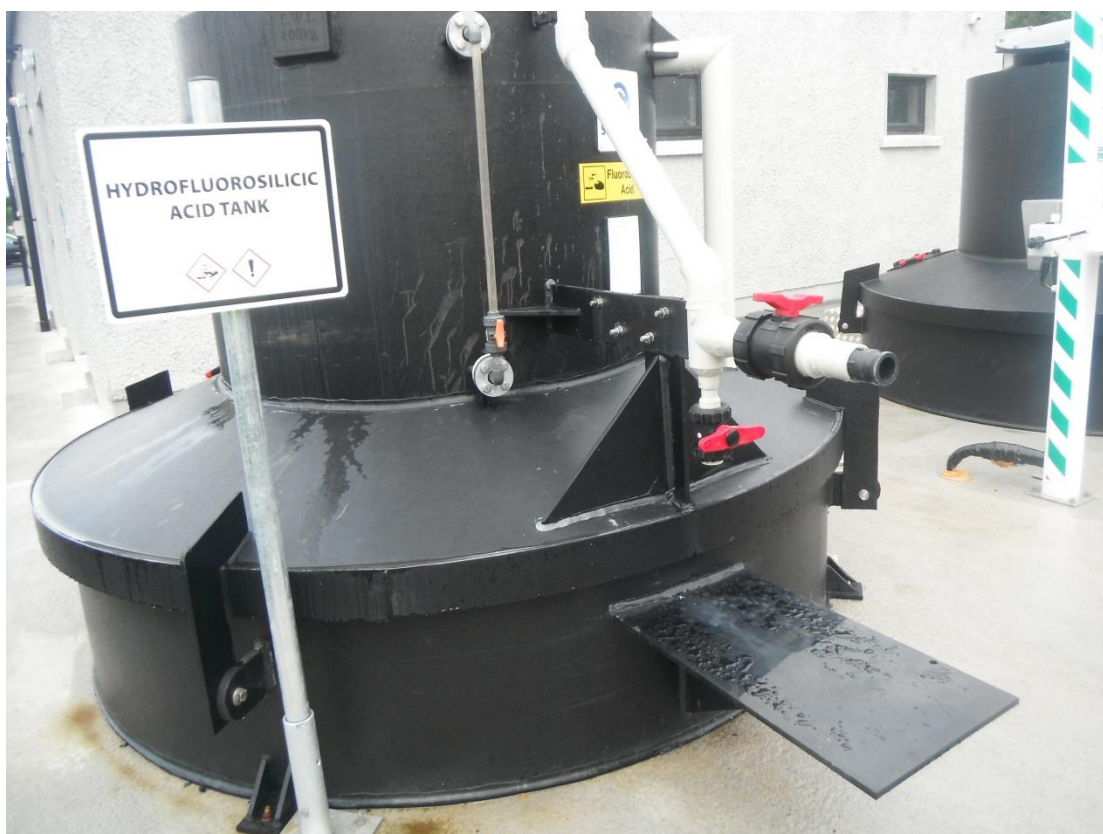
8.	<p>Chemical storage and bunds</p> <ul style="list-style-type: none"> a. Chemicals are delivered directly into the bulk tanks and are supervised by the plant operator. No delivery can be made without access being provided by the plant operator. b. All chemicals (chlorine, fluoride) are in double linked bulk tanks and day tanks are banded. All chemical tanks are fitted with level sensors to indicate when tanks are almost full. Spill kits are carried in the plant operator's vehicle. c. The fillpoints of the bulk tanks are not contained in a banded area (photograph 1).

Photograph 1: Example of delivery pipe to bulk storage tank not within bunded area.

3. Irish Water should review chemical storage arrangements at the treatment plant. Fill points for storage tanks should be within a bunded area. Refer to EPA guidance document –“*IPC Guidance Note on Storage and Transfer of Materials for Scheduled Activities*”.
