Drinking Water Audit Report

County:	Roscommon	Date of Audit:	29 th April 2015
Plant(s) visited:	Rockingham Drinking Water Treatment Plant (serving Boyle PWS, Boyle/Ardcarne PWS, Hughestown PWS in County Roscommon and Killaraght PWS in County Sligo).	Date of issue of Audit Report:	1 st May 2015
		File Reference:	DW2009/370; DW2008/87; DW2012/174
		Auditors:	Ms Yvonne Doris (lead auditor) Mr Brendan Wall Mr Darragh Page
Audit Criteria:	<ul style="list-style-type: none"> • The <i>European Union (Drinking Water) Regulations 2014 (S.I. 122 of 2014)</i>. • The <i>EPA Handbook on the Implementation of the Regulations for Water Services Authorities for Public Water Supplies (ISBN: 978-1-84095-349-7)</i> • The recommendations specified in the <i>EPA Drinking Water Report</i>. • The recommendations in any previous audit reports.

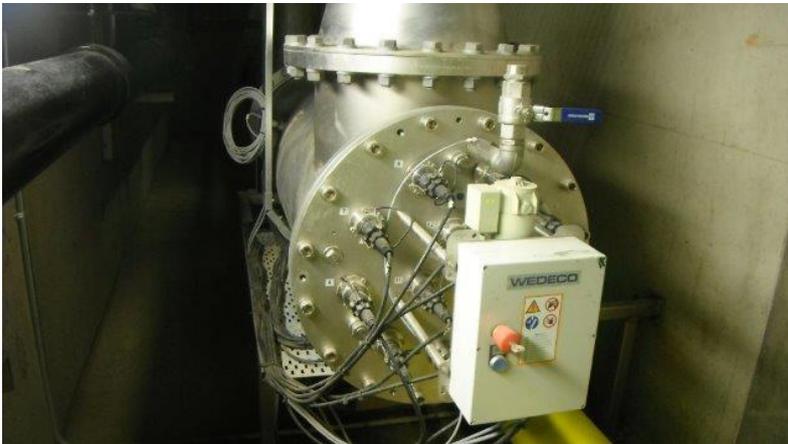
5.	<p>Chlorination and Disinfection</p> <p>UV disinfection</p> <p>a. A single Xylem/Wedeco Spectrum 900e UV reactor (photograph 1) validated to UVDGM</p>

- b. The UV reactor is validated to achieve 3-log reduction of *Cryptosporidium*, if operated at an incoming UVT of >69% based on the validation certificate document provided by the manufacturer and documentation stating same provided by Irish Water. Below 69% UVT the reactor shuts down and no undisinfected water can enter supply. An alarm is sent to the plant operator who attends the site on a 24 hour/7 day basis. The auditors discussed the importance of operating the UV treatment system in accordance with its validated range of controls at all times.

Photograph 1: Xylem/Wedeco Spectrum 900e UV reactor.

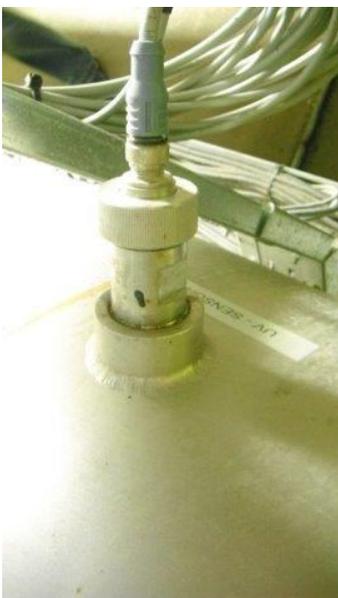
- g. The UV reactor has 2 UVI sensors (photograph 2) which are calibrated annually against a spare sensor. UVDGM (USEPA guidance manual on UV disinfection) recommends monthly calibration of UVI sensors. Spare sensors are stored on site.

Photograph 2: UVI sensor on UV reactor.

3. Irish Water should review the frequency of calibration of the UVI sensors to ensure that the UV disinfection system operates within its validated range at all times.
4. Irish Water should put in place a procedure in the event of the breakage of a UV lamp and the release of mercury.

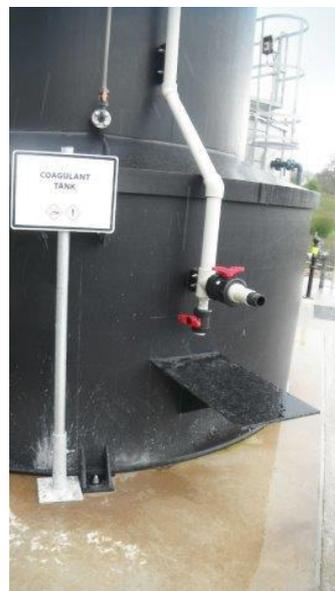
9.	<p>Chemical storage and bunds</p> <ul style="list-style-type: none"> a. Chemicals are delivered directly into the bulk tanks and are supervised by the plant operator. No delivery can be made without access being provided by the plant operator. b. All chemicals (PAC, poly, chlorine, fluoride) in bulk tanks are in double linked bulk tanks and day tanks are bunded. All chemical tanks are fitted with level sensors to indicate when tanks are almost full. Spill kits are carried in the plant operator's vehicle. c. The fillpoints are not contained in a bunded area (photograph 3). Spill trays are on site for use during deliveries. It was unclear if spill trays could contain the contents of bulk tank delivery pipes. Diesel for the onsite generator is stored in a double lined container. d. All chemical storage tanks are appropriately labelled and fitted with appropriate health and safety signage.

Photograph 3: Example of delivery pipe to bulk storage tank not within bunded area.

5. Irish Water should review chemical storage arrangements at the treatment plant. Fill points for storage tanks should be within a bunded area. Refer to EPA guidance document –“*IPC Guidance Note on Storage and Transfer of Materials for Scheduled Activities*”.
6. Irish Water should ensure that the spill trays used during the delivery of chemicals into bulk tanks have sufficient capacity to contain the contents of the delivery pipe.
