Drinking Water Audit Report

County:	Roscommon	Date of Audit:	03/07/2014
Plant visited:	Castlerea Regional (Longford Springs)	Date of issue of Audit Report:	17/07/2014
		File Reference:	DW2008/382
		Auditors:	Ms Yvonne Doris
Audit Criteria:	<ul style="list-style-type: none"> • The <i>European Union (Drinking Water) Regulations 2014 (S.I. 122 of 2014)</i>. • <i>The EPA Handbook on the Implementation of the Regulations for Water Services Authorities for Public Water Supplies (ISBN: 978-1-84095-349-7)</i> • The recommendations specified in the EPA Report on <i>The Provision and Quality of Drinking Water in Ireland</i>. • The recommendations in any previous audit reports.

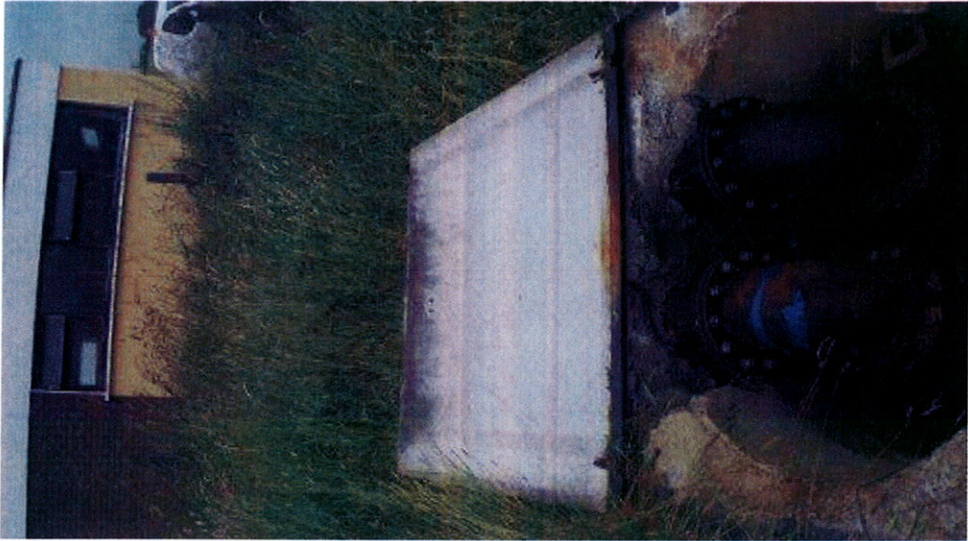
<p>1.</p>	<p>Source Protection</p> <ul style="list-style-type: none">a. The source is Longford Springs (photograph 1). The <i>Cryptosporidium</i> risk assessment score is 150 (very high risk). Longford springs overflows to the river Francis. The abstraction chamber contains two abstraction pipes (photograph 2). The water table fluctuates by about a metre. The water table was 1.2 m below ground level at the time of the audit but can be as high as 0.5m below ground level.b. The GSI report <i>Castlerea Water Supply Scheme Longford Spring and Silver Island Spring, Groundwater Source Protection Zones</i> (GSI, 2003) delineated the source protection zone for the Longford Spring as extremely vulnerable due to significant karstification. The zone of contribution (ZOC) comprises five springs including the Longford Spring. Groundwater within any part of the ZOC could reach the spring within 100 days and the entire ZOC should be classified as the Inner Protection Area. The report found total and faecal coliforms in the raw water samples and suggested that a source of contamination is likely to be organic waste, possibly farmyard wastes. The GSI recommended that, all potential hazards in the ZOC should be adequately assessed.c. The new borehole at Longford springs (photograph 3) produces 1,000m³/day. Further capping and wellhead protection work will be completed by Roscommon County Council. Demand in the Castlerea Regional supply is 1,300 m³/day.

Photograph 1: Longford springs abstraction and pumphouse

1. The Water Services Authority should characterise the variability in raw water quality and compile a source water safety plan in order to mitigate any risks to the abstracted water (http://whqlibdoc.who.int/publications/2009/9789241562638_eng_print.pdf). Trends in raw water quality should be analysed and used to determine the optimum treatment conditions for the water at the plant. Data should be used to identify whether rapid variations in raw water quality give rise to problems with the treatment process.

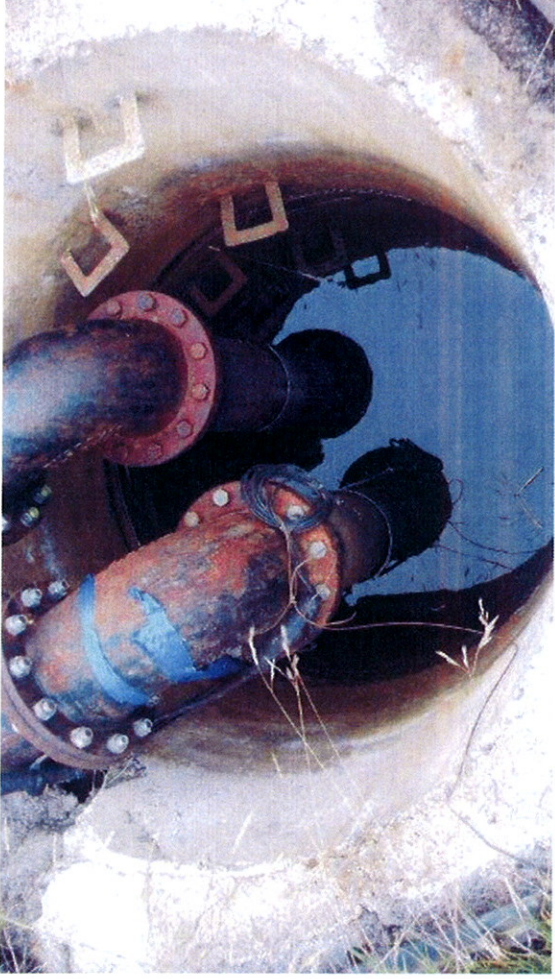
Photograph 2: Water table in abstraction chamber

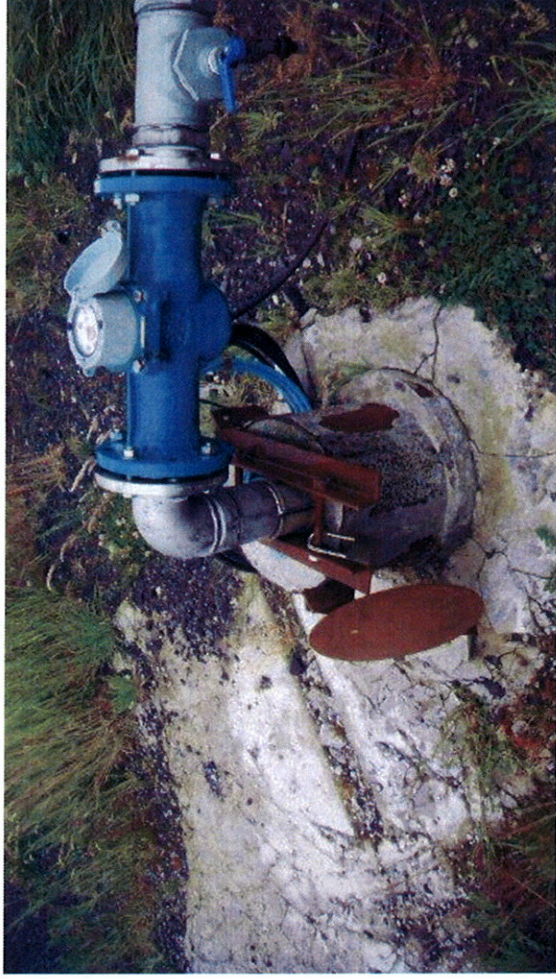
Photograph 3: New borehole at Longford Springs

4. The Water Services Authority should ensure that the borehole at Longford Spring is suitably capped and that the linings and seals are maintained.
